# Modeling of support system for preventing retrogressive slide of Ambarlı landslide in Avcılar district, Istanbul

İbrahim KUŞKU<sup>1\*</sup>, Süleyman DALGIÇ<sup>2</sup>

<sup>1,2</sup>Department of Geological Engineering, Faculty of Engineering, Istanbul University-Cerrahpaşa, Istanbul, Turkey.  
ibrahim@istanbul.edu.tr, dalgic@istanbul.edu.tr

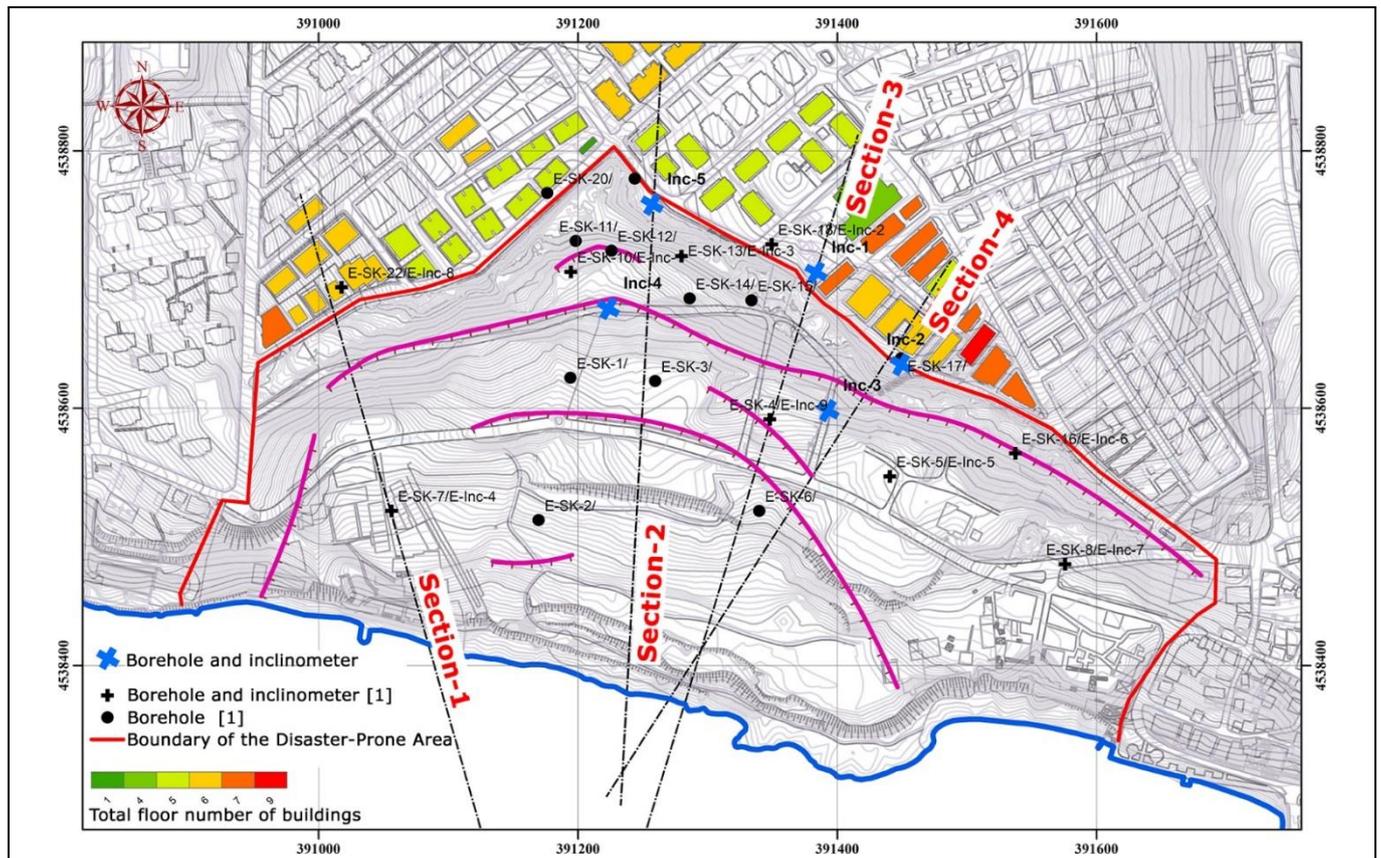
Figure 1. Borehole and inclinometer measurement points, section lines, surface ruptures of landslide in the study area (modified from Güler et al. [1]) and total floor number of buildings in the impact area.

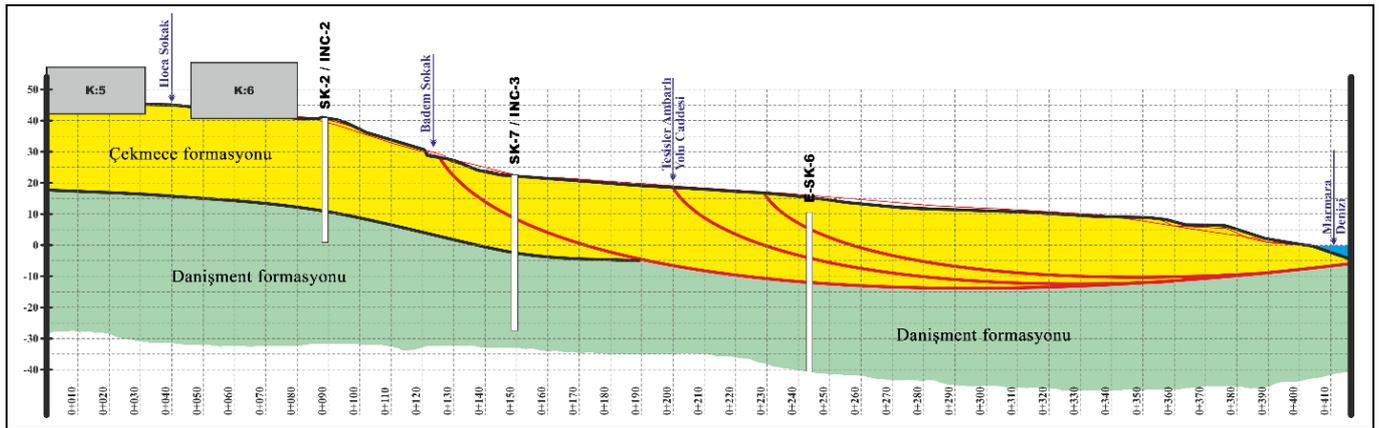
formation is characterized by clayey gravel or gravelly clay levels. Below the Çekmece formation are green-light brown, partly gravelly, tuff interlayered firm-compact clay (CH) levels of the Danişmen formation (Figure 2). In the Disaster-Prone Area, Danişmen formation-Çekmece formation are mostly bordered by slip plane. In the study area, groundwater depth is between 7.0 m and 10.0 m.

Figure 2. Simplified geologic section of landslide area along the section-4.

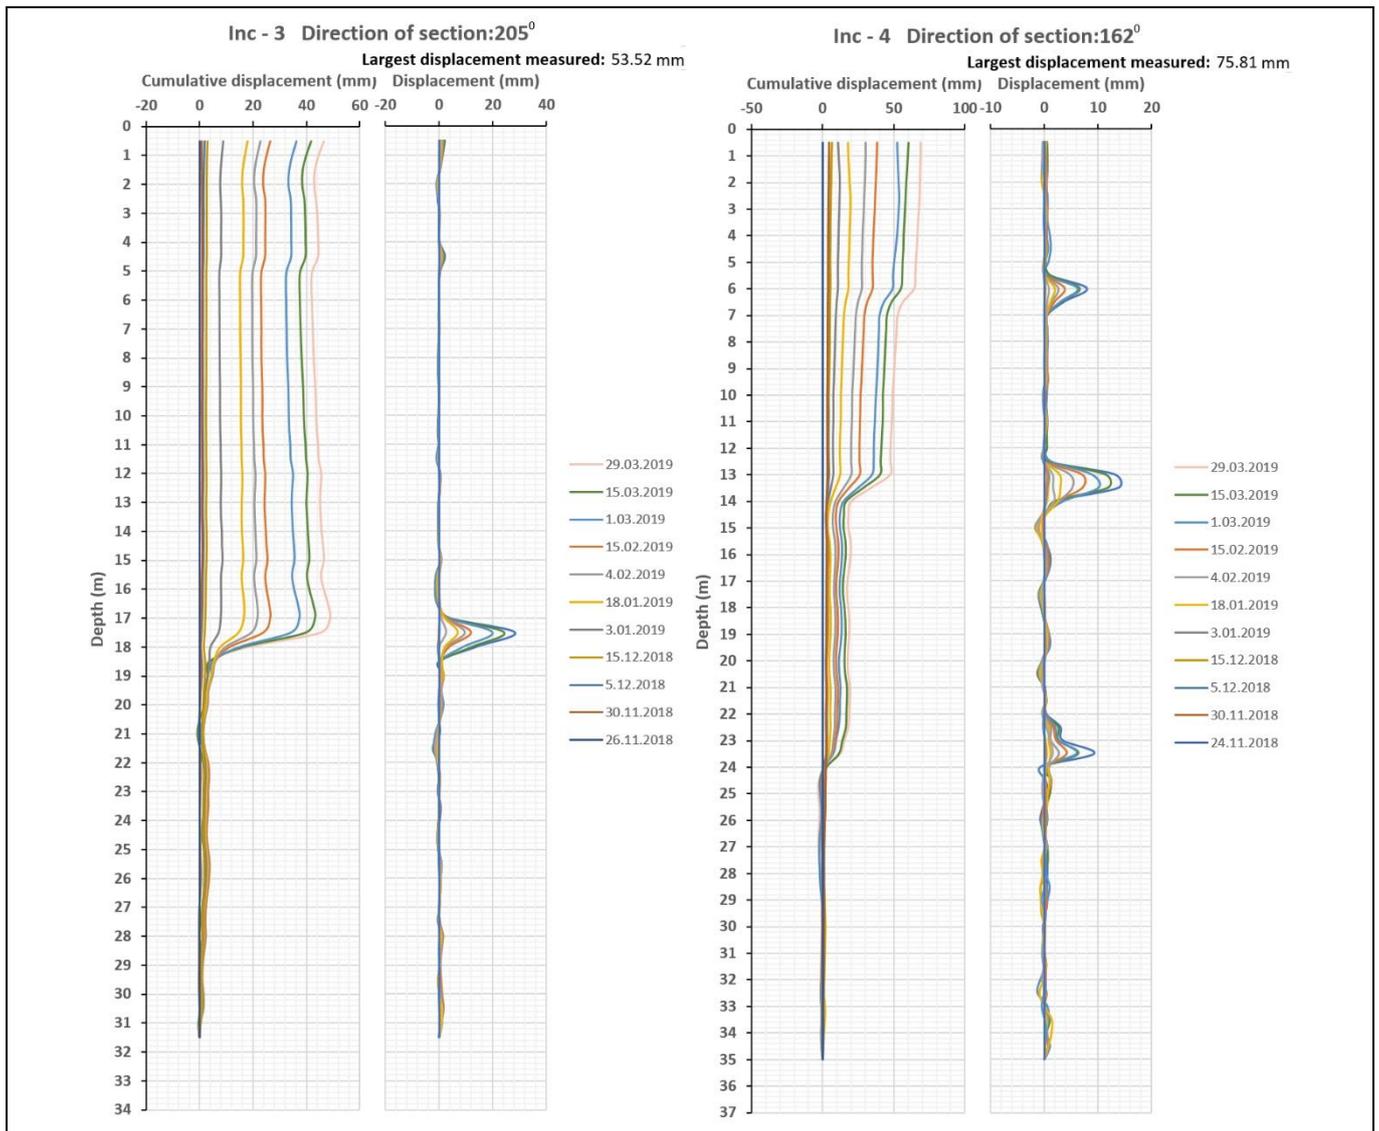
Inclinometer measurements conducted for 5 boreholes in the frame of this study yielded slip planes at depths between 5.0 m and 24.0 m. The slip determined at a depth of 5.0 m in borehole Inc-1 outside of landslide area occurs in the artificial fill at the contact of units of the Çekmece formation. In boreholes Inc-3 and Inc-4, 1 and 3 slip planes were observed, respectively. The depth of slip planes is 18.5 m in borehole Inc-3 and 6, 14 and 24 m in Inc-4 (Figure 3). The maximum displacements are 10.89 mm in Inc-1, 4.55 mm in Inc-2, 53.52 mm in Inc-3, 75.81 mm in Inc-4 and 5.46 mm in Inc-5. According to cumulative displacement velocity estimations, the maximum displacement rate is 0.086 mm/day in Inc-1, 0.037 mm/day in Inc-2, 0.397 mm/day in Inc-3, 0.549 mm/day in Inc-4 and 0.044 mm/day in Inc-5. The movements are toward the hillside slope and the average values are 172°K in Inc-1, 207°K in Inc-2, 205°K in Inc-3, 62°K in Inc-4 and 260°K in borehole Inc-5.

Figure 3. Inc-3 and Inc-4 depth-displacement graphics.

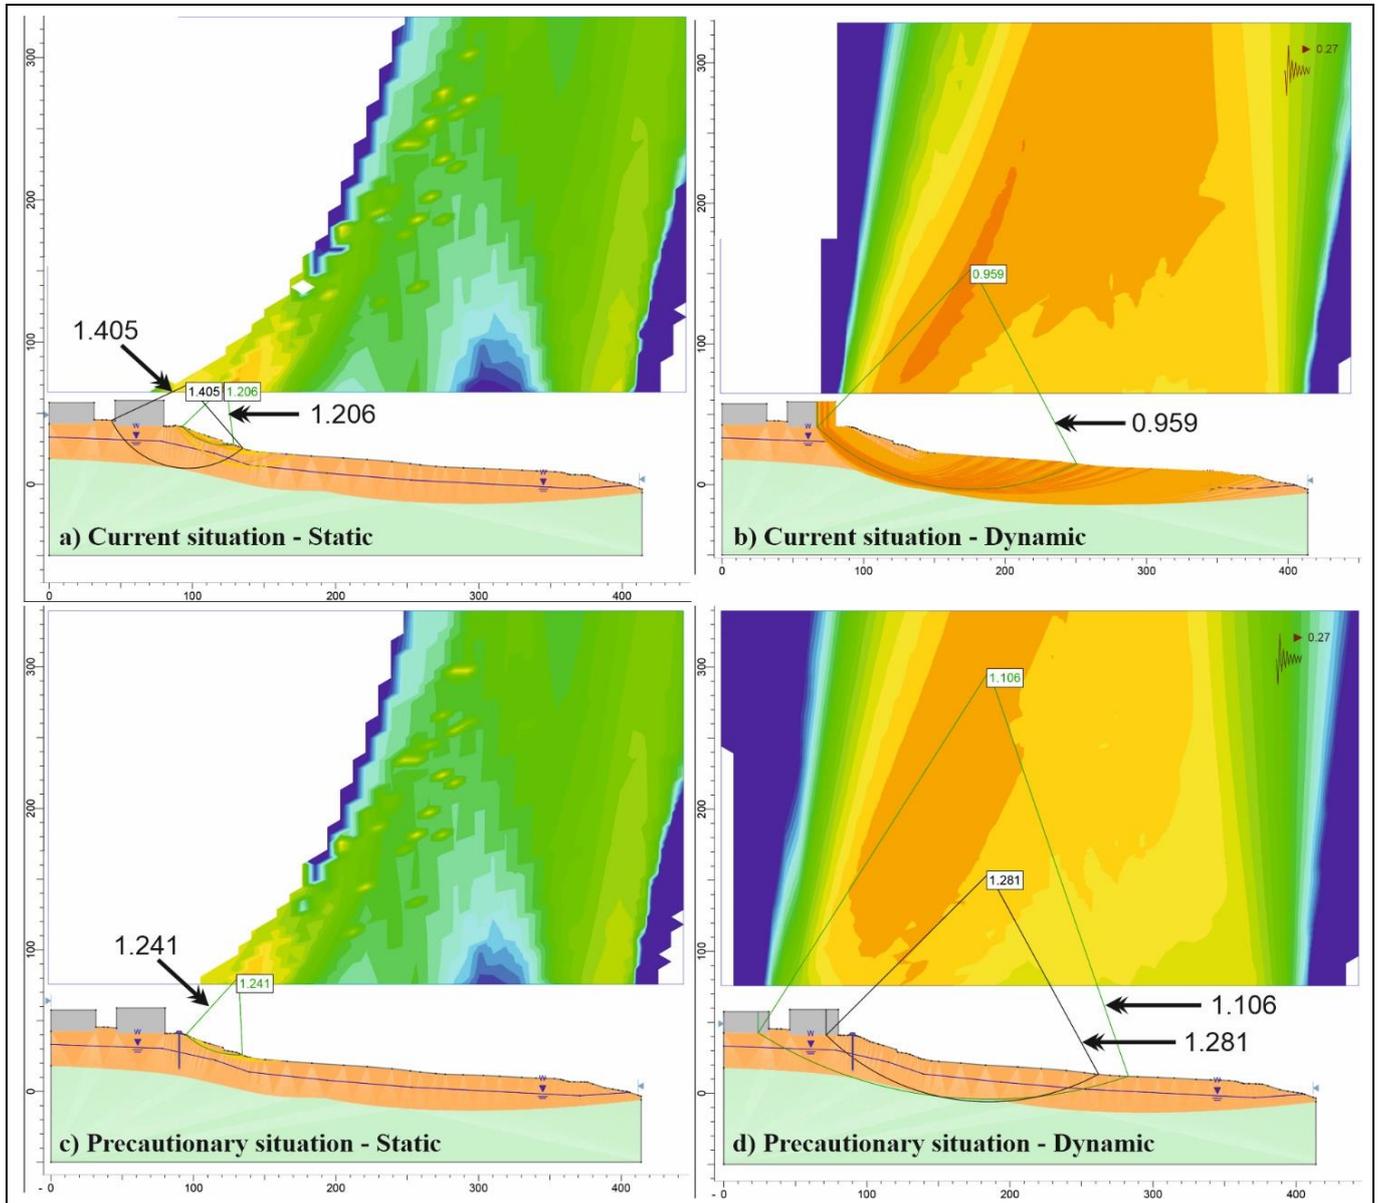
4 different analysis cases are shown in Table 5 and representative sections are given in Figure 4. Results of analysis indicate that stability problems along the Section-1, Section- 2, Section-3 and Section-4 extend outside the Disaster-Prone Area (Table 5). Results of stability analysis carried out at north of Disaster-Prone Area indicate that roads and buildings in this site are seated on soils with stability problems. This is also supported by velocities estimated by surface ruptures of slip planes, ongoing deformations and displacements revealed by inclinometer measurements.

established by the proposed rehabilitation method, the results obtained are given in Table 5, and representative section is shown in Figure 4. Results of analysis carried out proposed rehabilitation method reveal that Section-1, Section-2 and Section-4 at static condition and Section-3 at dynamic condition do not fulfil the safety criteria. However, safety coefficients

estimated lower than necessary limits and possible slip circles determined by these coefficients are within the Disaster-Prone Area. Considering the northward border of Disaster-Prone Area, results of analysis indicate that proposed bored pile system yielded successful results to increase the stability conditions.

Figure 4. For current and precautionary situations static and dynamic stability analyses along the Section – 4.

In this study, bored pile element structure was taken into consideration that is applicable for maintaining the stability. In the selection of the location and depth of the bored piles, it is aimed not to stop the landslide, but to prevent the landslide from regressing and not affecting the stability of the structures. Therefore, the system designed to be applied piles, which is diameter of 120 cm and length of 30 m, on the boundary of Disaster-Prone Area. The shear strength of the piles used 1300 kN/m in the stability analysis. The analysis was repeated for static and pseudo-static conditions using new models
