## Causes of Bursa Yıldırım district Mollaarap landslide and its improvement studies

Özkan CORUK<sup>1\*</sup>, Aydın KAVAK<sup>2</sup>

Special Issue Article/Özel Sayı Makalesi

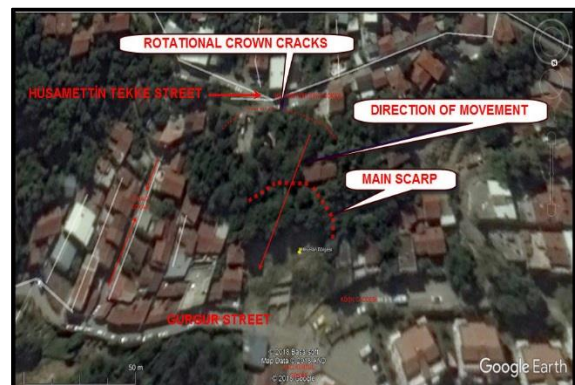
Uncontrolled excavations, uncontrolled fillings and uncontrolled technical operations that would change the load balance on the slope will degrade the area's stability and cause mass movements in all of the critical balance slopes in the region. As a matter of fact, the excavations that were carried out in the study area that were uncontrolled and/or conducted without considering the geological and geomorphological factors that were previously defined caused the landslide by disrupting the slope stability. The landslide occurred after uncontrolled excavation on the slope that slopes 70-75 degrees to the north between Gürgür Street and Hüsametttin Tekke Street (Figure 2). Thus, firstly, a north-northeast oriented movement took place along the excavation slope, and subsequently, secondary fractures and settlements that progressed up to +340,00 to +345,00 m elevations occurred in the section that also includes Hüsametttin Tekke street. Sliding or moving material thickness ranges from 3.00 to 5.00 meters. After the initial movement, backfilling was attempted to pile up the bottom of the slope, but this attempt, which was considered as a measure, was not successful.

Figure 2. The view of the landslide field on Google Earth image.

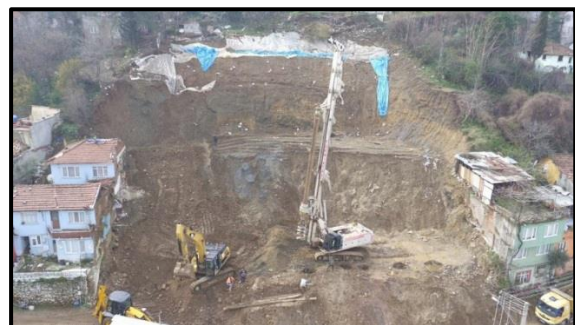
The mass movement continued approximately for 10 days with an average of 10.00 cm/day vertical and 5.00 cm/day horizontal velocity. During this period, seating and deformation on Hüsametttin Tekke Street increased, houses to the east of the excavation site were damaged, 84 households in this section were evacuated for security purposes. After the uncontrolled excavation, an area of approximately 8 decares shown in Figure 3 was affected by the landslide.

Figure 3. Landslide affected area.

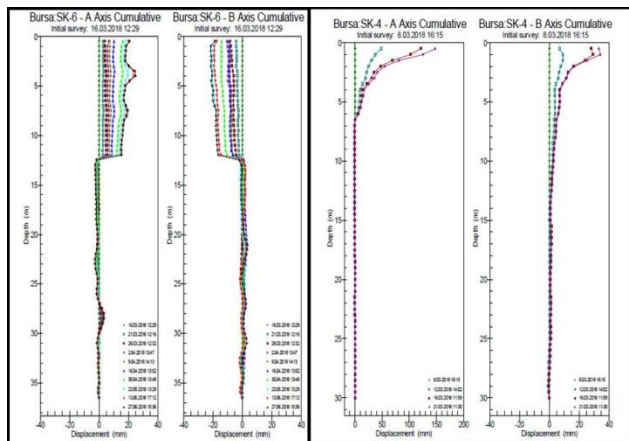
Periodic measurements were made by placing inclinometer pipes in 3 boreholes in order to determine the landslide sliding surface and to determine the sliding speed (Figure 4). After the reference reading, the measurements were continued for the next 2 months with 7-day intervals, then for the next 4 months with 15-day intervals, and until January-2019 at 30-day intervals.

Figure 4. Inclinometer measurement records.

The engineering geology profile was correlated with the deformation records obtained after the first 4 measurements, to determine the main sliding surface, the sliding speed, and secondary sliding surfaces. The sliding surface depth was 12 meters at the crown, 16 meters at the middle and 18 meters at the toe. By taking into account the geotechnical design parameters that were determined by the results of the laboratory experiments and units of the engineering geology model and main sliding surface derived via the inclinometer readings. The V2018 version of the Geo5-Slope Stability computer software was used in the slope stability analysis. As a result of the slope analysis made for non-earthquake and earthquake situations, the current unstable conditions are also revealed in the analysis results. Safety coefficients are very low, especially in the event of an earthquake. In other words, in case of an expected earthquake for the region, the risk of landslides increases even more (Figure 5).

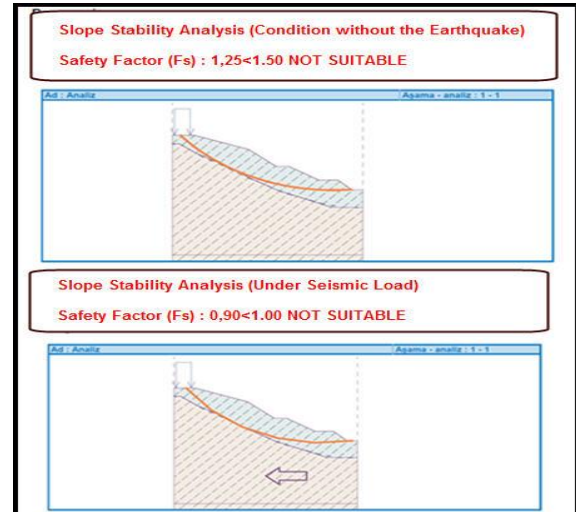
Figure 5. Slope stability analyses result for the current state.

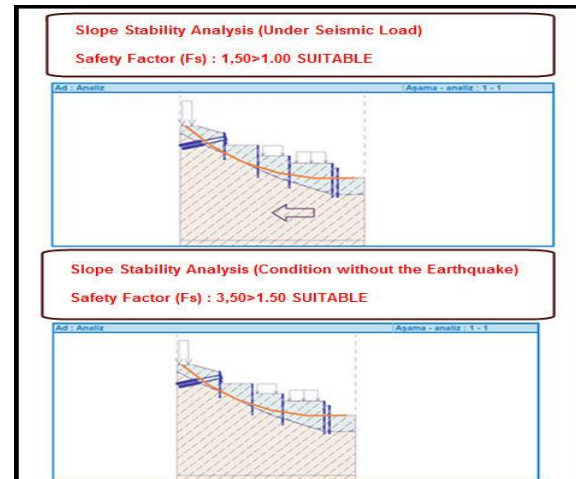
designed and stability analyzes were carried out under this condition. As a result of the slope analysis for this situation, stability conditions were reached in both earthquake and no-earthquake states (Figure 6).

Figure 6. Slope stability analyses after the bored piled and anchored support system.

The bored piled and anchored support system has been proposed as the improvement method to reinforce against the landslide or ensure slope stability. In line with this prediction, 4 rows of piles and 3 belts of anchors at the top row were

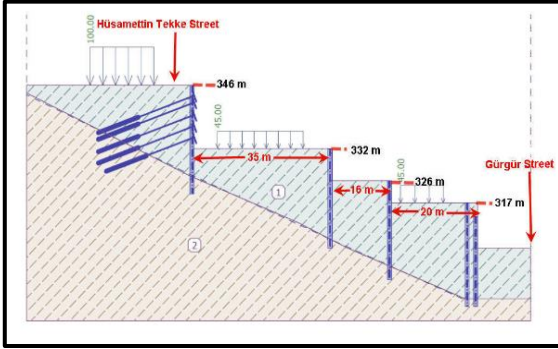
Figure 7. A general model of the support project.

The application project for the bored pile and anchored support system, which provides the stability condition as a result of the analysis, has been prepared. In the project, pile diameters, pile lengths, pile placement, and anchorage lengths were determined according to the engineering geology model and the geotechnical design parameters of the geotechnical units. All with the data, the loads that will be carried by the support systems were calculated and pile reinforcement and anchorage tension loads were defined accordingly. In this context, detailed project solutions were prepared. A general model of the project is presented in Figure 7.

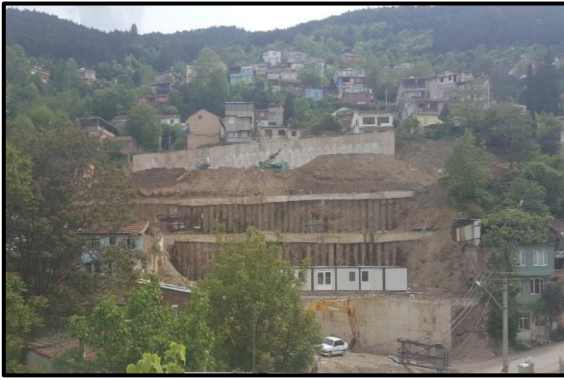
Figure 8. View of the applied support system.

The support structures secured the landslide on the slope. Stability in inclinometer readings and geodetic measurements indicates that the stability conditions are met in the landslide area.

Support applications and slope arrangements within the scope of the project were carried out in stages from the toe to the crown. In parallel with the improvement studies, a stationary trend was observed by the inclinometers. Within the scope of the improvement works carried out, a total of 290 piles and 314 meters long head beam were manufactured in 4 different rows in the study area. In order to reach Hüsamettin Tekke street

elevation (+346.00 meters) on the top row head beam, a curtain wall of 5.00 meters high and 67.00 meters long was built. The structure behind this wall for drainage, backfill, anchoring and barbican outlet is an ongoing effort. The current state of the pile-supported walls and the location of the platforms behind these support structures are presented in Figure 8.
