Delayed therapy and syncope due to excessive charging time in a patient with implantable defibrillator during a fast ventricular tachycardia episode

Uğur Canpolat
Metin Okşul
Kudret Aytemir
Giray Kabakçı
Department of Cardiology,
Hacettepe University
Faculty of Medicine,
Ankara, Turkey

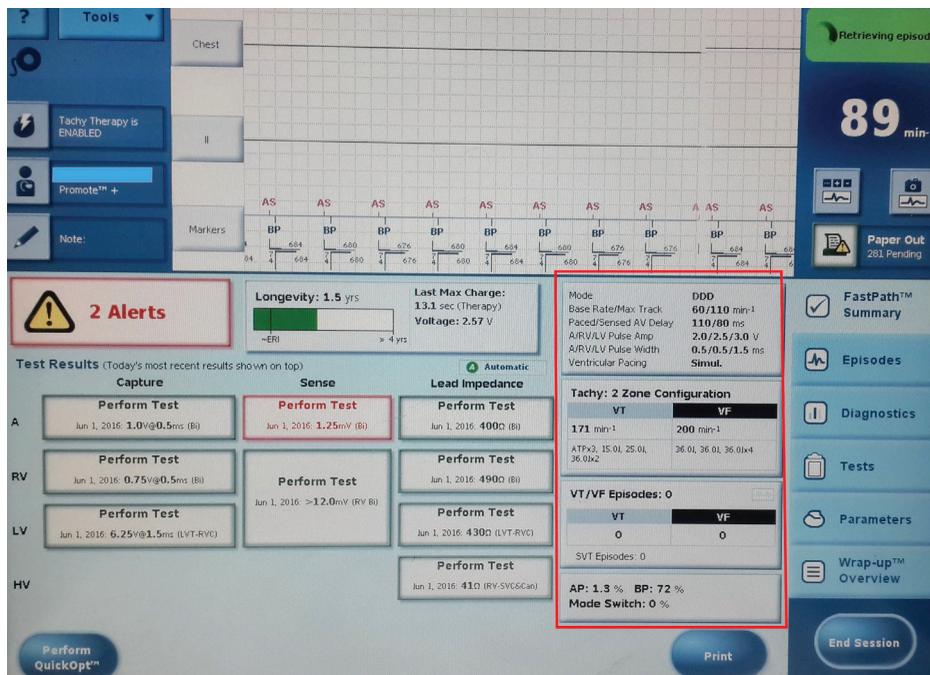
serum creatinine and blood urea. Device interrogation indicated: DDD (biventricular) 60 bpm, ventricular tachycardia (VT) detection of 171-200 bpm and ventricular fibrillation (VF) detection of >200 bpm. Therapies were programmed as follows: VT zone: antitachycardia pacing/burst pacing (ATP) (3 attempts) followed by shock, and VF zone: shock (Figure). Battery longevity was 1.5 years and lead functions were normal. Two episodes of nonsustained VT terminated by ATP and 1 VF episode were logged. The episode logged in the VF zone was actually a fast VT (218 bpm), but it fell into the VF zone because of the rate criteria. Video 1* shows the fast VT episode, which was associated with syncope. Despite successful termination of arrhythmia with a 36-J shock, there was a total of 24.1-second delay in battery charging, which was the cause of delayed therapy and syncope (Video 2*). Therefore, increased charge time was considered a reason for a potential further loss of functioning and immediate battery replacement was performed.

Figures– The baseline programming of the Cardiac Resynchronisation Therapy Defibrillator model (St. Jude Medical, Inc., St. Paul, MN, USA). *Supplementary video files associated with this presentation can be found in the online version of the journal.
