# Material analyses and field applications for the conservation of archeological remains found in the aerial cable car station construction site in Hatay (Türkiye)

Dilek EKŞİ AKBULUT<sup>1\*</sup>, Mehmet UĞURYOL<sup>2</sup>, Burak HAZNEDAR<sup>3</sup>

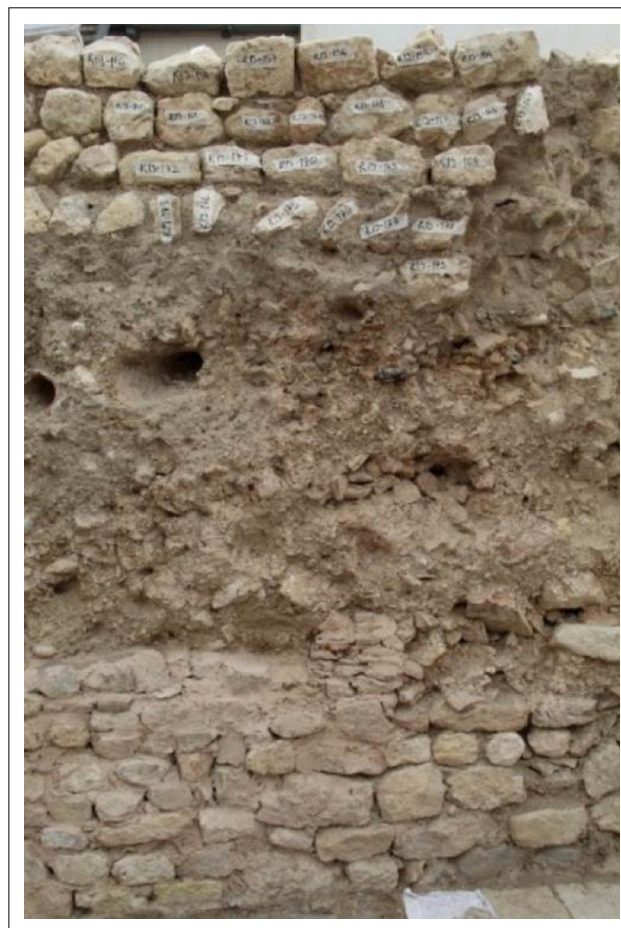
Although the walls were being supported with sandbags against rain, it was predicted that precipitation would pose a threat in winter conditions, especially to the weak masses containing soil, rubble, and broken terracotta fragments (Figure 12) present between some stone walls at different elevations.

**Figure 12.** Weak masses containing soil, rubble, and broken terracotta fragments that are prone to erosion by rain.

The weak masses containing soil, rubble, and broken terracotta fragments shown in Figure 16 that are prone to getting damaged by precipitation were reinforced by coating them with a hydraulic lime mortar of higher strength than the one designated for pointing the walls (Figure 15). NHL 5 type natural hydraulic lime and river sand were used for this purpose, in line with the proportions given in Table 12.

Furthermore, prognosticating that precipitation would pose a threat to the weak masses containing soil, rubble, and broken terracotta fragments present at different elevations, these masses were reinforced by coating them with a hydraulic lime mortar of higher strength than the one designated for pointing the stone walls.

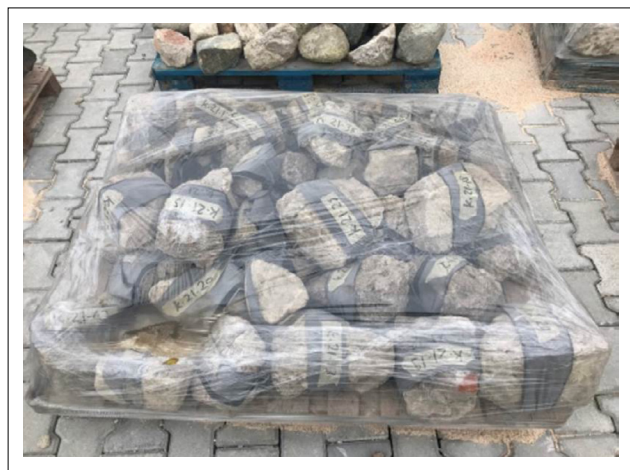
**Condition of the walls:** In September 2018, partial wall removal work started in the regions where the well foundations correspond. The removed wall stones were numbered and properly kept in a storage area (Figure 11). A scaffold was erected for the work related to well foundations. The wells were dug by hand.

**Figure 11.** Numbered wall stones.

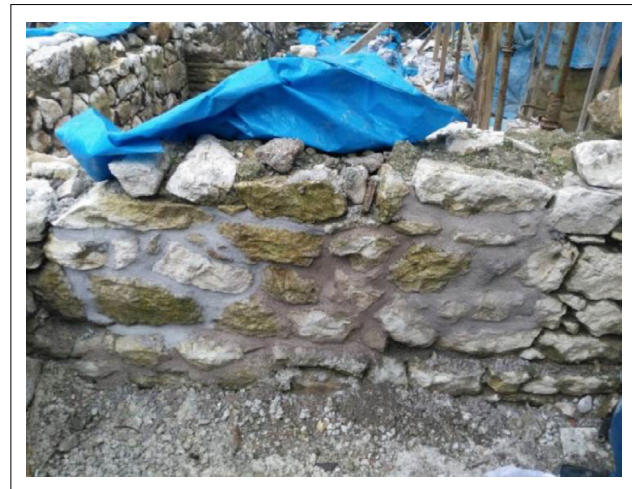
**Figure 15.** Previously applied lime mortar with a lighter color and fresh trial mortars with the hybrid binder (they can be distinguished by the color differences between them) applied to a small section infested by algae.

proportions. These mortars, which also contain river sand, tuff fragments, and tuff dust, were applied next to the previously applied mortar (Figure 15).

Mortars containing only NHL as the binder were also prepared, but it was observed that the workability of the mortars with the hybrid binder was better than that of the mortars containing only NHL as the binder. Two weeks after the application, it was realized that the strength of the mortars with hybrid binders, whose workability was also high, was at a satisfactory level. Therefore, a mortar with a hybrid binder composed of lime putty and NHL in equal proportions was decided to be used.

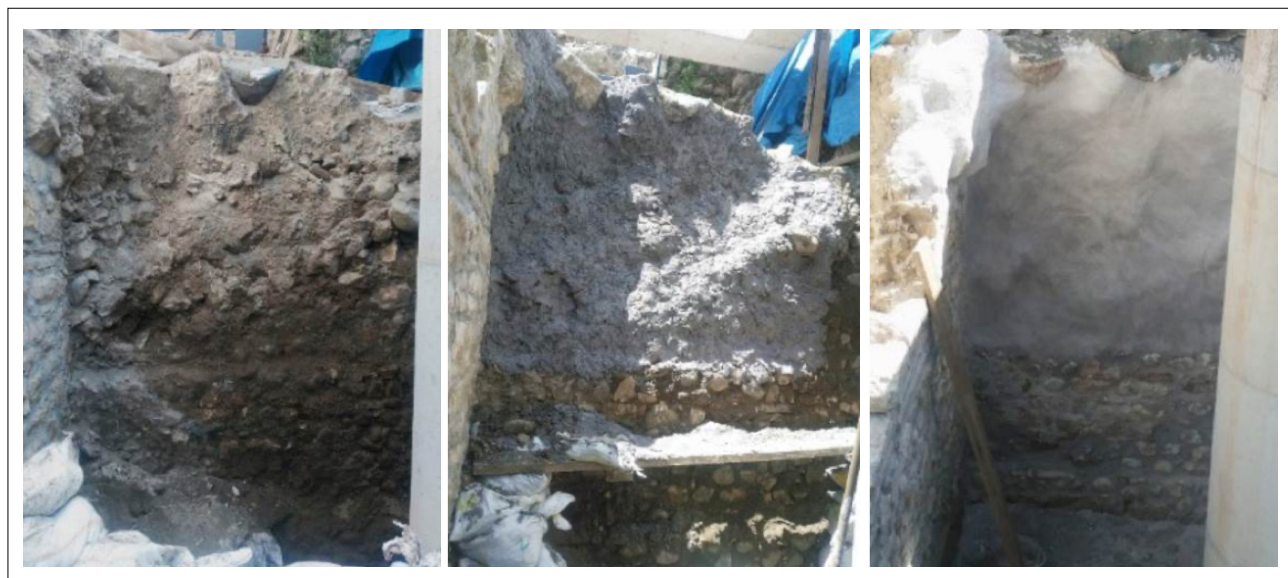
**Figure 16.** A weak mass consolidated by covering it with a lime mortar containing NHL 5.

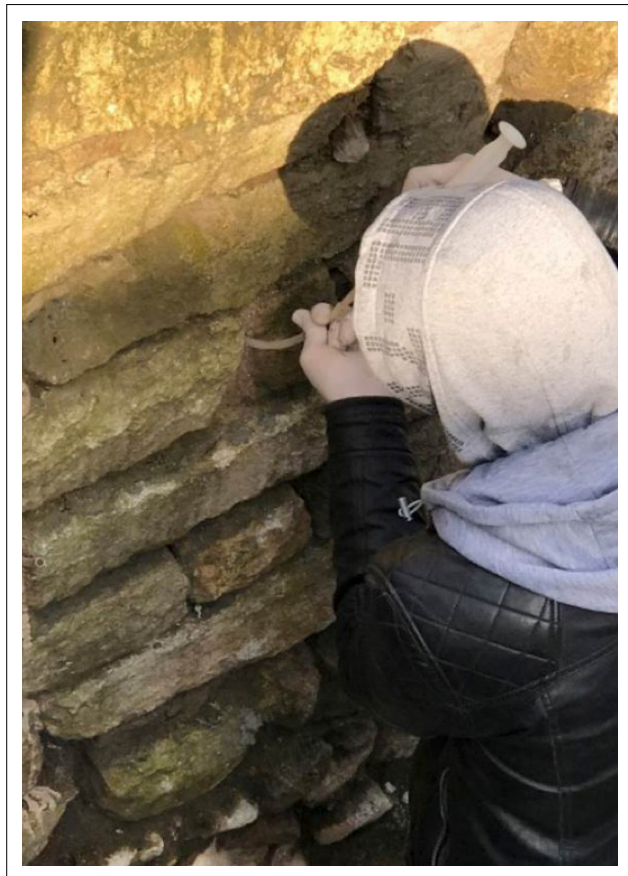
**Figure 18.** Grout application through injection on a wall infested with algae.

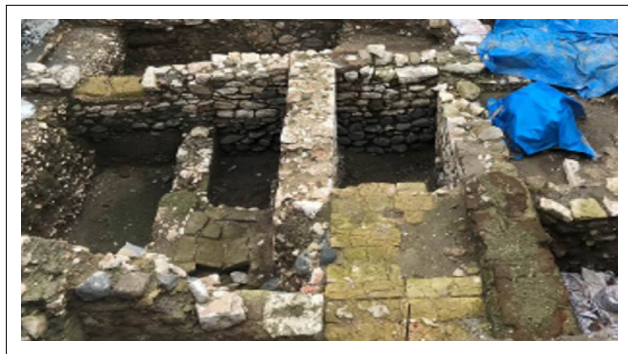
**Figure 19.** Algae formation on the horizontal surfaces of the walls.

Interventions to control the biological activity were also carried out as part of the conservation of the walls. In this respect, a biocide containing benzalkonium chloride succeeded in the removal and prevention of the algae, though dampness should be controlled under the glass platform and cleaning operations should be repeated if infestation occurs again. Moreover, assembly and cleaning works performed on the earthenware pipes and terracotta sarcophagus fragments were carried out successfully under the conditions available at the worksite.

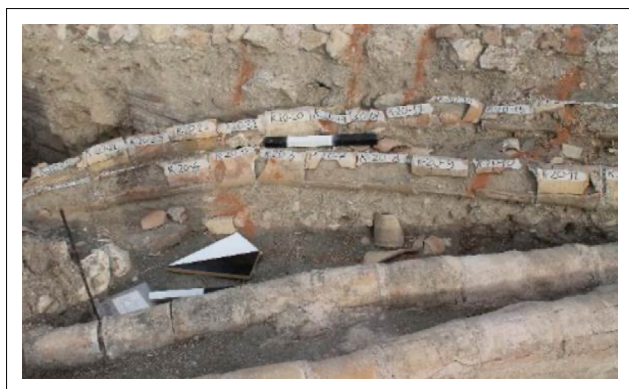
**Figure 20.** Earthenware pipes (on the left) and a terracotta sarcophagus (on the right) broken into pieces.

The excavated earthenware pipe and terracotta sarcophagus fragments (Figure 20) were cleaned and assembled in the workshop set up on the worksite to be displayed in situ. The fragments were assembled in sandboxes using epoxy resin (Figure 21). To remove loose deposits, water and plastic brushes were used, while concretions were removed using scalpels and dental instruments.

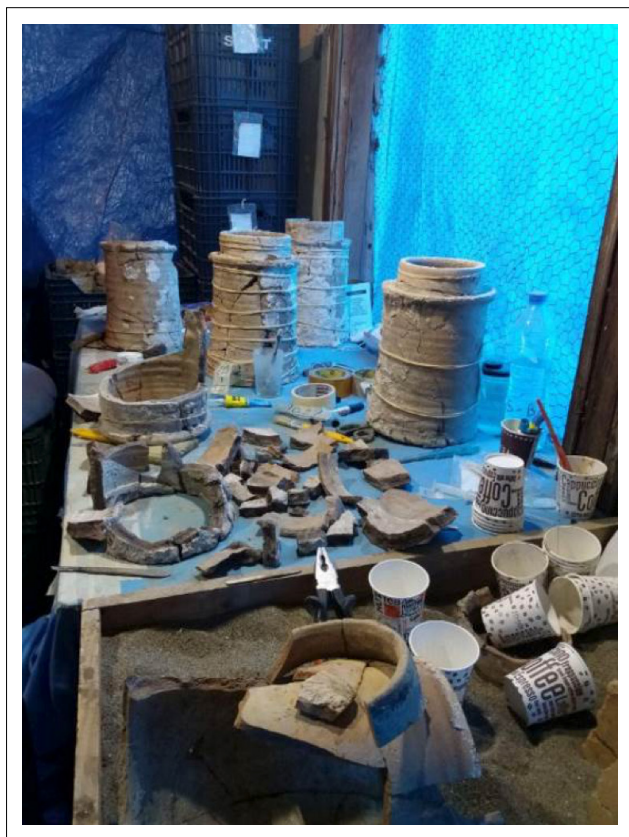
**Figure 21.** Earthenware pipe fragments that were cleaned and assembled in the workshop set up at the worksite.

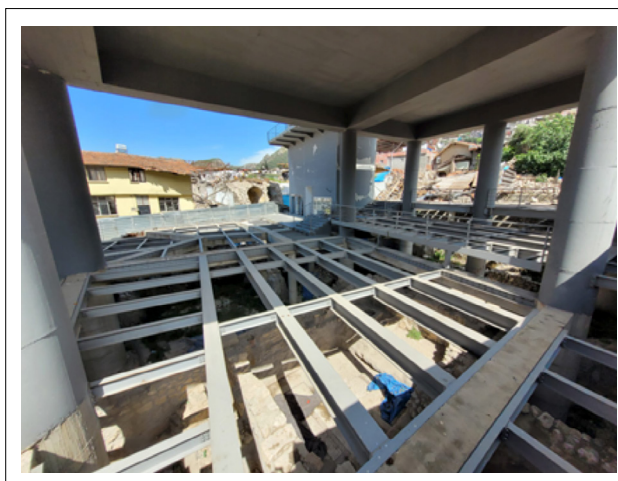
**Figure 22.** General view of the site after the earthquake.

It should finally be noted that, after the earthquake, the site is not allowed to be visited or inspected yet; however, according to the view from outside the archaeological site, the consolidated remains seem sound and undamaged by the earthquake (Figure 22).
