## Unexpected cause of lead fracture: A stylet left inside the right ventricular pacemaker lead

*Elektrod kırığının beklenmedik bir nedeni: Sağ ventrikül elektrodu içinde bırakılan stile*

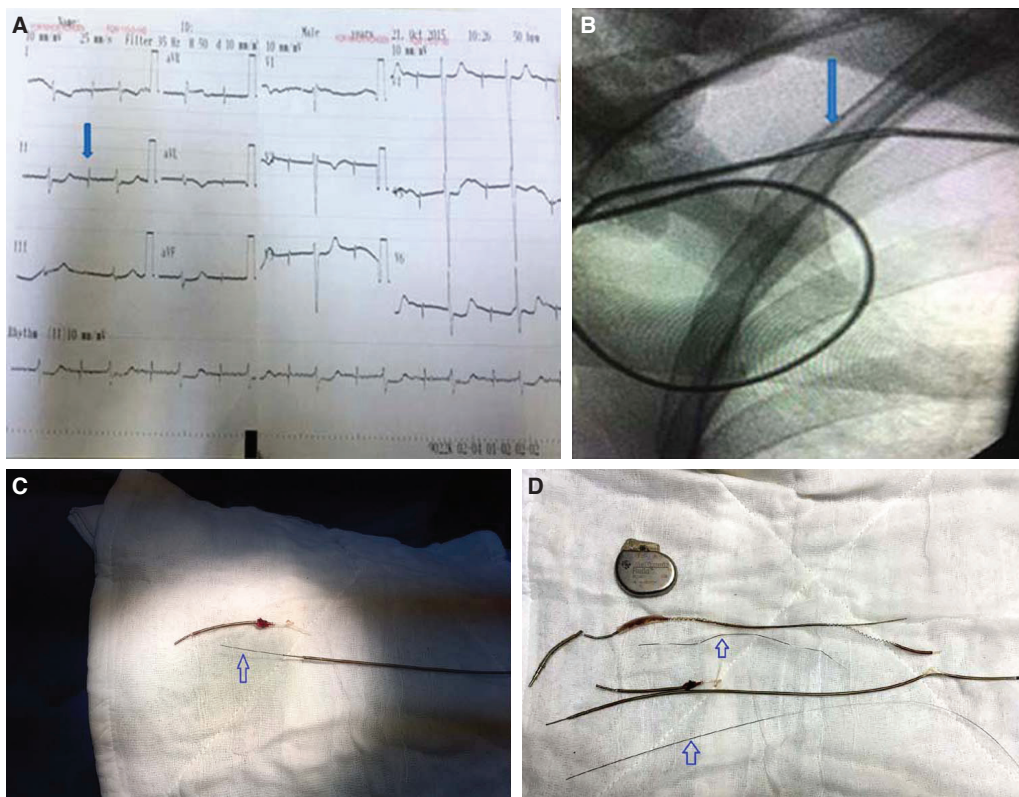
A 55-year-old female patient with earlier diagnosis of cardiac cirrhosis and mitral valve implantation was admitted with complaints of weakness and dizziness. She had undergone VVIR pacemaker implantation 9 years earlier due to low ventricular rate atrial fibrillation and had generator replacement procedure 3 months previously. Electrocardiogram indicated pacemaker dysfunction due to failure to capture (Figure A). Evaluation of pacemaker revealed high impedance and threshold data after implantation. Chest X-ray and fluoroscopic image showed lead fracture (Figure B). Large right heart chambers

with left ventricular ejection fraction of 32% were detected in transthoracic echocardiography. Following these evaluations, extraction of fractured lead and pacemaker and implantation of VVIR implantable cardioverter-defibrillator (ICD) was planned. Transvenous lead extraction system (Spectranetics Inc., Colorado Springs, CO, USA) was used for procedure. Pacemaker generator and lead were carefully dissected and completely freed from scar tissue, and pacemaker generator was removed from lead and pacemaker pocket. During the extraction procedure, we cut the proximal part of the lead and attempted but were unable to advance locking stylet through the lead. We discovered that inner lumen of electrode contained unexpected stylet previously left behind (Figure C). Passive manual traction was applied and the lead was extracted successfully. Stylet left inside the electrode was removed (Figure D). In the same session, VVIR-ICD was implanted from the same side.

**Figures– (A)** Electrocardiogram showing pacemaker dysfunction due to loss of capture. **(B)** Fluoroscopic image of lead fracture. Stylet left inside the electrode (arrows). **(C)** Stylet from inside the electrode after manual traction. **(D)** Two pieces of the stylet removed from the electrode.
