Uzay neşteri (CyberKnife®) uygunsuz şok nedeni olabilir

CyberKnife® can cause inappropriate shocks

Dr. Nazmiye Çakmak, Dr. Hale Yılmaz, Dr. Nurten Sayar, Dr. Betül Erer

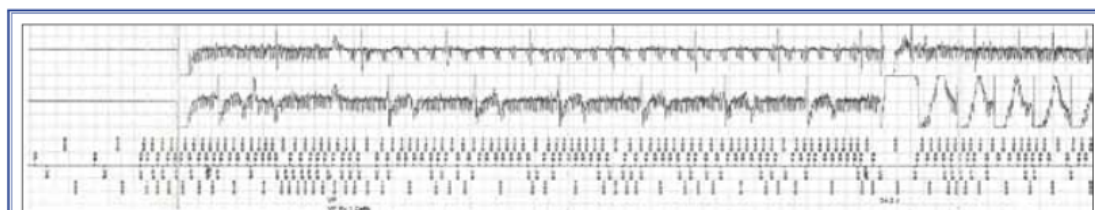
the memory of ICD were analyzed, it was determined that 5 attacks on separate days each lasting for 13-20 secs occurred and ICD defibrillated the heart with a higher-shock energies of 34 joules at each attack. It was also learnt that he was receiving radiotherapy, and felt shivering while these shock waves were delivered. The patient thought that this was due to the radiotherapy therapy he was receiving. Before this therapy he hadn't felt any ICD generated shocks. When all the episodes were analyzed, electromagnetic interferences were detected in atrial, and ventricular channels. It was determined that these vibrations which mimic intracardiac potentials induced oversensing in the form of ventricular fibrillation in the ventricular channel

which resulted in the emergence of inappropriate shocks. (Figure 1) During pacemaker controls, any abnormality with the device was not encountered. However, rapid, irregular, and episodic pulses generated from atrial contractions were revealed. Also during the controls, it was observed that he had been suffering from episodes of atrial fibrillation for the last 48 hours. Then he was hospitalized in the clinics, and cardioversion was planned. Anticoagulant therapy was initiated because of the past history of thrombotic stroke. Upon detection of a thrombus in the left atrial appendage on transesophageal echocardiograms, cardioversion was given up, and the patient was discharged while on warfarin therapy.

Figure 1. Interferences in both channels during intracardiac recordings are seen. Interferences detected in the ventricular channel are sensed as ventricular fibrillations, and thus ICD delivers defibrillation therapy using 34 joule energy. Upper row: atrial channel; intermediate row: ventricular channel; lower row: reference (index) channel. AR: Heart beats sensed during refractory period in the atrial channel which do not cause generation of any response by ICD; Ab: Atrial beats sensed during the refractory period which do not cause generation of any response by ICD AS: sensing of the atrial beats; VS: sensing of the ventricular beats; FS: sensing of the ventricular fibrillation; CE: completion of the charge time; CD:

wave in every recording of ICD within 13-20 seconds during application of multiple daily radiotherapeutic doses delivered from different angles on separate days in radiotherapy sessions lasting nearly one hour has been associated with electromagnetic interferences generated during this short time period. Artifacts on the ventricular channel because of EMI were sensed as intracardiac potentials. These interferences defined as ventricular fibrillation due to oversensing by ICD, induced inappropriate shocks because of tachyarrhythmia treatment mechanisms of ICD had not been inactivated beforehand.

resolved by changing its site of implantation before, and if not possible, replacement of the ICD should be thought after the procedure. ICD should be at least 3 cm away from the radiation field. The amount of radiation exposure of ICD should be known beforehand. This measurement can be performed using dosimetre or estimated by calculation formulas. [17] Before radiotherapy, safe dose should be determined in collaboration with the firm representative in-charge. It has been recommended that radiation dose exposed by ICD should not exceed 1-5 Gy depending on its manufacturer, and model of the device. Radiation dose exposure limit of the ICD of our patient was determined as 5 Gy by the manufacturing firm.[18] Immediately before the procedure, a magnet should be placed over the ICD or ICD should be reprogrammed in order to inactivate ICD's treatment mechanisms of tachyarrhythmias. Thus, ICD will only monitor the patient, and will not activate its treatment mechanism even in case of ventricular tachyarrhythmias. For that reason, during the procedure, patient's heart rhythm should be monitored, and executive representative of the manufacturing firm of the patient's ICD, and the equipment required for cardiopulmonary resuscitation should be readily accessible. If any problem related to ICD arises, a cardiologist should be consulted. ICD should be controlled in detail before, and at weekly intervals during radiotherapy (some authors

suggest after termination of radiotherapy) and at the end of the therapy. These controls should be maintained during the first months after treatment in consideration of cumulative effects of radiation. If functional disorders appear, ICD should be replaced.[3-5,19,20] If all of these safety measures are implemented, then harmful effects of radiation on ICD can be minimized. Besides, development of extremely painful inappropriate shocks will be prevented, and battery life of ICD will be prolonged.
