Entrapment of a Multipolar Mapping Catheter in a Mitral Valve Prosthesis

CASE IMAGE OLGU GÖRÜNTÜSÜ

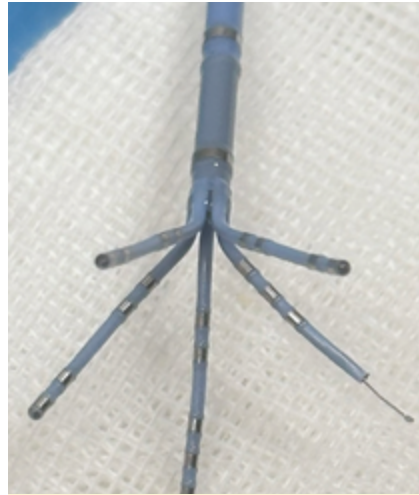
We report the case of a 74-year-old woman with coronary artery disease, prior coronary artery bypass grafting (CABG) and mechanical mitral valve replacement, who was referred for atrial fibrillation ablation. During mapping with a PentaRay catheter near the posteroinferior mitral annulus, resistance was encountered. Cine fluoroscopy revealed entrapment of a spline in the valve, resulting in leaflet obstruction and hemodynamic instability. Manual manoeuvres—including counterclockwise rotation of the PentaRay hub and advancement or withdrawal of the sheath over the catheter shaft—failed to release the catheter. It was eventually withdrawn with force (Videos 1 and 2), which restored valve function but caused rupture of a spline (Video 1, Figures 1 and 2). The ruptured fragment embolized while preparations were underway to retrieve it with a snare. Fluoroscopy localized the embolized catheter in the left hemithorax. Angiography ruled out pulmonary embolization, suggesting localization within the thoracic vasculature (Video 1). Echocardiography confirmed normal valve function. The procedure concluded without further complications and the patient was discharged after 48 hours of observation. Follow-up imaging later identified the fragment in a distal intercostal artery (Figure 2, Video 3).

Figure 1. Ex-vivo catheter image showing four normal splines and one ruptured spline.

If entrapment occurs, initial management should prioritize hemodynamic stability and cessation of all catheter manipulation. Gentle sheath advancement or catheter rotation under imaging guidance may resolve the entrapment. Forceful withdrawal should be a last resort, particularly in the setting of hemodynamic compromise. It is essential that electrophysiology lab staff are trained to recognize and respond promptly to catheter entrapment scenarios.

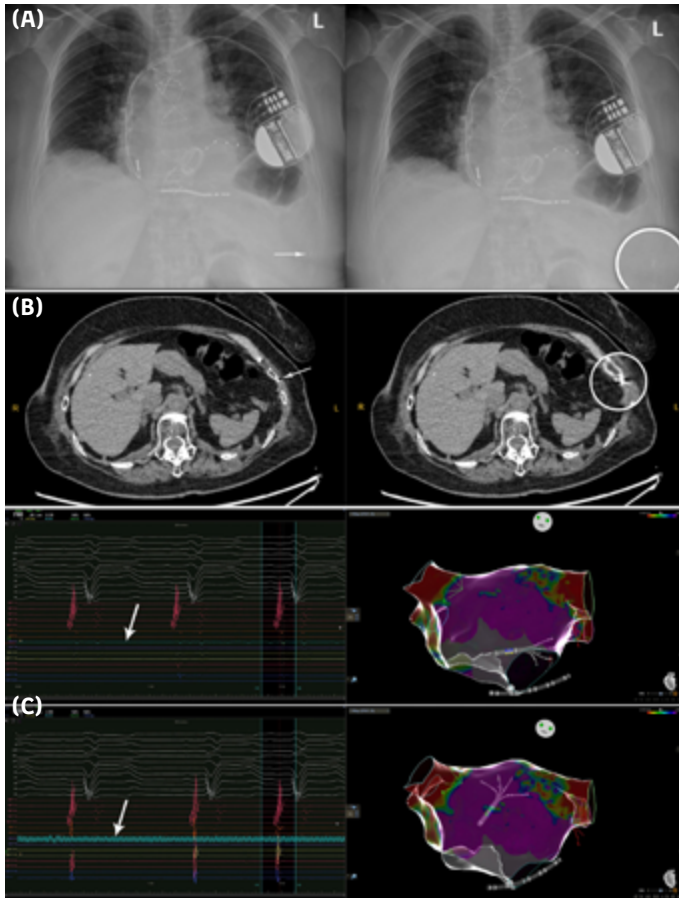
Figure 2. Teleradiograph showing the embolized segment (arrow) near the distal left rib cage in normal (left) and magnified (right) images (A). Computed tomography showing the embolized segment (arrow) in the distal portion of the intercostal artery in normal (left) and magnified (right) axial images. 3D mapping showing all five splines, with at least one located at the orifice of the mechanical valve and far-field atrial and ventricular signals on intracardiac electrograms (arrow) (upper). 3D mapping showing four splines in the left atrial cavity and continuous artifact recording in bipole 5-6 (arrow), with normal electrograms in the remaining electrodes (lower).
