Airbag cover impact: a rarely seen reason for mandibular defects

✉ Ersin Akşam, M.D., ✉ Erhan Sönmez, M.D., ✉ Önder Karaaslan, M.D., ✉ Mustafa Durgun, M.D.

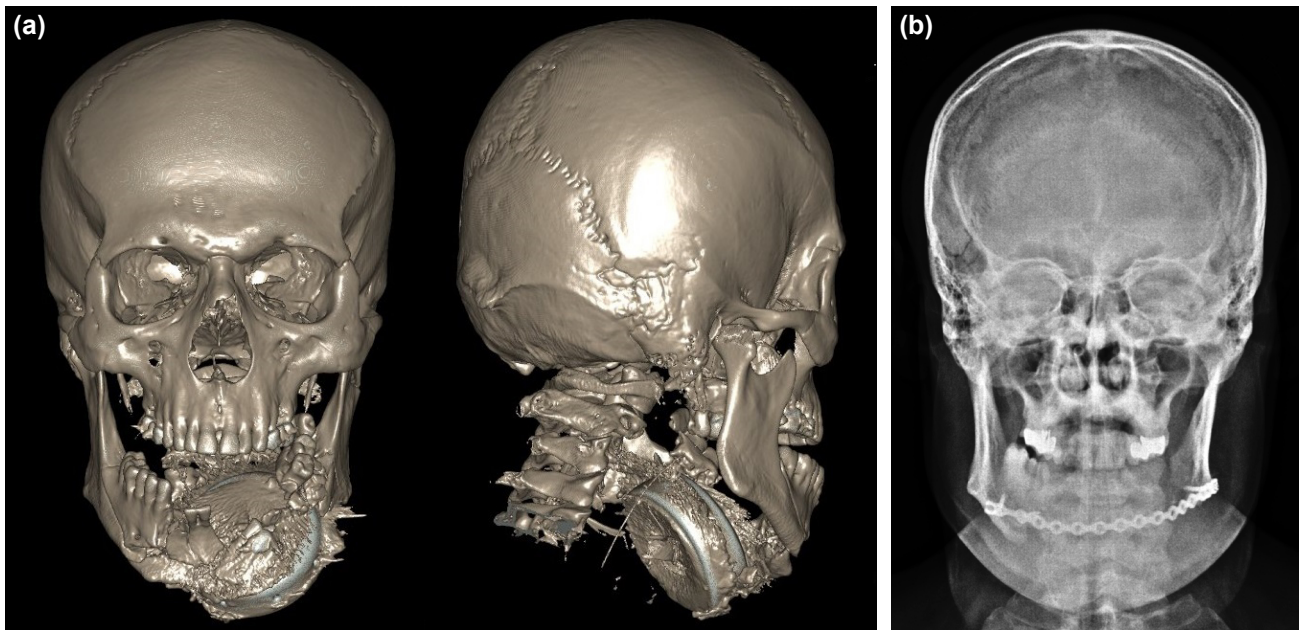
Figure 1. (a) Anterior and lateral oblique view of the three-dimensional computed tomography of the patient. The cover of the steering wheel was embedded into the mandible causing a multi-segment fracture. (b) After excision of the airbag cover and removal of necrotic bone segments, left hemi-mandibular defect was temporarily repaired with plate and screws to prevent its collapse.

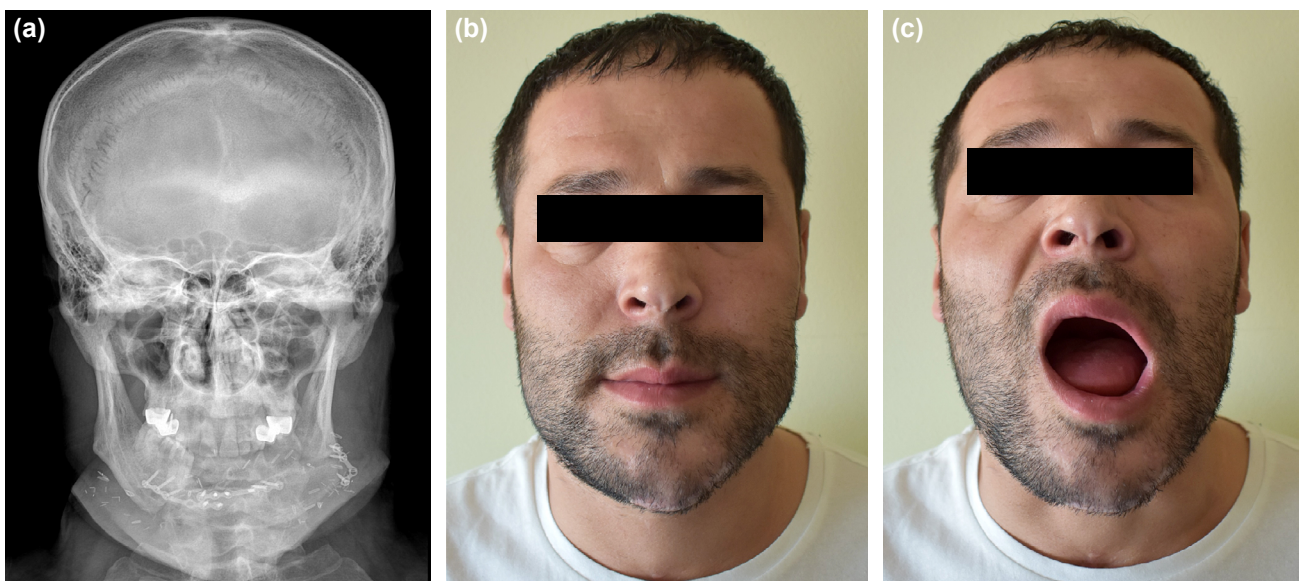
Figure 2. (a-c) Postoperative radiograph and view of the patient. The iliac crest free flap was properly incorporated to the defect. The occlusion and mouth opening was very good.
