As an Example of Urban Space Square – Investigation of Isparta Kaymakkapı Square and Architectural Heritage Structures

M. Elif YAKARTEPE,¹ Ayşe Betül GÖKARSLAN²

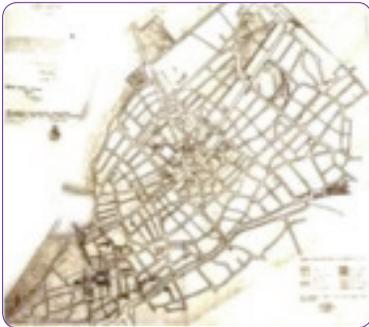
Figure 2. Isparta city first development plan prepared by Prof. Ölsner and Kemal Ahmet Aru in 1938-1943 (Source: Isparta Valiliği, 2001).

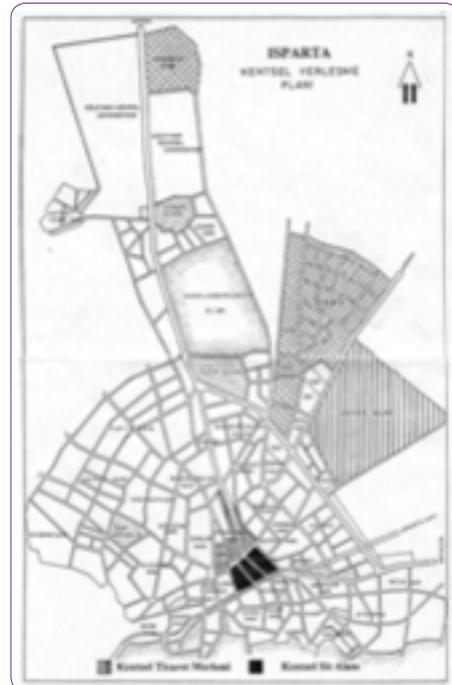
Figure 3. Isparta urban layout plan and urban protected area (Source: Isparta Municipality Archive).

Arrangement works of urban protected sites initiated in 1977 and end off in 1979. Conservation plan, which was made after 1979, preserved the protected site as a whole, hardly to until 1984 (Fig. 2). In 1984, this plan and decisions abolished by The Ministry of Culture and Tourism Cultural and Natural Heritage Preservation Board decision and today conservation applications, which are continued, are started. Area designated as a historic site has been very restricted and this application, for protecting to scale of a single structure in different areas, ruined to the historic pattern in the course of time (Fig. 3) (Sargın, 2005).

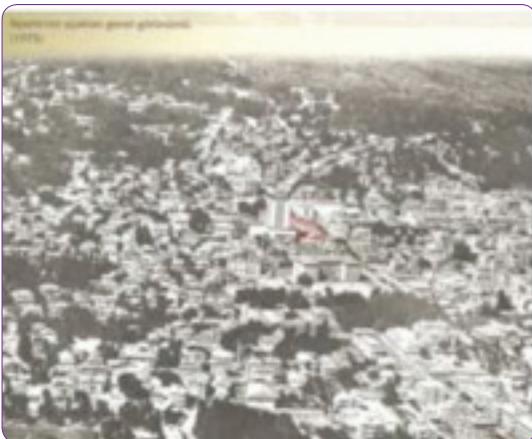
Figure 4. Location of Kaymakkapı Square in Isparta 1975 (Source: Isparta Valiliği, 2001).

Most of the buildings associated with Kaymakkapı Square belong to second part of 20th century. Generally, there are many examples of demolished historic buildings for alteration and new building had been constructed instead of it (Fig. 4).

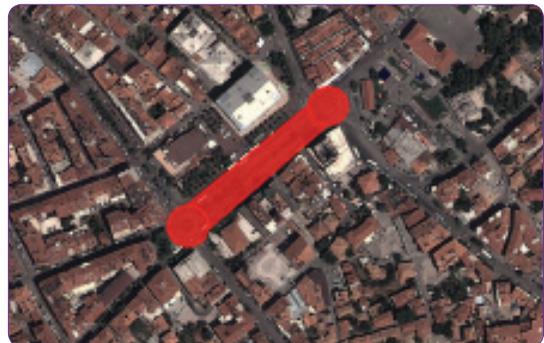
Figure 5. The Borders of Kaymakkapı Square (Source: Google Earth).

Today, Kaymakkapı Square's borders can be described with Üzüm Bazaar, Mimar Sinan Street and İstasyon Street at the north; at the west Municipality Office Building (Municipality Business Center / Belediye İşhanı), Culture Cinema (Kültür Movie Theatre) with adjoining row-shops and Cumhuriyet Street; on the south Community Policing Branch Office (Çarşı Police Station), The Building of Special Provincial Administration, Kavaklı Mosque, Haberdashery Stores Building (The Tuhafiyeciler Sitesi), Isparta Hotel; on the east Hasan Fehmi Street and Firdevs Bey Covered Bazaar. Even though Kaymakkapı Square was urban focal point throughout history, it had showed an alteration like a boulevard in first part of 21st century. Finally, today, it becomes transportation square (Fig. 5) (Table 1).

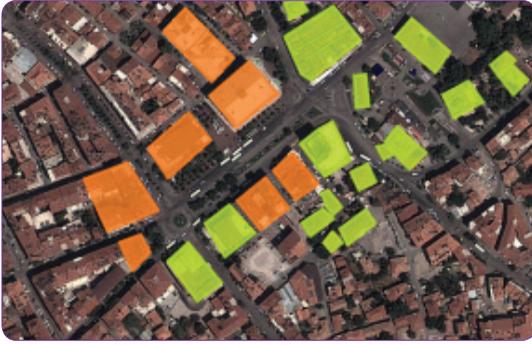
Figure 6. Green: Historical Buildings (before 1970), Orange: New Buildings (after 1970), (Source: Google Earth).

The structures of Kaymakkapı Space described as historic and new buildings (Fig. 6).

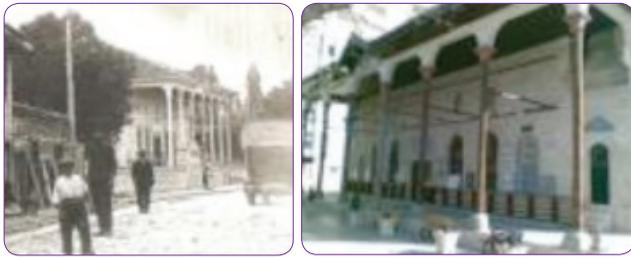
Figure 7. Kavaklı Mosque 1950-2012 (Source: Isparta Valiliği, 2001)

1782 dated, known as "Çinili (Tiled) Mosque" or "Peygamber (Prophet) Mosque", Kavaklı Mosque has been constructed instead of Kadı Small Mosque. Also it had been undergone many restorations in 1831-1832, 1878, 1886-1887, 1914 and 1950 (Fig. 7) (Fig. 8) (Isparta 1880-1980, 2001).

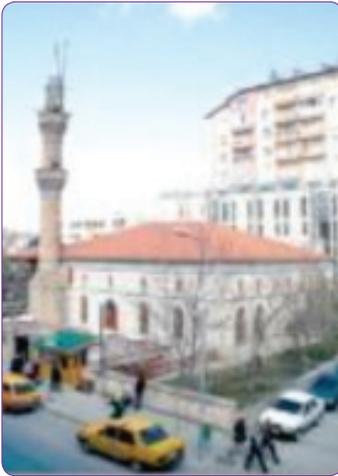
Figure 8. Kavaklı Mosque (Source: Isparta Valiliği, İl Kültür ve Turizm Müdürlüğü, Isparta Kültür Envanteri, cilt: 1, s. 153).

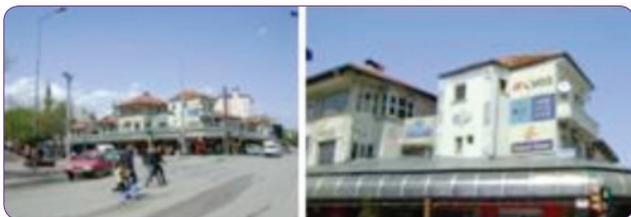
Figure 9. Üzüm Bazaar and its tiled facade type.

and is under protection. The stores, where grapes and salt were sold in the past, are currently functioning as various clothing stores. The Greeks had sold these shops to the Turks during the emigration. It's construction date is not known definitely. However, as the nearby buildings are from the Ottoman Period, it is believed that the Grape Market also was built in the Ottoman Period and the first buildings of it were constructed in this era. According to Tola, the area of the Grape Market was subject to rearrangement work in 1945 as per item 18 of the Construction Law. Before this work,

there were only two stone buildings in the Grape Market and the others were made of timber. However, with the practice of item 18 all of the wooden buildings were pulled down, the construction zones were changed and two or three-story concrete stores were built in the new land parcel order. The side streets of the buildings on this island were covered with a plastic-based material by Aybatlı in 1996. In 1996 the frontals of the stores to the streets and to the Kaymakkapı Square and the streets were covered with a plastic-based material from the ground level between the first and second

floors (Fig. 9) (Tola, 1998).

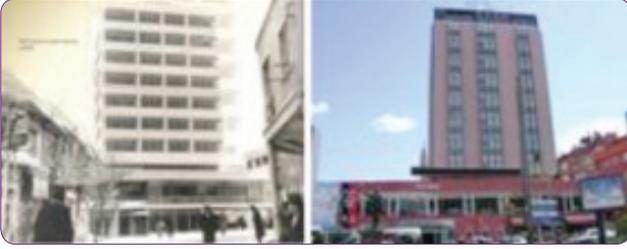
Figure 10. Isparta Hotel 1964-2012 (Source: Isparta Valiliği, 2001).

Isparta Hotel had been constructed in 1962. It is totally 9-story with 7-story rooms' block on the two-story service block. When its first architectural character reflected Republican Period Architecture, today, the air conditioners and various metal elements cause to deteriorations on the Hotel's façades (Fig. 10) (Fig. 11).

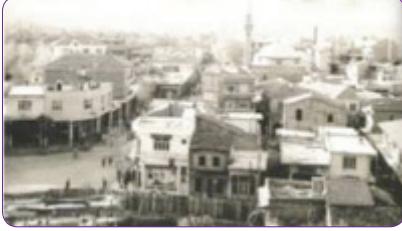
Figure 11. Isparta Hotel Construction 1960 (Source: Isparta Valiliği, 2001).

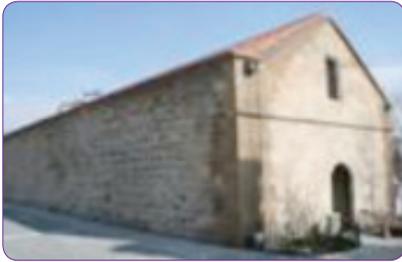
Figure 12. Firdevs Bey Covered Bazaar (Source: Isparta Valiliği, 2001).

Historical Firdevs Bey Covered Bazaar, Isparta's traditional covered bazaar sample, one of the surrounding buildings. It had constructed in 1561 by Isparta Governor Firdevs Bey. The 16-shops covered bazaar, which are made by indigenous material named as "kövke". It has been registered in 1977. It had been decided to continuation of registration, a decision taken in 1990 (Fig. 12).

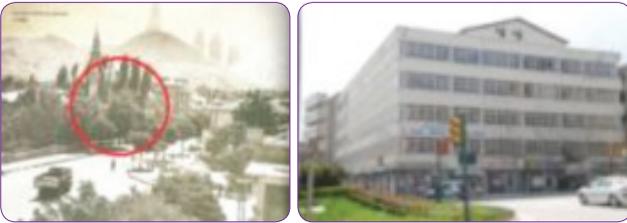
Figure 13. The Building of Special Provincial Administration 1968-2012 (Source: Isparta Valiliği, 2001).

This Structure, has been constructed in 1970's, is 5-story with the ground floor. Before 1970's, there were a green area and Konak Hotel at the close quarters. Today, is taken a decision of demolish about this building (Fig. 13) (Fig. 14).

A decision for pulling down the Special Provincial Building has been taken currently. However, the building in question carries the traces of the Ottoman Period Architecture. Besides, it has a similar façade characteristic the Isparta Hotel and the Vakıflar Business Center of the same period. Therefore, it is believed that a better decision would be to convey the building to the next generations with a strengthening project (Fig. 24).

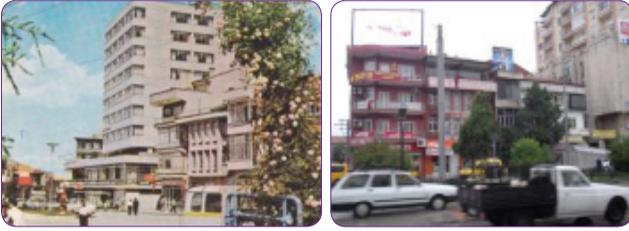
Figure 15. Notary and Driving Courses Building-Block (1980-2012).

This masonry building block, was constructed in 1957, had been renovated with extra floor in 1959. Until today, it had been undergone many restorations for many times. It had been built up to instead of the parcel of the residential area and Province Printing House area. This block is formed from the three or four floors. Moreover, the other entrance of the underground bazaar is located at the front of this building block. The discord of the character of façade and incompatible number of floors are clearly seen. It exhibits to miserable view with the buildings at the back of this block (Fig. 15).

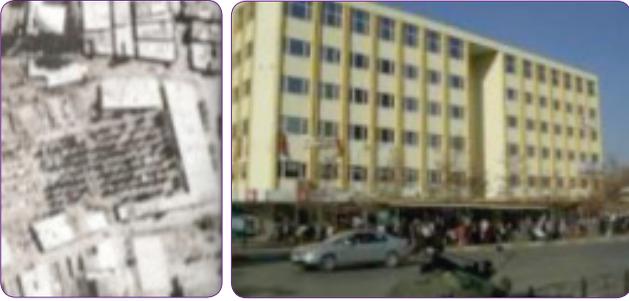
Figure 16. Municipality Office Building (20 October Office Building) 1950 - 2012 (Source: Isparta Valiliği, 2001).

“Office Building”, has been constructed in 1997. It is a six-story with ground floor and concrete structure. Also it had been constructed instead of the cemetery and a row of small abandoned structures. There are merely renovation or alteration projects and documents in Isparta Municipality archives. Today, mobile phone sales offices and political parties' offices are taken in this building (Fig. 16) (Fig. 17).

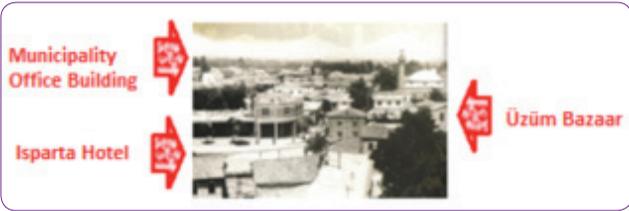
Figure 17. Municipality Office Building area, Üzüm Bazaar and Isparta Hotel area - 1955 (Source: IspartaValiliği, 2001).

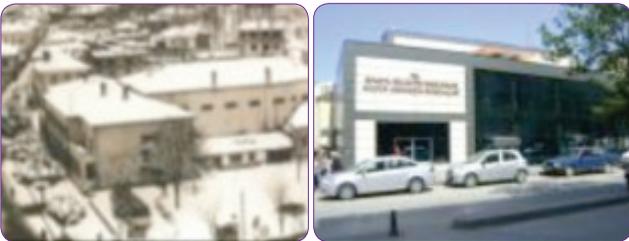
Figure 18. Community Cinema and had been constructed in 1998, new Culture Cinema 1965-2012 (Source: Isparta Valiliği, 2001).

This structure has been constructed to instead of the existed “L” planned Community Cinema in 1998. Today cinema building is rectangle planned and two-story with ground floor (Fig. 18). There are many two-story shops, which are attached to cinema building of south-east façade and north-east façade. The most of these shops are meat doner-shop or fast food (Fig. 19).

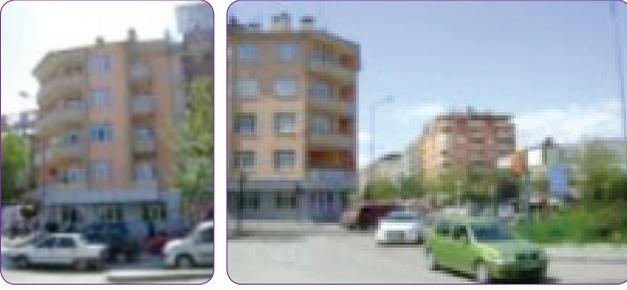
Figure 20. Community Policing Branch Office (Çarşı Police Station), Apartment and the circular junction.

1977 dated, this masonry structure had been renovated in 1988. Also this building had been undergone in many restorations (Fig. 20).

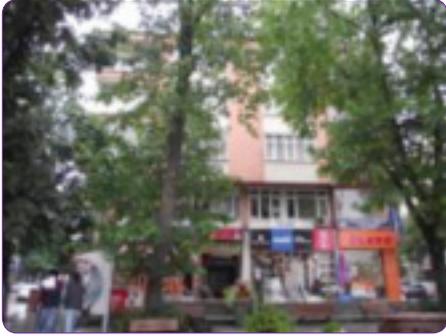
Figure 21. The Apartment of Nur Patisserie and Ülker Shop.

1977 dated, this masonry structure had been renovated in 1979 (Fig. 21).

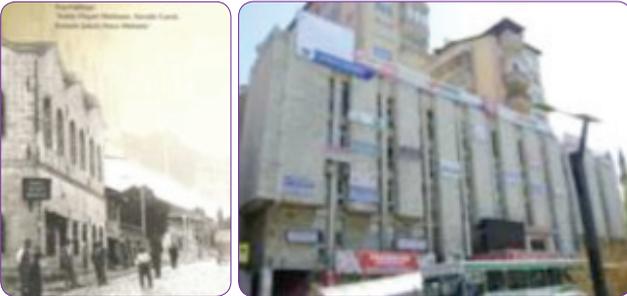
Figure 22. Province Printing House and Haberdashery Stores Building (The Tuhafiyeciler Sitesi) 1930-2012 (Source: IspartaValiliği, 2001).

The Tuhafiyeciler Sitesi has a ground area and height to run over the Kavaklı Mosque right next to it. With its huge mass, solid appearance and material, it has

closed the Kavaklı Mosque completely from the east façade and caused the mosque not to be perceived.

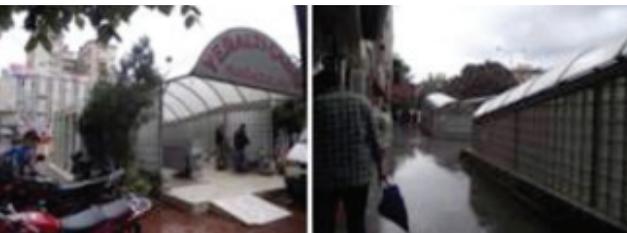
Figure 22. Underground Bazaar (near the Municipality Office Building-front of the Haberdashery Stores Building).

Underground bazaar, which is given a condominium, is constructed in 1997 (Fig. 23).

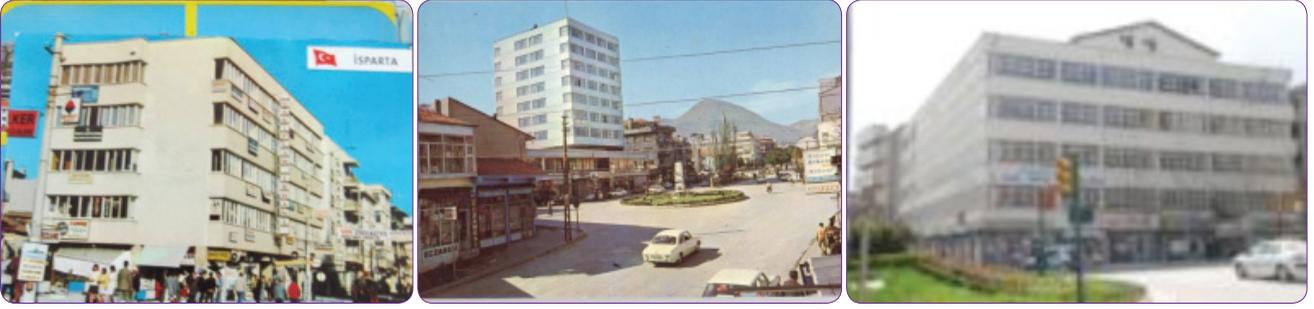
Figure 24. Vakıflar Business Center (1977, postcard), Isparta Hotel (a postcard from the 1970s), Special Provincial Administration (2012).

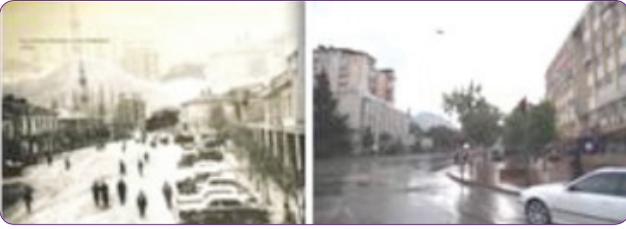
Figure 25. Kaymakkapı Square 1963 – 2012 (Source: Isparta Governorship, 2001, Google Earth).

In the 1960's the buildings were less high and therefore, the square had a form to breathe. There was a spatial integrity. As the transportation technology developed in that period, vehicles started to occupy the yard gradually (Fig. 25). However, today, due to the intensiveness of the public transportation and private vehicles, and also to the jam of the stops, the traffic has become problematic. Rather than a meeting corner for the pedestrians, it has become a square for the vehicles and this area and the buildings around it were impacted negatively.

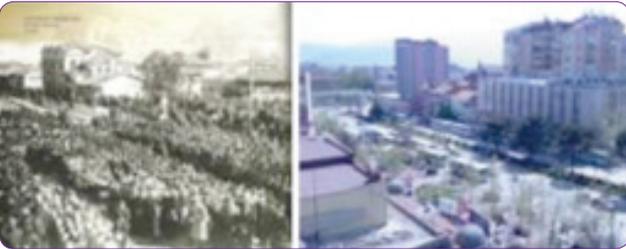
Figure 26. Kaymakkapı Square 1930 - 2012 (Source: Isparta Governorship, 2001, Google Earth).

The environmental quality of the field of vision makes a negative impact with defective parking solutions, bad quality architectural examples and inharmonious façade characters of the buildings. Besides, another problem is that the high rise buildings give a suppressing appearance over the historical buildings. The height of the Kavaklı Mosque is less than the height of the Complex (Fig. 26).

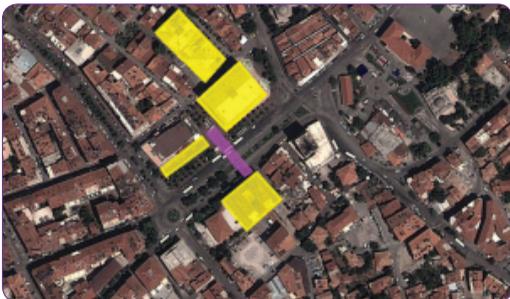
Figure 27. Buildings that should be pulled down and included in the public area (yellow) and the crosswalks (purple).

cal Parties. There are shops that sell and repair telephones. Pulling it down and including this place in the public area will provide ease for the square (Fig. 27).

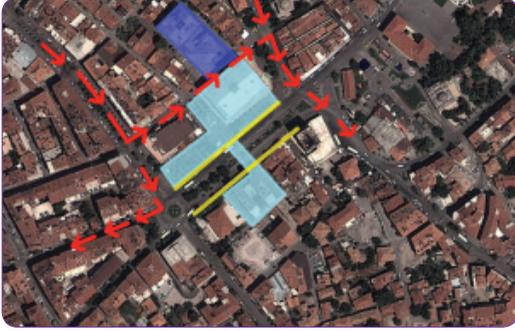
Figure 28. The transport scheme of the buses (red), bus stops (purple), restriction for the pedestrians (yellow).

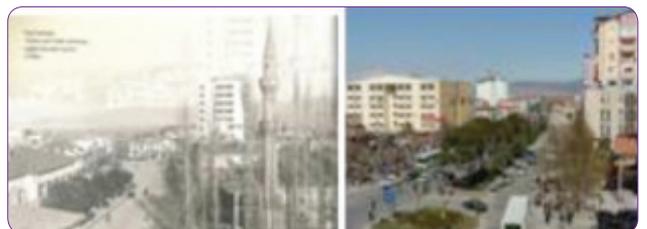
Figure 30. Kaymakkapı Square 1960 - 2012 (Source: Isparta Governorship, 2001, Google Earth).

the square (Fig. 30). Extending the square will be beneficial for afforestation in the square.
