# Conservation Problems of Traditional Housing with Continued Original Function and Recommended Solutions: Safranbolu “Eski Çarşı District”

Sibel ECEMİŞ KILIÇ,<sup>1</sup> Gülşen TÜRKÖĞLU<sup>2</sup>

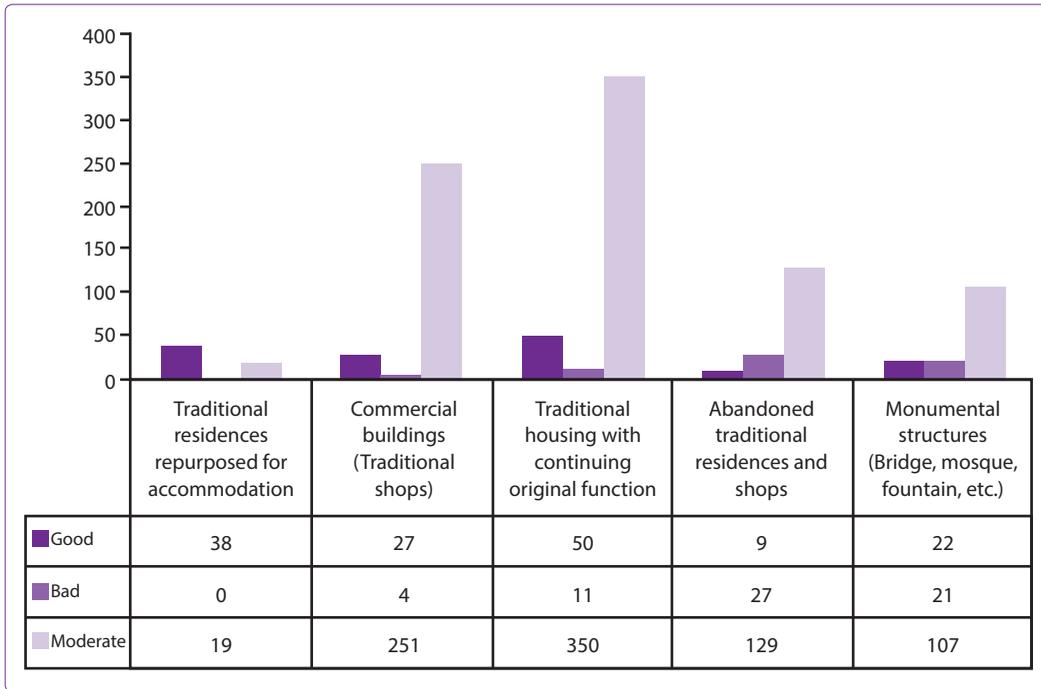
The current physical conditions of the registered structures were empirically evaluated<sup>1</sup> and classified according to types of use (Figure 3). As a result of this evaluation, the physical condition of registered structures with residential use has been observed to be moderate (85%) to a great extent. The number of structures in good condition is exceedingly low.

Figure 3. Current physical condition of registered structures (according to number of units).

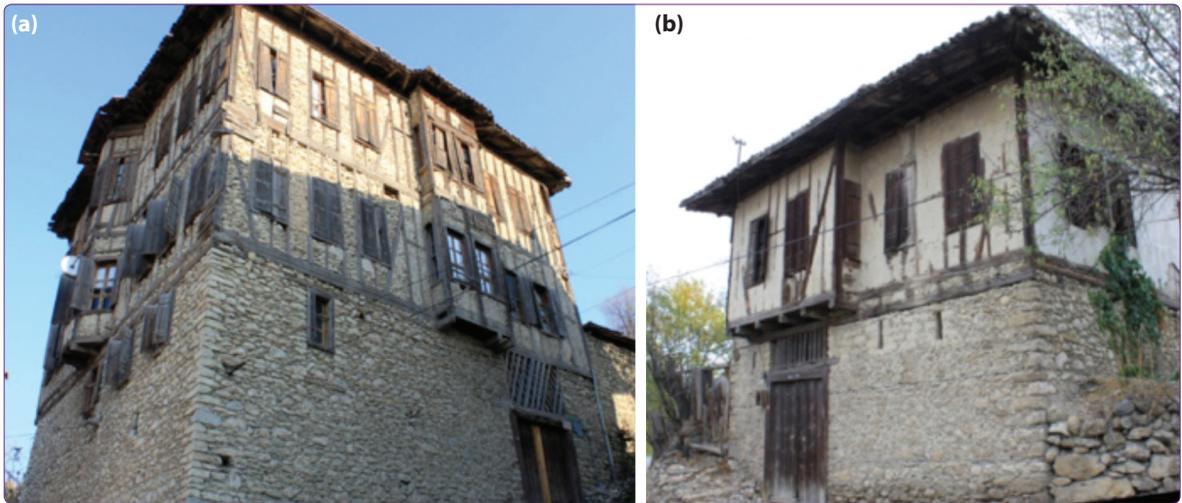
Structures sharing similar façade features such as building systems, building materials, schematics, doors, windows, etc. may differ in terms of detail, size, situation and additions styled according to the street, all reveal the rich variety of the urban fabric (Figure 4a, b).

Among the 411 traditional housing structures maintaining their original function, only 84 units (20%) reveal either none or limited signs of modification/deterioration. Compared to the overall percentage of registered structures that are authentic or show limited signs of modification/deterioration (33%), this ratio is exceedingly low. The low rate of this ratio is an important risk. Also, the interior of some of these buildings have been exposed to modification/deterioration.

Figure 4. (a, b) Structures substantially maintaining authenticity.

The existence of structures with these qualities is a significant potential. It is crucial, therefore, that the documentation drawings of these structures be given priority. It is possible to develop typology studies and obtain detail projects regarding authentic components from this building inventory.

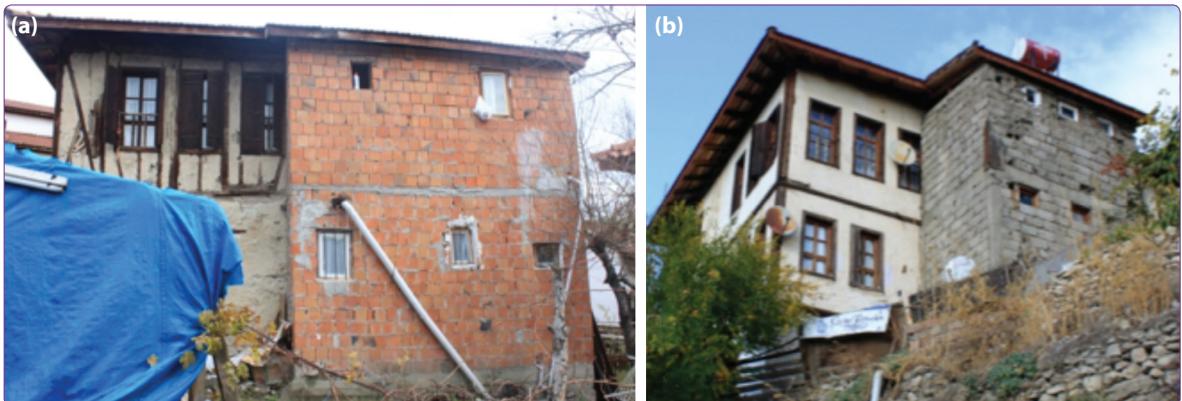
Figure 5. (a, b) Buildings with inconsistently renewed wet places.

This group generally consists of extensions made due to renewal/expansions of wet areas. In addition to which extensions such as staircases, terraces, etc. are included enabling different floors to work as independent areas (Figure 5a, b).

Among the 411 traditional housing structures maintaining their original function, 65 units (16%) have inconsistent extensions. This ratio is 10% higher than the overall percentage observed in registered structures. The incompatibility of these extensions regarding the use of materials, technical and façade properties negatively affect the characteristics of registered structures visually disrupting the urban fabric. These inconsistent

extensions bear the risk of information loss regarding authentic spaces (especially wet spaces).

Original wet areas, specifically in traditional housing structures, are not compatible with today’s conditions; thus the need for modifications. However, extensive studies must be carried out where solutions may be suggested on how to meet today’s requirements without damaging the traditional fabric.

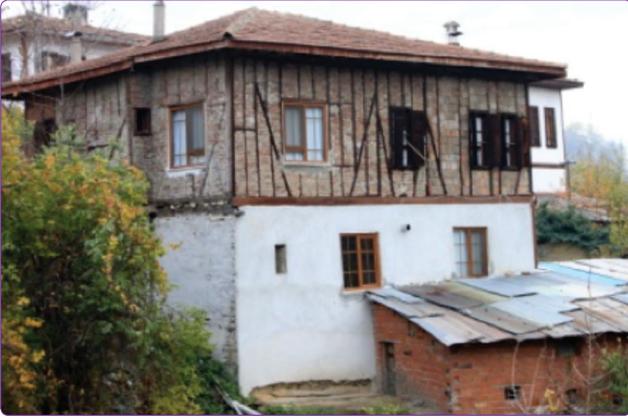
**Figure 6.** Additional structure adjacent to housing structure.

According to other deterioration types these additions are found less, or perceived less due to courtyard/garden walls. They take the form of storage units, car parks, arbours, etc. in dwellings and winter gardens, arbours, heating plants, service areas, etc. in accommodation purposed structures (Figure 6).

Among the 411 traditional housing structures maintaining their original function, 11 units (3%) have inconsistent garden/courtyard extensions. This ratio is 2% higher than the overall percentage observed in registered structures. Unsanctioned and proliferating cases cause deterioration in the dwelling-garden relationship and traditional fabric properties triggering a crucial risk.

Social and cultural changes have also affected garden use practices. Solutions must be generated providing a balance between traditional landscaping and new needs. In order to ensure the health of traditional residences, the extensions should be reversible, and situated in a way that would not affect/ weaken the original structure’s appearance.

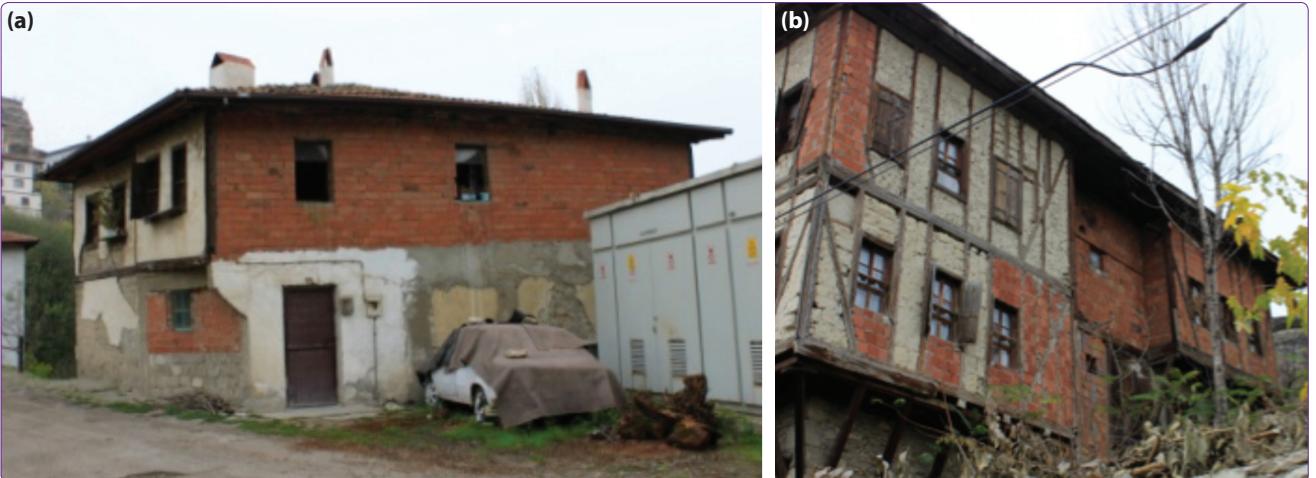
**Figure 7. (a, b)** Structures with changed materials.

adobe material and the proliferation of new material production that is cheaper and easier to obtain inevitably leads to new material use in repairing weakened sections (Figure 7a, b).

Among the 411 traditional housing structures maintaining their original function, 95 units (23%) have changes in the structure's material. This ratio is 15% higher than the overall percentage observed in registered structures. The traditional wooden frameworks are either left unplastered or plastered around the wooden frame leaving it bare; therefore, changes in the materials used generally disrupt the perception of the fabric negatively.

Solutions regarding material endurance and traditional material access must be generated, master builder training should be taken into account, and the public should be supported in traditional material use.

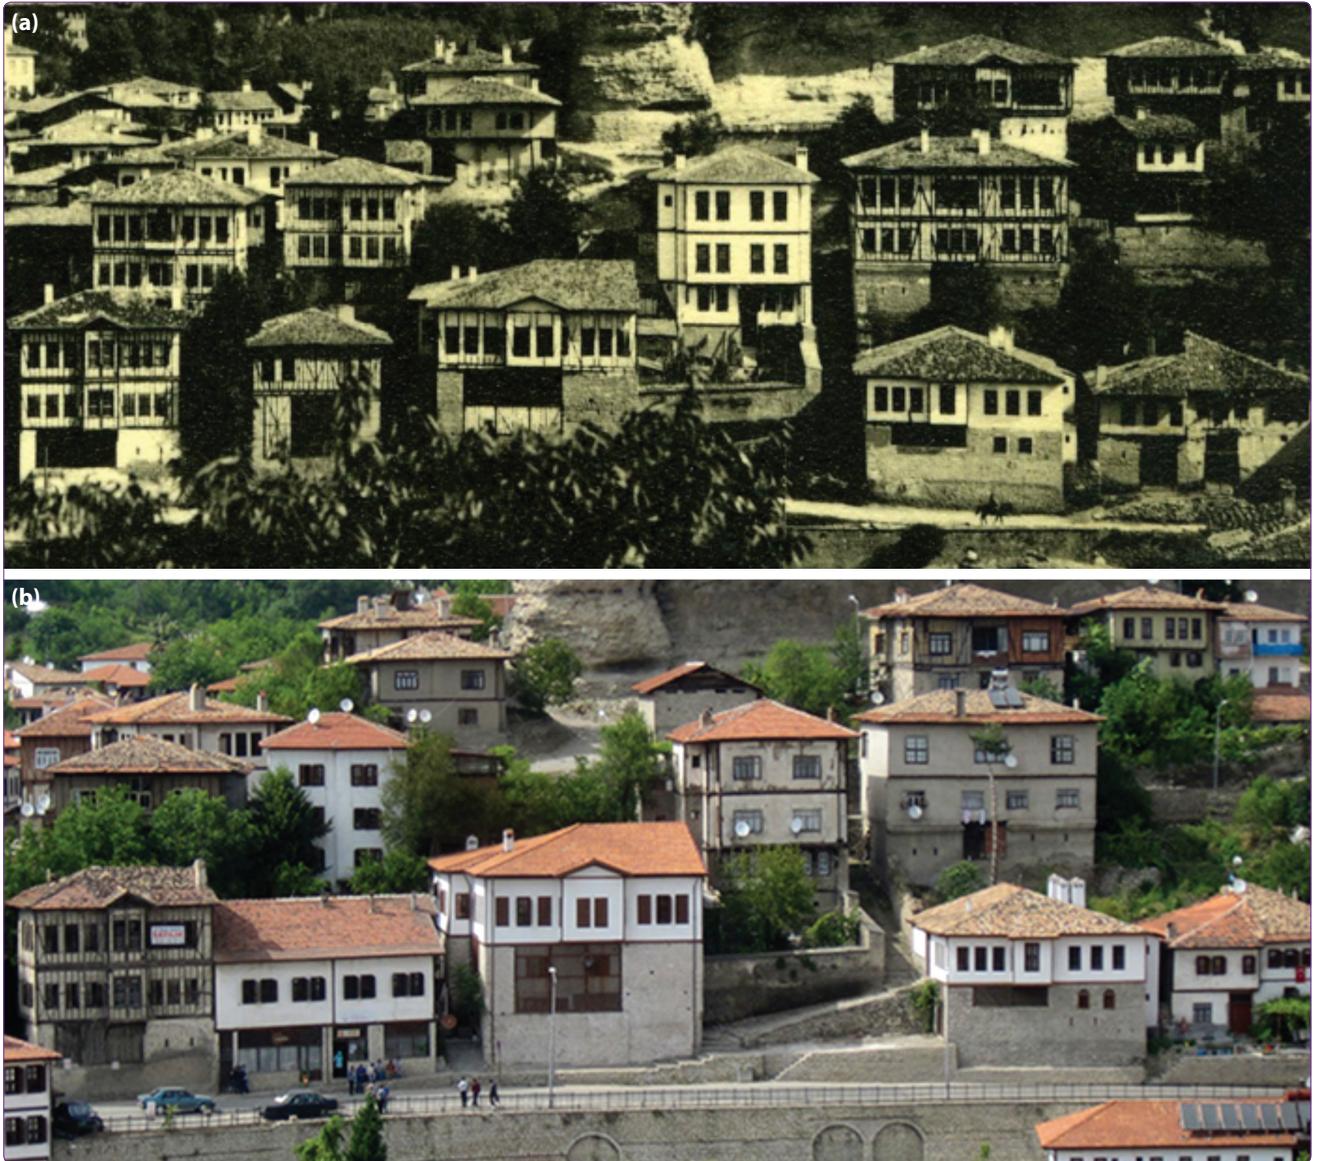
The wooden frame, a distinctive feature of Safranbolu's traditional fabric, forms the building's structure and reveals a decorative façade; however, difficulties in maintaining adobe material strengthens the tendency to either change the material or cover it with plaster and paint (Figure 8a, b).

**Şekil 8. (a, b)** Two Photos of the Same Area (Figure 8a: The photo, date unknown taken from the Safranbolu Municipality Archives, indicates a plethora of plastered buildings that leave the unplastered/wooden frame bare. In comparison, the contemporary photo reveals the increased tendency of covering these wooden frames with plaster.)

consistent plaster, paint and façade coatings. This ratio is 48% higher than the overall percentage observed in registered structures. The gradually increasing tendency of plastering and painting buildings with unconventional plaster techniques and materials carries a great risk in terms of the general perception of the urban fabric. Unfortunately, in many buildings repaired with restoration projects, contemporary materials have been used to fill the frame after which they have been covered up with plaster and paint.

Structures maintaining authenticity to a great extent should use traditional materials and traditional plastering techniques during maintenance and repairs.

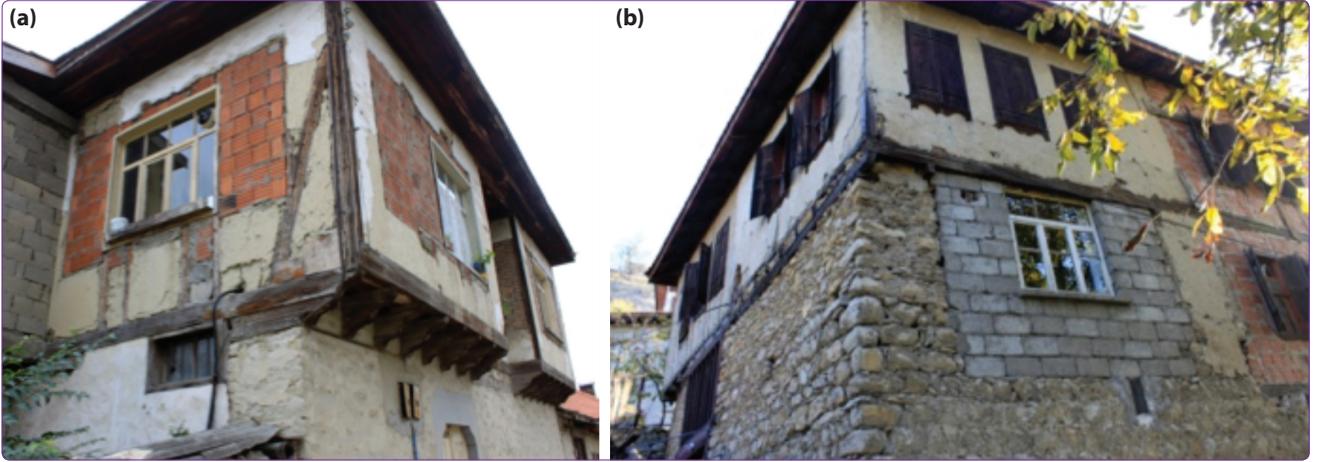
Figure 9. (a, b) Renewed windows.

The tendency of renewing important façade elements such as windows, doors, glistes, and bay windows inconsistent with the traditional fabric in terms of style, dimension and materials emerges as a significant problem (Figure 9a, b).

Among the 411 traditional housing structures maintaining their original function, 181 units (44%) have window, door, gliste, bay window, and showcase modifications. This ratio is 35% higher than the overall percentage observed in registered structures. Boarded up windows, widened windows, use of PVC joinery is seen mainly in residential structures but all other types of buildings also have these modifications. Additionally, in projects that modify the function of spaces, authentic façade features also slightly change (i.e. the widening of gliste gaps due to reorganisation of windows of newly added wet areas, ground floor kitchens, living areas, etc.).

Supervision, advising, easy and cheap access to traditional materials will reduce these problems.

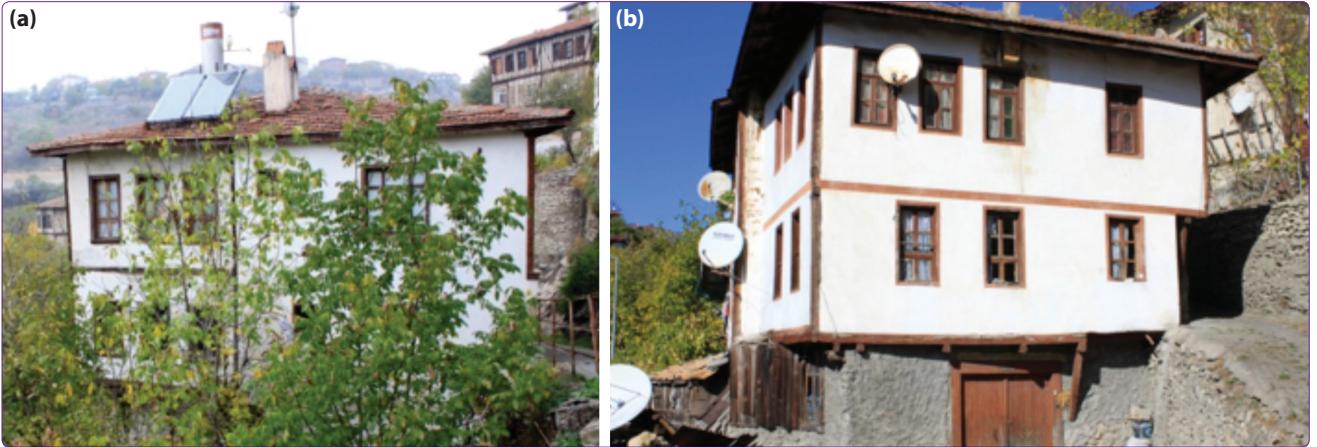
Figure 10. (a, b) View of solar energy panels and dish antennas.

rary living requirements, heating/cooling equipment, satellite dishes, solar energy panels, signs with different colours, shapes and sizes, street coverings in commercial areas all cause visual pollution (Figure 10a, b).

Among the 411 traditional housing structures maintaining their original function, 40 units (10%) have shading, air conditioner, antenna, solar energy panels, signboards, etc. modifications. This ratio is 22% lower than the overall percentage observed in registered structures. Solutions developed spontaneously, with individual preferences disregarding the traditional fabric undesirably affect the traditional fabric. The chaos created with signs, shade coverings, etc. specifically in areas with dense commercial structures make it difficult to perceive the structures and urban fabric.

The integration of contemporary living requirements into the fabric is a necessity for the sustainability of life in these regions. The effects of these additions to the fabric should be minimalized, standardised, and realised through a common language that needs to be generated through plans and designs.

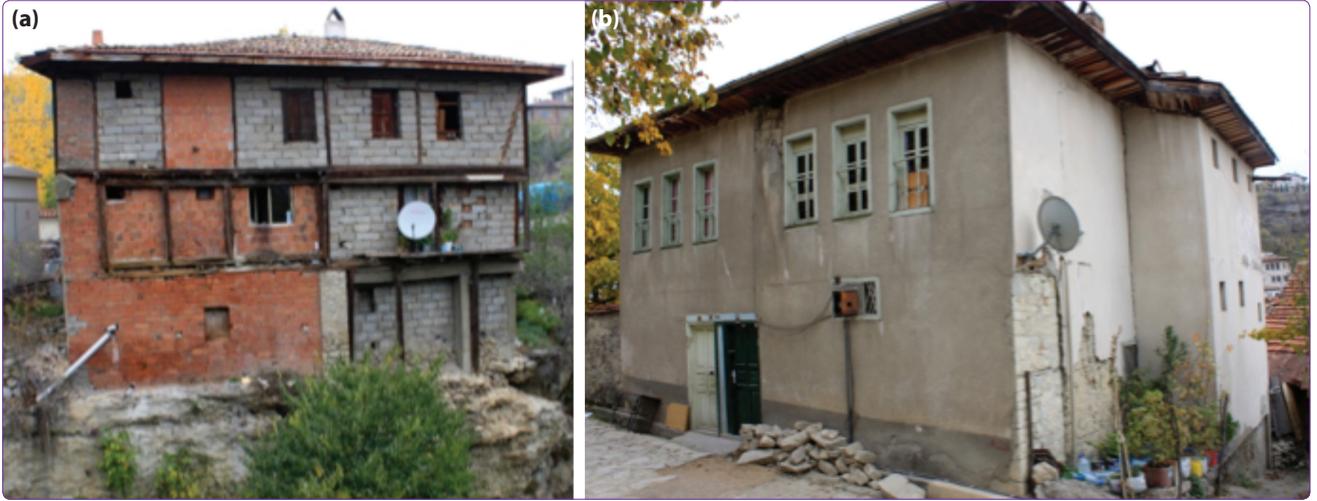
**Figure 11. (a, b)** Structures harbouring more than one type of modification.

Among the 411 traditional housing structures maintaining their original function, 222 units (54%) harbour two or more modification types simultaneously. This ratio is 41% higher than the overall percentage observed in registered structures. Buildings that have seen extensive disturbances lose traces of originality making project designs difficult. Especially with the loss

of distinctive features, projects designed according to common period features generally lead to standardization (Figure 11a, b).
