## The leading example of western-influenced structures in Ottoman architecture – “Çit Kasrı” at the Yıldız Palace and its repairs

The Kasrı is a single-story building of masonry construction with a partial basement. It was built generally of imported materials. In Ottoman architecture; cement materials, prefabricated imitation stone elements, and interior space decoration covered with silk cloth were certainly used for the first time in this building.

The building was repaired in 1982–1983 by the Research Centre for Islamic History, Art and Culture. It was vacated in 2017 as part of the project to reunify the Yıldız Palace. Today, the building, which is currently idle, is waiting to be repaired and reused.

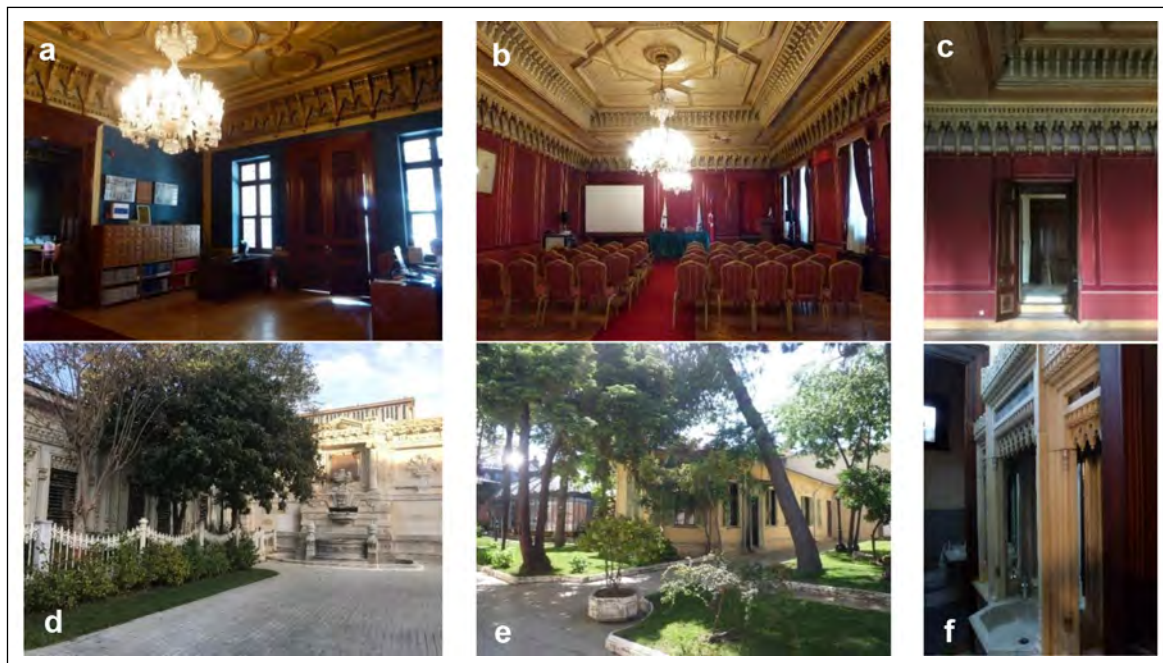
**Figure 4.** (a) The Blue Room, (b) The Red Room, (c) The Harem gate on the northern wall of the Red Room, (d) Çit Kasrı and The Kaskadlı Harem Wall, 2017, (e) The Garden Kiosk and the Greenhouse, 2014, (f) The WC with a marble sink, 2017 (Erdem).

Garden Kiosk from the Harem Courtyard or through the Greenhouse (Ezgi, 1962) (Figure 4e). While we don't know how protocol arrangements between foreign representatives

courtyard was designated to serve both separate sections (Figure 4a).

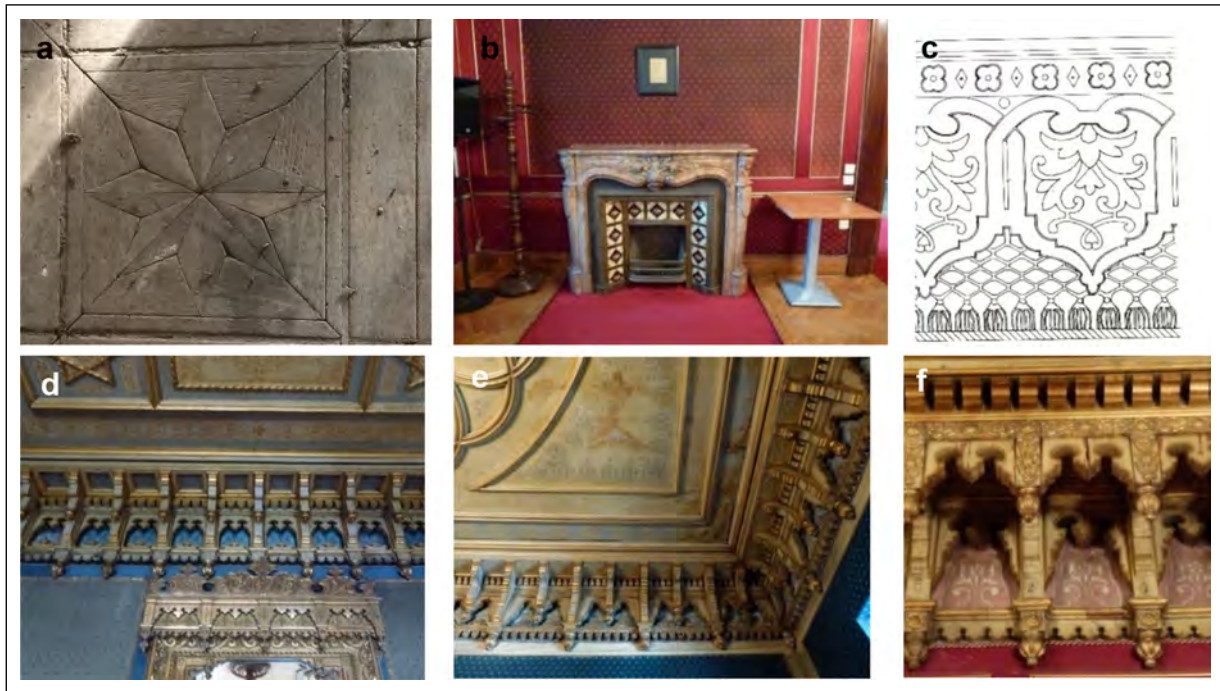
**Figure 6.** (a) The wooden mosaic parquet, (b) The red fabric with yellow stars, 2017, (c) The Pattern of “chit”, the original cloth, 1982, (d) The yellow fabric with blue stars, (e) The blue fabric with yellow stars and oilcloth ceiling, (f) The ceiling molding with corbels, 2017 (Erdem).

was completed with wooden mosaic parquet with star motifs (Figure 6a).

Before being coated with silk and satiny material, the internal faces of the walls were planned with modules and borders between modules. To accomplish this, wooden lathes were nailed onto the plastered walls, and then narrow wood strips were nailed to the stretched satin cloth (Figures 6b, d, and e). Only a small piece of the original, yellow-Bordeaux cloth with stylised floral motifs known as “chit” and dating to the construction period of the Çit Kasrı has remained extended (Figure 6c). The other pieces of the cloth were found to consist of silk satin cloth woven with blue and yellow

stars on a yellow, blue, and red ground that belongs to the Abdülhamid period. From the colours of these fabrics, we can assume that the borders were made up of yellow, blue, and red. The edges of the fabric borders were bounded by the door frames, wooden baseboards, and ceiling moulding (koltuk silmesi) encircled by cording (Figures 6f and 7a).

the use of wooden corbels (*furuş*) of the ceiling mouldings. The plastered areas between the wooden corbels were decoratively painted (Figure 6f).

Although the central heating system was used in the Küçük Mabeyn and Cihannüma Kiosk, which were built before the Çit Kasrı, Çit Kasrı was heated with fireplaces and porcelain stoves for an unknown reason. Each room of the Kasr had its fireplace, except Room 105, which had a porcelain stove (Figures 7d and e). From the pipe holes in the wall, we can assume that the Blue and Red Rooms had also been equipped with porcelain stoves. Generally speaking for the fireplaces, both coloured marble and imported tiles were used (Figure 6b).

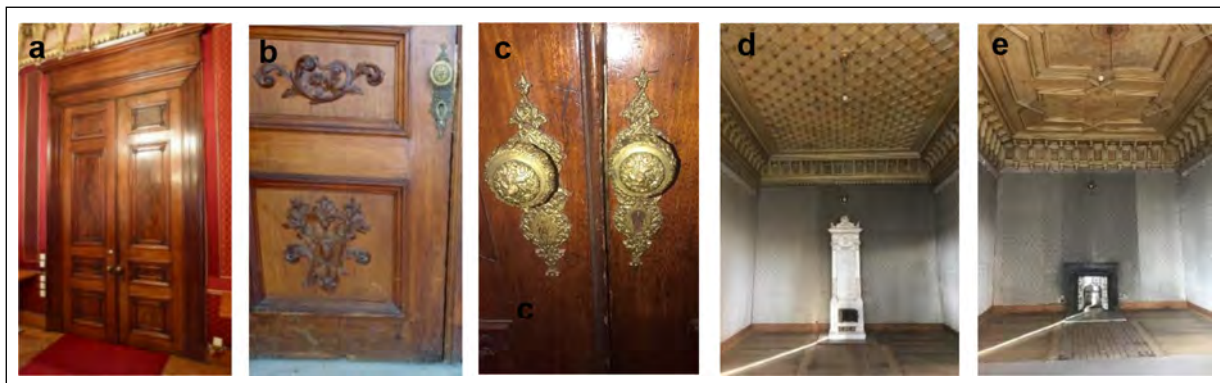
**Figure 7.** (a) The door made up of mahogany and walnut, (b) Mahogany rosettes on the walnut veneer panels, (c) The brass knocker instead of the silver and bronze knocker, (d) The porcelain stove of Room 105, (e) The fireplace in Room 104, 2017 (Erdem).

The windows and doors were constructed of both mahogany and walnut. Solid mahogany was used for the window woodwork, the casings, and corniches of the doors, and in the making of the decorative rosettes and wooden strips. While mahogany veneer was used for the door frames and wings, and walnut veneer was used for the door panels (Figures 7a and b). The door knockers were cast from an alloy of silver and bronze (Figure 7c), while brass casting was used for the door latches, bolts, keys, and locksets.

During this restoration, an extra effort was directed toward researching both the date that the wall fabrics had been hung and how they had been implemented. The walls of the meeting rooms located in the eastern section pointed to the fact that the fabric primarily dated from the period of Abdülhamid II and consisted of a fine satin cloth with yellow and blue star motifs on a red, yellow, and blue ground. It was decided to re-weave this fabric with polyester. The way the fabric had been fixed to the wall was determined by closely observing the nail holes remaining in the underlying lathes. The relationship between the star module and the satin border was thus re-established. The geometric designs used on each of the walls were recorded and drawn during the process of this implementation, and wooden strips were fixed accordingly over the plaster. This step was followed by stapling the fabric onto the lathes. These were further fixed in place by using bright golden-coloured strips (Figures 12c–f). The walls of the western section, which was to be used as a library, were covered in the determined arrangement by using fabric available in the current marketplace (Figures 7d and e).

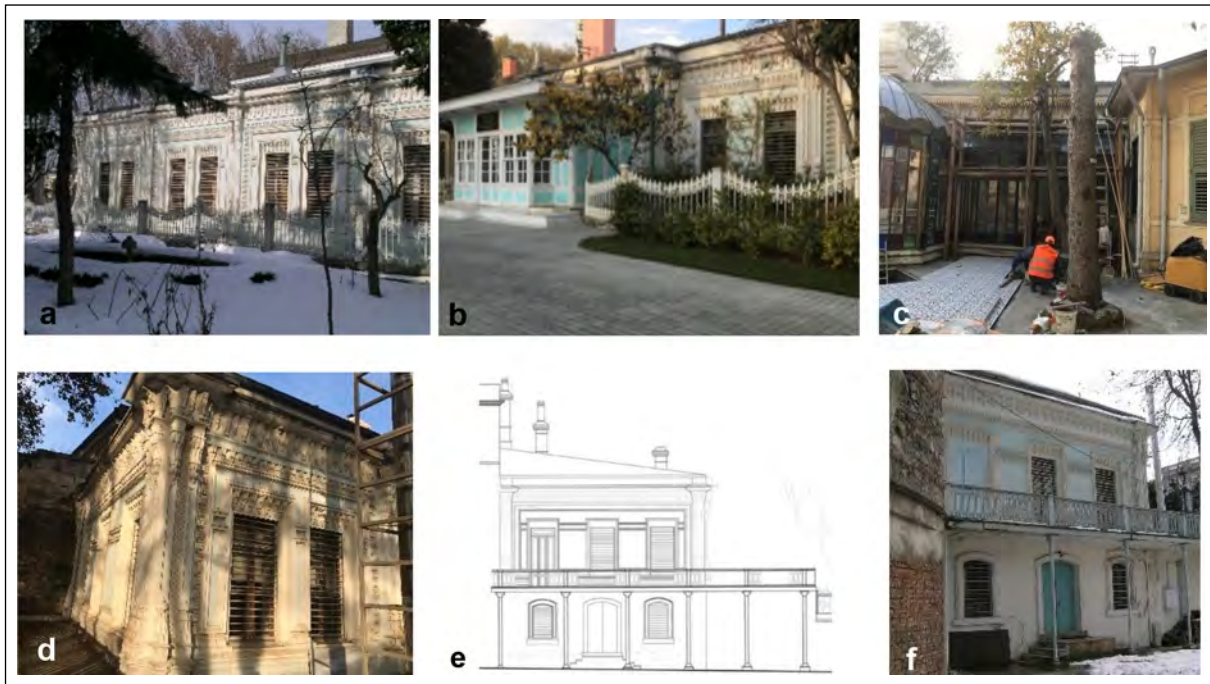
**Figure 8.** (a) West side of the southern facade, 2006, (b) The main entrance, southern facade, 2017, (c) Greenhouse (eastern face) 2018, (d) Southwest corner of the Çit Kasrı, 2017, (e, f) The western facade from the road, 2006 (Erdem).

Because its north wall is attached to the Çukur Palace, the Harem Wall, and the Garden Kiosk, Kasr has only three exposed faces. These exposed facades were designed as modules and were decorated with imitation stone elements (Figures 8a, b, and d). Stylized Turkish-Islamic motifs

(stalactites and tassels) were used in the decoration of these imitation stone facings (Figures 5b and c). Each room facing the long southern/ entrance facade serves as a single module, while the red room of the building represents three modules. On the southern facade, each module is delineated by two windows, while the entry module has a double entry door set between the two windows. The modules were perpendicularly limited with imitation stone pilasters. Besides, at the eaves level, over and under the windows, and on both sides of the pilasters, were also decorated with faux stone elements consisting of stalactite and tassels. Because of the old photo in the past and the screw holes, we understand that the rectangular, winged windows once had wooden shutters, but they no longer exist (Figures 10 and 12a). For security purposes, the horizontal iron grills are placed in front of the windows (Figures 5b and 8d). The original windbreaker (Figures 9, 10) that fronted the main entrance module, had been constructed of iron (Ezgü, 1962), but had since been replaced twice by a wooden counterpart in the Republican period (Figures 2b and 8b).

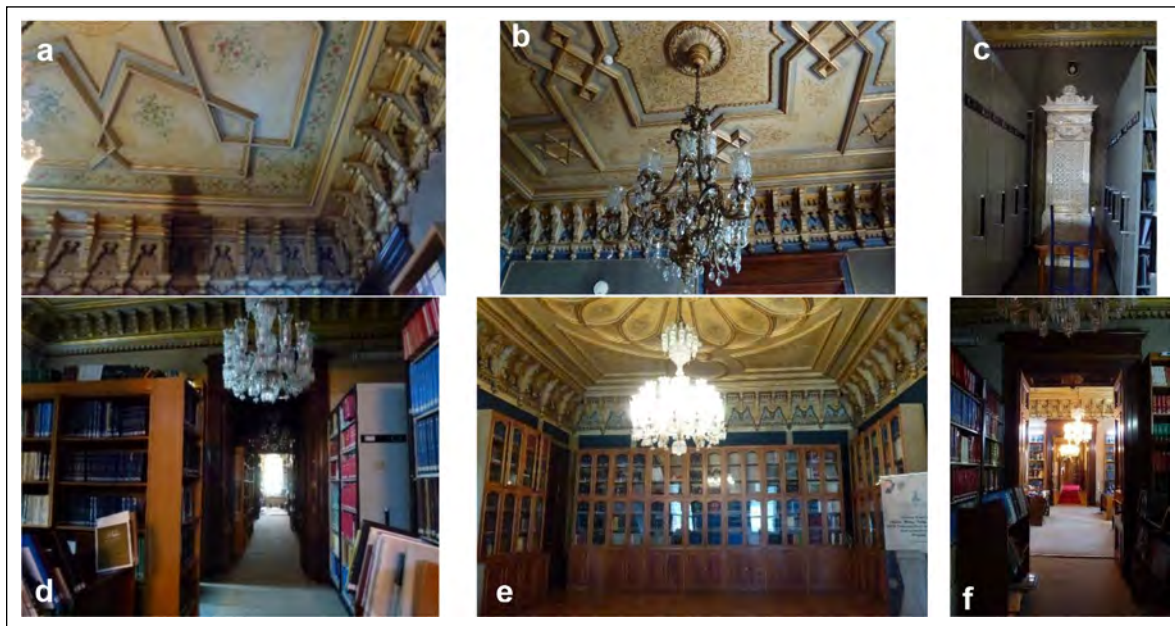
**Figure 13.** (a) The ceiling of Room 106, (b) The chandelier was brought from the Grand Mabeyn, 2017, (c) Compact type book cabinets in Room 105, (d) The other side of Room 105, (e) Blue Room (Main entrance hall), (f) Room 106 and the book cabinets, 2017 (Erdem).

Because the building's original illumination chandeliers had not been found, researchers decided to investigate the chandeliers extant in other buildings of the palace. A three-armed and badly damaged chandelier found in the Grand Mabeyn was repaired and hung in the Yellow Room (Figure

13b). New chandeliers were hung in the other rooms (Figure 13d and e). An original glass lamp shade was found in the palace and was used as a model for new shades made and embossed with the AH (Abdülhamid) emblem.

During the restoration period, it appeared that utilising this building for the library and conference hall purposes was appropriate for the building's function. Retrievable compact type libraries were used for the library function. However, as years went by, the library was overfilled with book donations made to the IRCICA. Soon, the entire western section was stuffed with books and bookshelves, thus robbing the space of its fine aesthetic features (Figures 13c–f).
