Treatment of invasive cervical resorption leading to an extensive crown destruction: A case report

Elçin Yüzgüleç,¹ Lale Rizeli,² Ayşe Zeynep Zengin,² Cangül Keskin¹

¹Department of Endodontics, Ondokuz Mayıs University Faculty of Dentistry, Samsun, Turkey

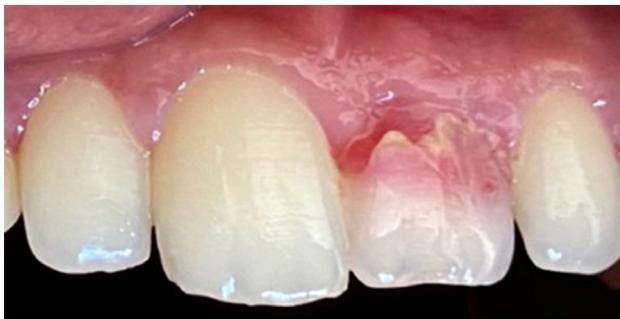
Fig. 1. Intraoral photograph of the patient showing diffuse irregular hard tissue destruction in the resorption area and granulation tissue causing a "pink spot" appearance (A black layer has been added to the background of the image [Adobe Photoshop CS6, Adobe Systems, San Jose, CA, USA]).

A healthy 19-year-old male patient presented to Oral and Maxillofacial Radiology Clinic, Faculty of Dentistry, Ondokuz Mayıs University, with an aesthetic complaint related to his anterior tooth. The clinical examination revealed granulation tissue that completely covered the cervical half of the vestibular surface of tooth no. 21 and caused partial destruction of the enamel tissue (Fig. 1). The color of the coronal half of the crown was observed to turn pink because of this large granulation tissue and there were no caries in the tooth. As the isolation of the tooth was not possible due to tissue loss in the cervical region, the electrical pulp test could not be performed. While the tooth was sensitive to percussion, second-degree mobility was detected according to Miller. The periodontal examination revealed inflammation related to the buccal, mesial, and distal gingiva and a periodontal pocket in the buccal gingival groove. When evaluated in terms of occlusal trauma, the presence of premature contact was detected on the palatal surface of tooth no. 21.

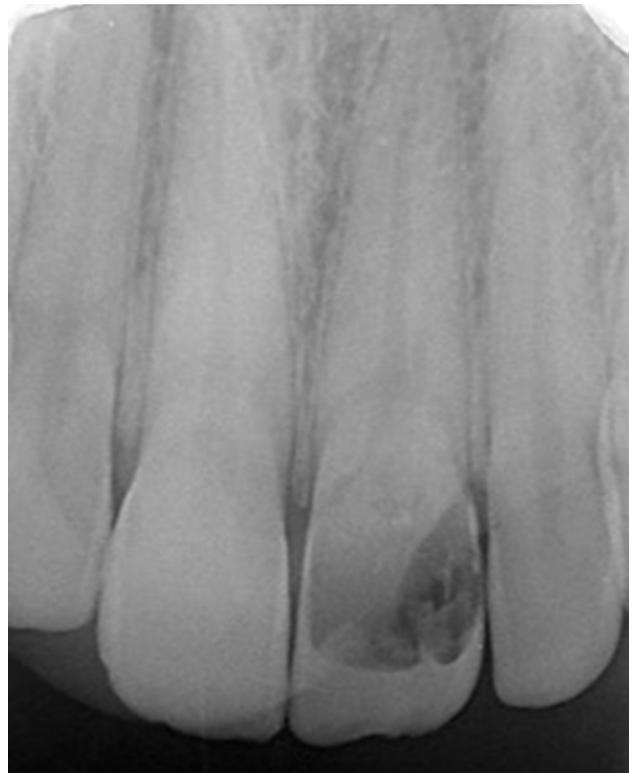
Fig. 2. In the periapical radiograph taken from the patient, a heterogeneous radiolucent area extending from the 2/3 of the cervical part of the crown of tooth no. 21 to the root, with good borders in the coronal part, but irregular and indeterminate borders in the apical part, superposed on the pulp chamber, was observed.

Furthermore, a heterogeneous radiolucent area extending from the cervical part of the crown of tooth no. 21 to the root with well-circumscribed borders in the coronal part and irregular borders in the cervical part, superposed on the pulp chamber, was detected on the periapical radiograph. A slight widening in the periodontal ligament space in the apical region was also detected (Fig. 2). The images were acquired by a bisecting angle technique using phos-

phor plates (VistaScan, Dürr Dental, Bietigheim-Bissingen, Germany) and a dental X-ray device (Sirona Heliodont Plus, Sirona Dental Systems, Bensheim, Germany) with 60 kVp and 7 mA parameters and scanned using a scanner (Dürr Dental, Bietigheim-Bissingen, Germany). The cone-beam computed tomography (CBCT) images (GALILEOS Comfort Plus, Sirona Dental Systems, Bensheim, Germany; 98 kV, 15–30 mA, large field of view) showed extension to the mesial and distal surfaces of the crown causing destruction to the vestibular surface, cervical 2/3 of the root. A well-demarcated, heterogeneous hypodense lesion, extending to the middle third of the root, was evident (Fig. 3).

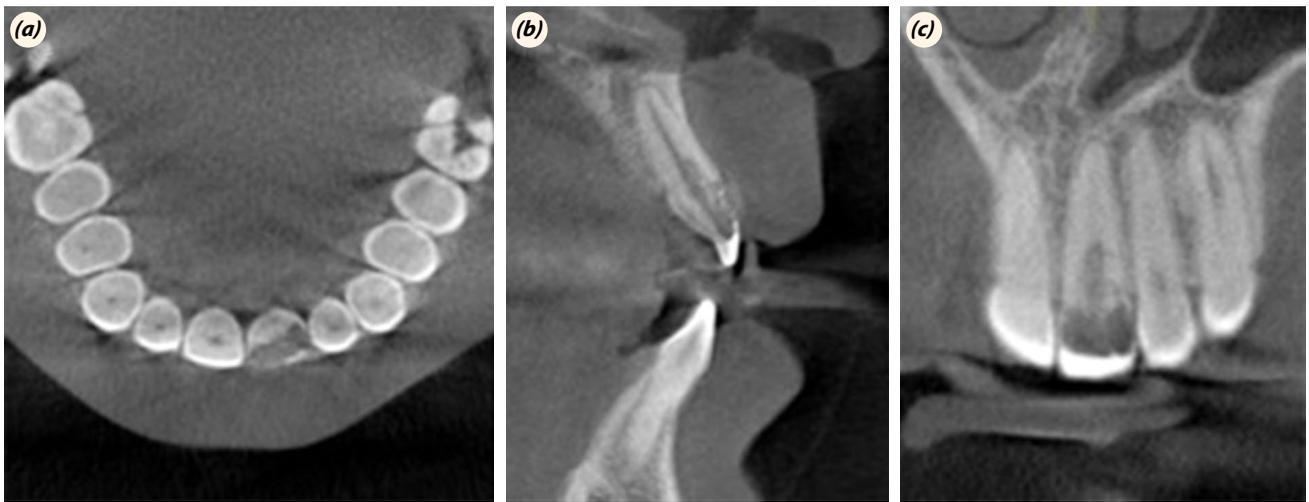
Fig. 3. Cone-beam computed tomography image. **(a)** The axial section shows a hypodense lesion extending to the mesial and distal surfaces of the crown of the tooth and causing destruction on the vestibular surface. **(b)** The cross-sectional view shows a heterogeneous hypodense lesion extending to the middle third of the root that includes 2/3 of the cervical part of the crown of the tooth, causing buccal cortical bone destruction. **(c)** The coronal section shows that a heterogeneous hypodense lesion with a well-demarcated apical is observed in the crown, which extends from two-thirds of the crown to the middle third of the root. When the images were evaluated, it was found to be compatible with Heithersay type 3 resorption.

The patient was referred to the endodontics clinic with a prediagnosis of external resorption. The CBCT image taken from the patient showed that there was a radiolucent area compatible with Heithersay (8) type 3 and Patel et al. (9) type 2 cervical resorption. Based on examinations and evaluations, the case was diagnosed as external cervical root resorption. The patient was informed about the diagnosis, treatment options, and possible results. Then, local infiltration anesthesia was applied (Ultracaine D-S Forte 40 mg/ml articaine HCl + 12 µg/ml epinephrine

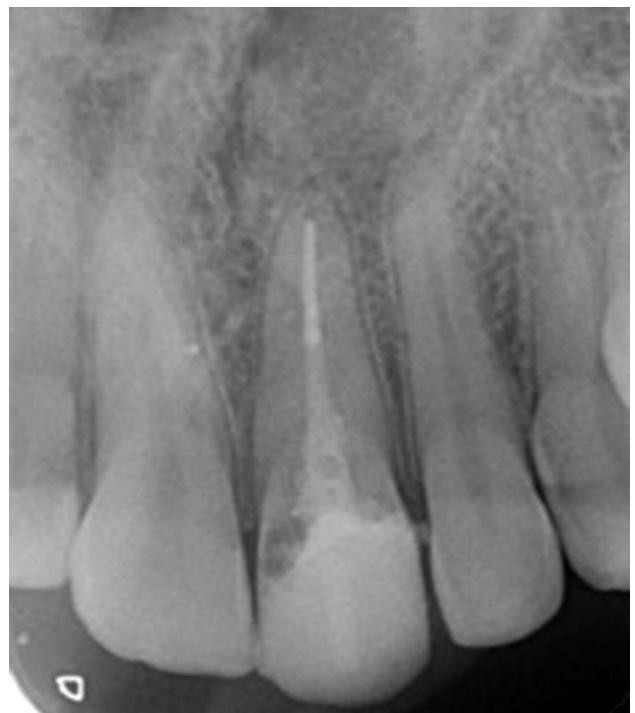
Fig. 4. Periapical radiography of the tooth restored with fiber post after root canal treatment.

part of the canal up to 5 mm was removed using the drills of the fiber post system (Cytec Blanco, Hahnenkratt, Germany). In addition, the coronal dentin surface, to which trichloroacetic acid (Sigma-Aldrich, MO, US) was applied previously, was modified with a steel round bur. After applying 37% orthophosphoric acid (3M ESPE, St. Paul, MN, USA) to the dentin surfaces and drying, the length of the fiber post was adjusted in the canal. The post cavity was bonded (3M Single Bond Universal, 3M ESPE, St. Paul, MN USA) and polymerized for 20 seconds with an LED light device (Woodpecker, Guangxi, China). Dual cure resin cement (RelyX Ultimate, 3M ESPE, MN, USA) was prepared according to the manufacturer's instructions and applied to the canal, and then the fiber post was carefully placed in the root canal and polymerized for 40 seconds. The tooth restoration was performed using direct composite resin (Gradia Direct, A2 anterior, GC, Tokyo, Japan). The polishing of the restoration was completed by applying aluminum oxide disks from thick to fine grain (Figs. 4 and 5).

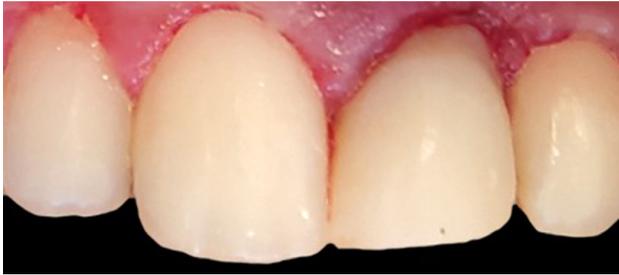
Fig. 5. Intraoral view of the tooth after restoration.
