# Deaths due to “patpat” accidents in the Black Sea Region, Turkey

**METHODS:** A patpat is a single-axle, two-wheeled tractor with a trailer attached. In this descriptive study, the descriptive characteristics and causes of death were analyzed of case related to patpat accidents for which autopsies were performed by the Forensic Medicine Institution Trabzon Group Directorate between 2006 and 2017.

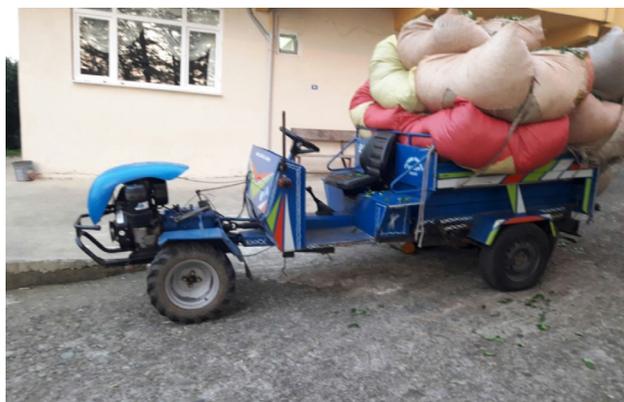
Figure 1. An example of a patpat used for carrying loads.

loads. Overtime, agricultural machines have been designed appropriate to more simple needs, instead of tractors which have a wide area of use. An example of these is the “patpat,” so named because of the sound of the motor, and for which the main purpose is ploughing. A patpat is a single-axle, two-wheeled tractor with a trailer attached<sup>[1]</sup> (Fig. 1).

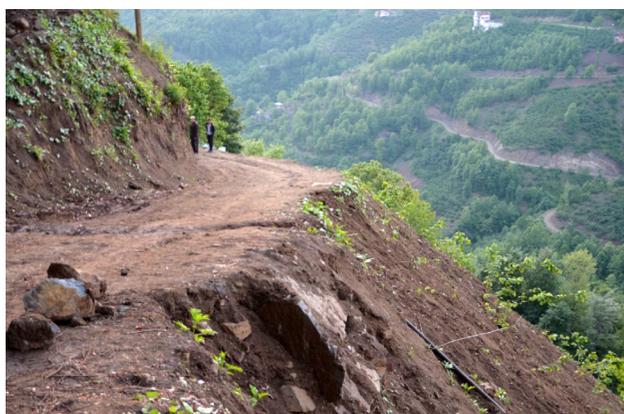
Figure 2. The steep unmade roads in the fields and rural areas in the region (real accident scene image).

it has become necessary to use patpats in relatively small agricultural areas because of the mountainous, rugged features of the land and the rainy climate (Fig. 2). Due to the geographical features of the region and the use of patpats other than for agricultural activities, the likelihood of accidents increases. The previous studies in literature have reported injuries and deaths as a result of patpat accidents.<sup>[2,5]</sup>

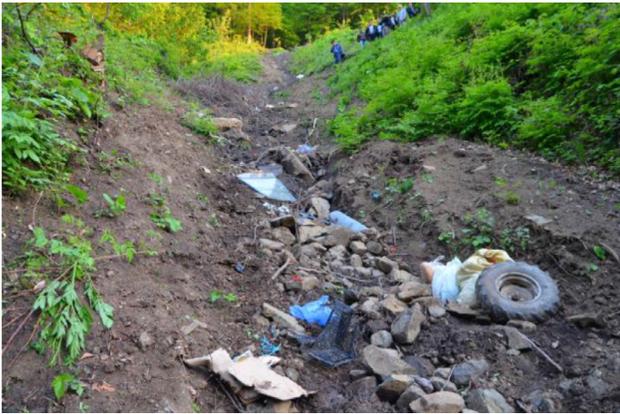
**Figure 4.** A patpat that breaks into a large number of pieces due to rolling over the abyss.

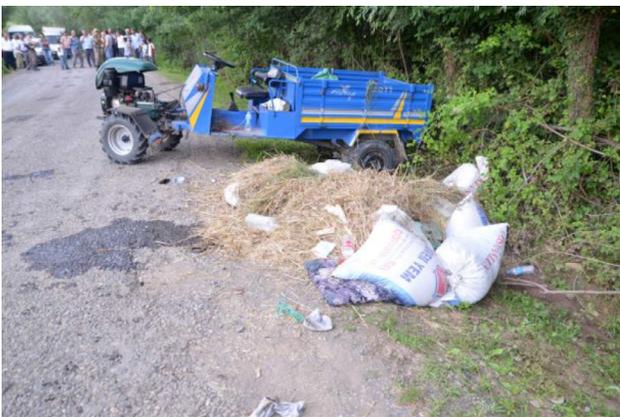
**Figure 5.** A patpat that has been knocked over because of roll over.

conditions where they are used. According to the scene of accident reports, 85.7% (n=18) of the patpats in this study were found to be overturned or on their side following the accident. This is also seen as significant in tractor accidents, with overturning of the vehicle responsible for approximately half of tractor deaths.<sup>[6,7]</sup> The high rate in the current study can be attributed to serious problems related to the safety of the users of patpats produced from other vehicles in an uncontrolled and unsupervised manner. As no differential is used in these vehicles, the two wheels turn at the same rate going round a bend and this can cause the patpat to overturn.
