Fracture resistance of occlusal veneer and overlay CAD/CAM restorations made of polymer-infiltrated ceramic and lithium disilicate ceramic blocks

Atf/Citation: Gürpınar, B., Celakil, T., Baca, E. & Evlioğlu, G. (2020). Fracture Resistance of Occlusal Veneer and Overlay CAD/CAM Restorations Made of Polymer-Infiltrated Ceramic and Lithium Disilicate Ceramic Blocks. Ege Üniversitesi Diş Hekimliği Fakültesi Dergisi, 41(2), 131-142.

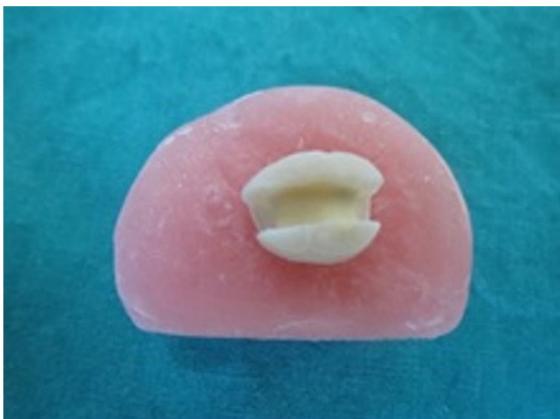
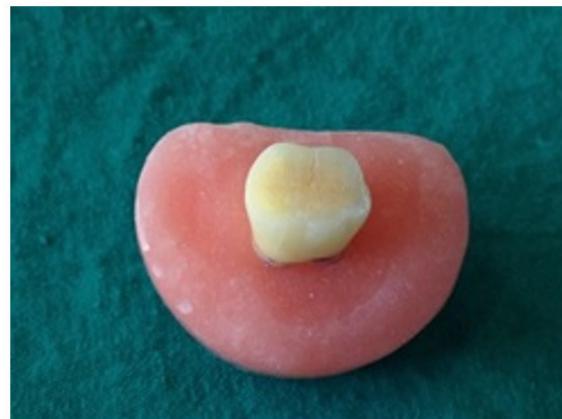
Figure 2: Overlay and occlusal veneer preparations

Two different preparation designs were defined for the study groups: overlay preparation group: mesio-occluso-distal box cavity form was applied, and the depth and width of isthmus area was 3 mm. The margins of the mesial and distal box were placed 1 mm over the enamel-cement junction. The width and height of the steps were adjusted to be 2 mm. The functional and nonfunctional cusps were reduced by 2 mm, and the angle between the cavity walls was adjusted to be 6 degrees. Overlay preparations were made with the help of a standard set of rotary instruments (Intensive FG Ser- Inlay Set III Extended, L. Sevük, Prof. Ç. Sevük, İstanbul)

For the occlusal veneer group, a standardized tooth preparation was made to imitate occlusal wear. The worn surface was prepared on the enamel with the help of a standard fissure cutter (Intensive FG-305 L CB) to expose

the dentin. Buccal and lingual margins were positioned 5.5 mm over the enamel-cement junction, and 2.5 mm over the central fossa, and the cusp curves were protected as much as possible¹³ All cavity preparations were made by a single clinician (B.G.) (Figure 2).

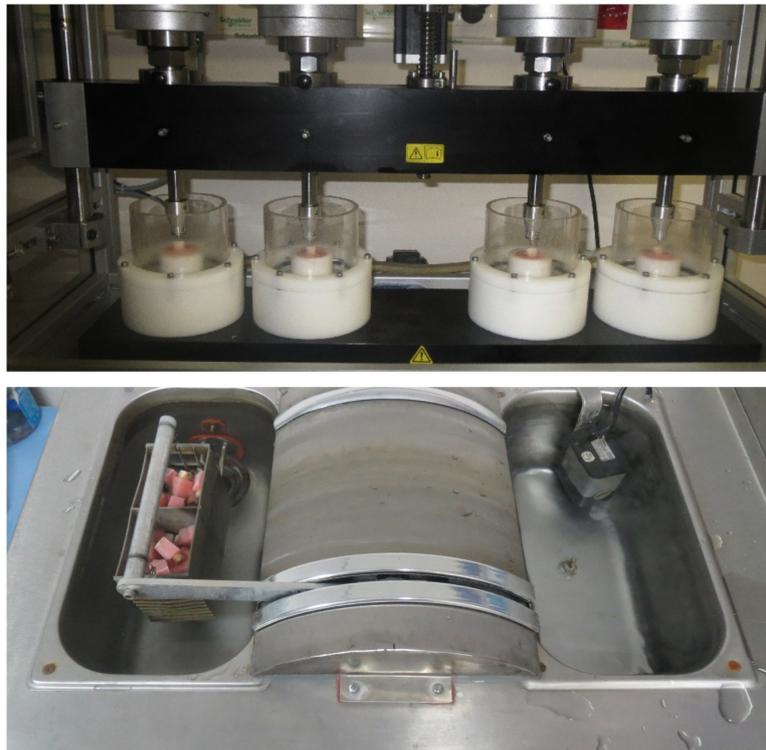
Figure 4: Artificial aging process of the specimens

The specimens were subjected to a dynamic and thermal fatigue process. For the first artificial aging step, the specimens were subjected to 50 N force with

1.6 Hz frequency³ in a moist environment through 100 000 dynamic cycles¹⁵ in the chewing simulator machine (Chewing Simulator CS-4, SD Mechatronic GmbH, Germany). For a thermal cycling process, the specimens were submerged into two water baths at 5 °C and 55 °C for 30 seconds for a total of 5000 cycles⁵ (Figure 4). The fracture test was performed by using a universal testing machine (Shimadzu Co., Kyoto, Japan) with loading using a custom 6-mm-diameter spherical stainless-steel tip^{16,17}. The tip was placed exactly at the center of the restorations from the buccolingual and mesiodistal sides and touched the restorations on both the buccal and lingual sides (Figure 5) to simulate tripod contacts along the cuspal inclines². The crosshead speed was 0.5-mm/min.² The fracture force value was recorded when cracks or small fractures occurred in the specimens. All specimen fractures were examined with a stereomicroscope (Olympus SZX7) and a camera (Canon EOS 450D) to determine the structures that were included in the fracture, size of the damage and failure mode. The Burke classification¹⁸ was used to determine the failure mode (Figure 6). Burke classification: I merely the restoration fracture; II the restoration fracture including a small tooth tissue; III the fracture including more than half of the tooth and not including periodontal tissues; IV serious restoration and/or tooth fractures including periodontal tissues (catastrophic fracture).
