Evaluation of Refunctioning/Adaptive Reuse in terms of Cultural Tourism in the Conservation of Architectural Heritage: *The Example of Diyarbakır Ferit Köşk (Mansion)*

Nursen IŞIK

Architecture Department, Faculty of Architecture, Dicle University, Diyarbakır, Turkey.

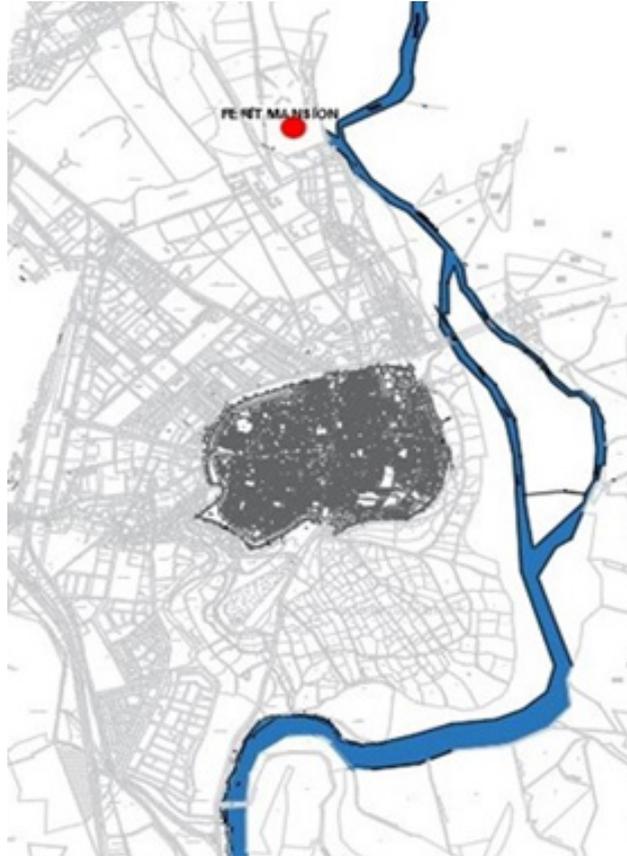
Figure 2. The Location of Ferit Köşk (Mansion) in the Suriçi Region (Işık, 2021)

Ferit Köşk (Mansion) is located south of the city walls and northwest of the Tigris River. Located at the end of Ferit Köşk (Mansion) quarter of Diyarbakır Fiskaya district, the mansion has survived to the present day as empty and heavily damaged (Figure 2).

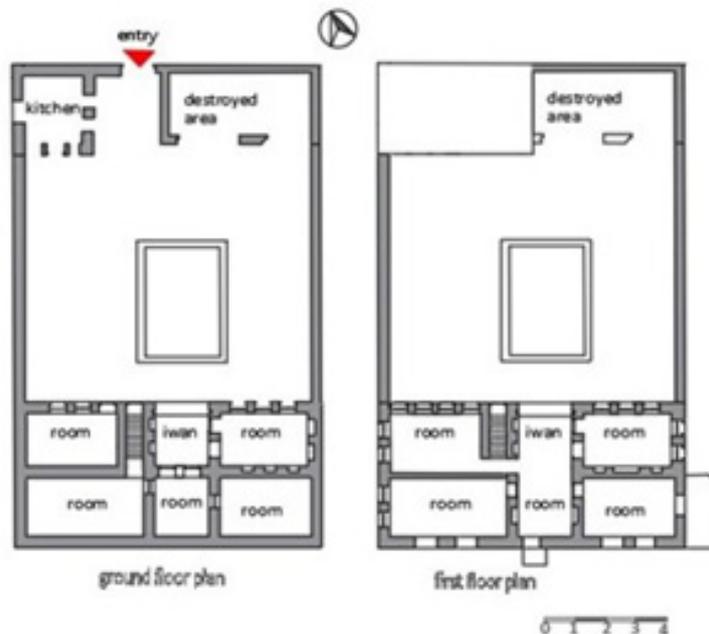
Figure 2. Ferit Köşk (Mansion) Floor Plans (2021)

Ferit Köşk (Mansion) was built with two floors and masonry construction technique. The main entrance of the mansion is in the southeast direction of the courtyard and has been closed today. The courtyard of the mansion, which is surrounded by high walls, is entered through an open space in the north (Figure 3).

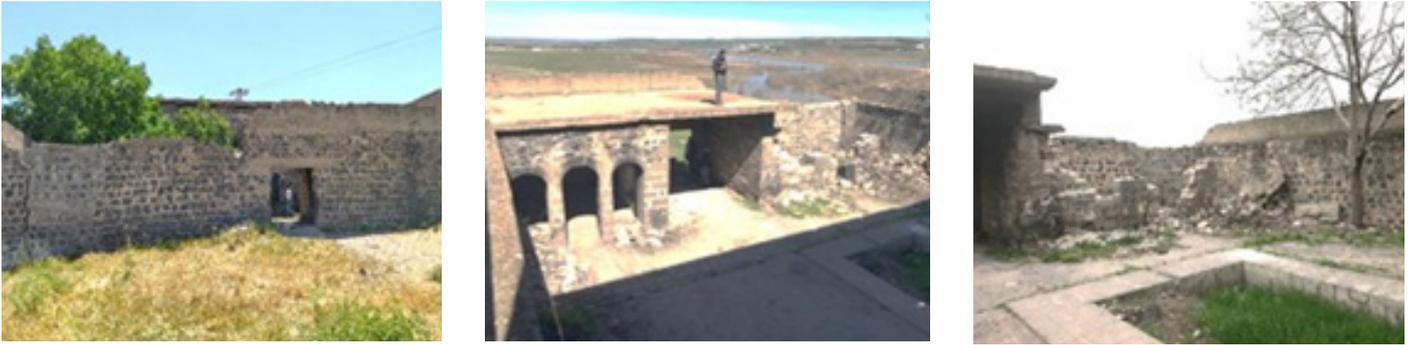
Figure 4. Ferit Köşk (Mansion) entrance section, the kitchen, and the ruins of the destroyed space (Işık, 2021)

There is a kitchen with a stove in the northwest of the courtyard. The kitchen, with its two semicircular arched windows and door, overlooks the courtyard. The wall facing the entrance is damaged and partially collapsed. The upper cover of the kitchen was changed to reinforced concrete. In the northeast of the courtyard, there is a ruin thought to have been added later, which is thought to be a service space in ruins today (Figure 4 a, b, c).

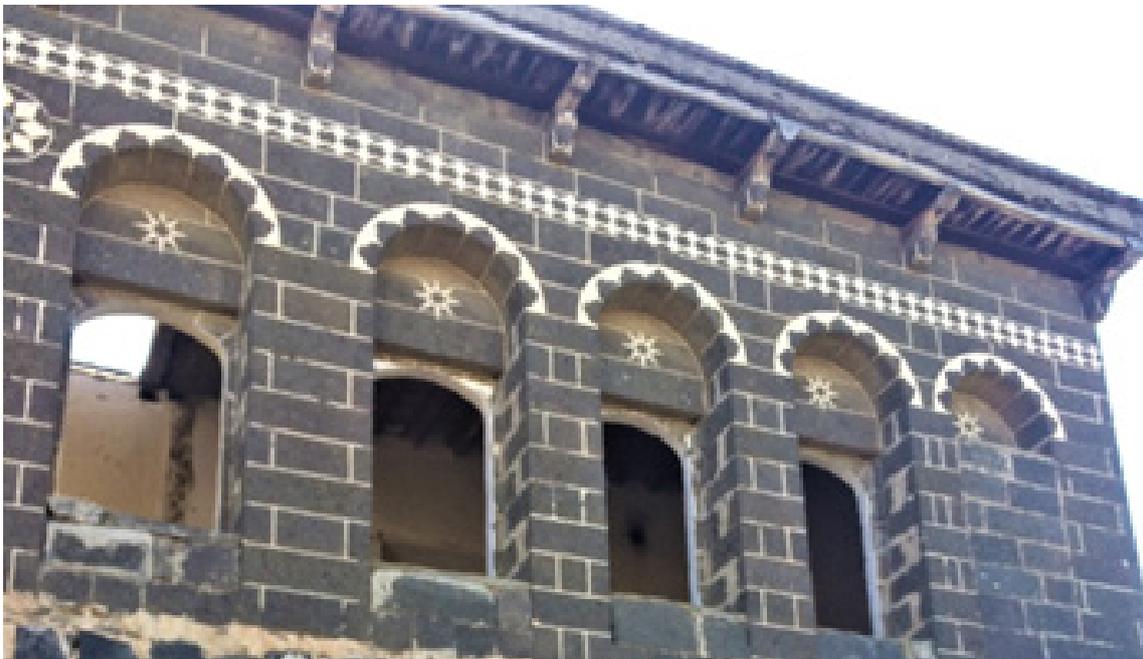
Figure 5. The decorations on the window arches on the northern façade of Ferit Köşk (Mansion) (Işık, 2021)

Local basalt stone was used as the main construction material in the mansion. There is a rectangular shaped local pool in the courtyard. On the northeastern façade of the mansion facing the courtyard, the ground floor is made of rubble stone and the first floor is made of cut stone and decorated (Figure 5).

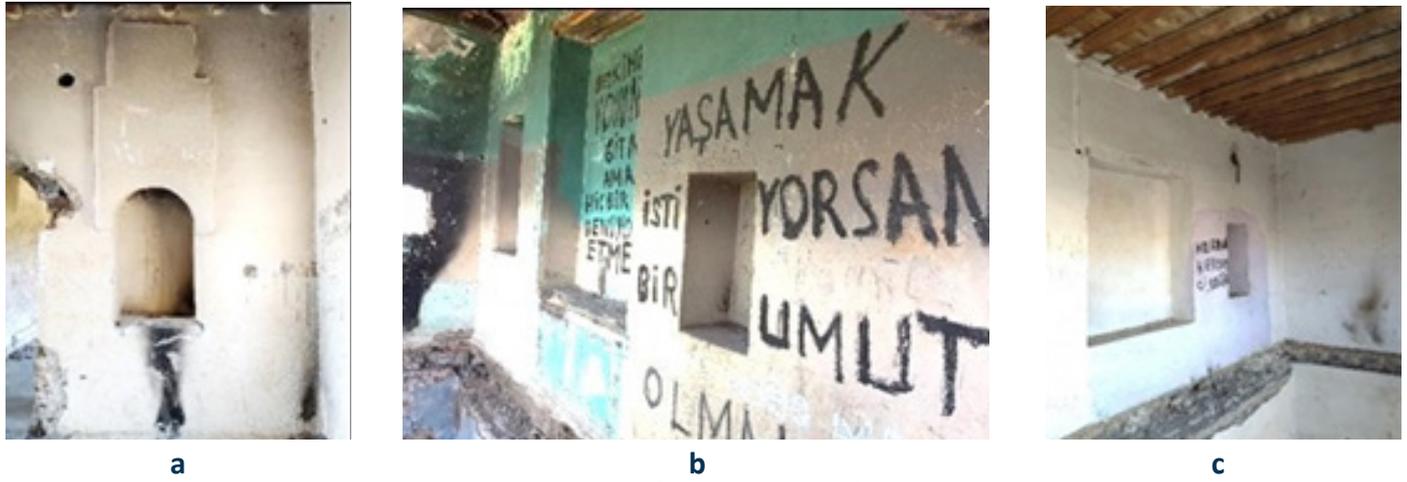
Figure 6. Examples of Niches in Rooms (Işık, 2021)

The entrance to the ground floor of the mansion is provided by a semicircular arched iwan. On the ground floor of the building, the east and west rooms facing the courtyard have doors opening to the courtyard and windows with two semi-circular arches and “cis, cas” decorations on the top. A single-armed stone step staircase reaches the upper floor of the mansion, which has an iwan on the ground floor and first floor. There is an entrance to the rear rooms in the east and west directions from the gap in the south of the iwan on the ground floor. The walls of the rooms on this floor are plastered and painted, and there are niches on the walls. The mezzanine floors of some rooms on the upper floor of the mansion have been completely demolished today. There are traces of the room being closed with wooden beams on the walls.

The layout on the first floor of the mansion is the same as the ground floor plan. After reaching the first floor by stairs, there are four rooms, two in the east and west directions. On this floor, which has a pointed arched iwan in the middle, the floors of the rooms were destroyed. The wall facing the courtyard on the east side of the building was demolished, and the destroyed stones remained in the courtyard. The walls on the upper floor are all plastered and painted, and there are niches on the walls as in the ground floor (Figure 6 a, b, c).

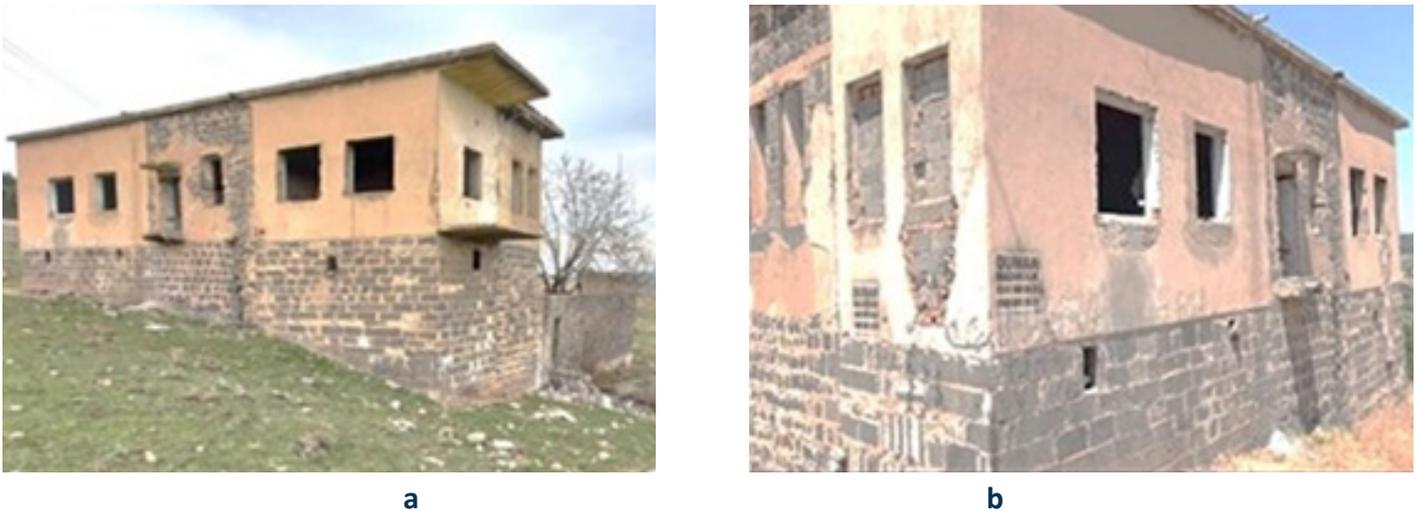
Figure 7. Ferit Köşk (Mansion) entrance section, the kitchen, and the ruins of the destroyed space (Işık, 2021)

The semicircular arched windows on the northern façade of the walls opening onto the courtyard are decorated with flat lintels. The ceiling tile, which had wooden beams in its original architecture, has been replaced with a reinforced concrete slab. The walls in front of the iwan on the first floor of the building have collapsed. There are partial collapses in all of the room walls opening to the iwan. Except for the north façade facing the courtyard, the first floor façade walls made of stone were covered with plaster and paint (Figure 7 a, b).

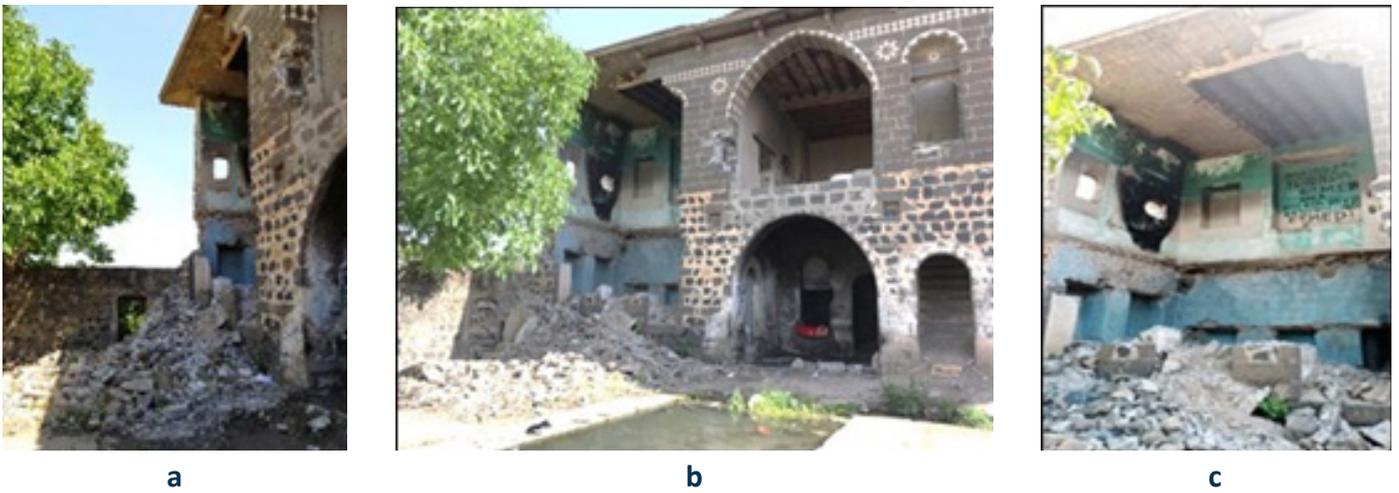
Figure 8. Damages on the northeastern wall of Ferit Köşk (Mansion) (Işık, 2021)

During the field study conducted between 2018-2021, it was observed that the damage of the structure increased over time. The northeastern wall of the building, which was partially damaged in 2018-2019, was demolished in 2020 (Figure 8 a, b, c)

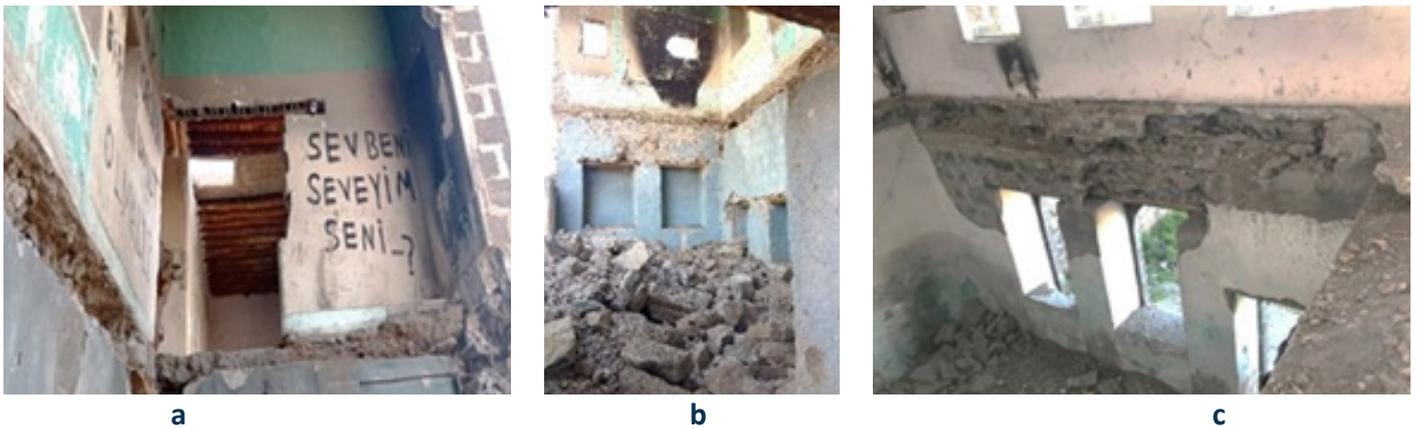
Figure 9. Ferit Köşk (Mansion) floor damages (Işık, 2021)

No comprehensive restoration and repair work has been carried out in the mansion, except for the simple repairs of the owners from past to present. Replacing the upper cover of the mansion with reinforced concrete flooring increased the load and damages on the structure.

The collapse of the floors of some rooms on the first floor caused damage to the exposed walls. The floors of the rooms in the southeast and southwest of the mansion facing the courtyard have been destroyed, and the rooms filled with the collapsed floor pieces are unusable (Figure 9 a, b, c).

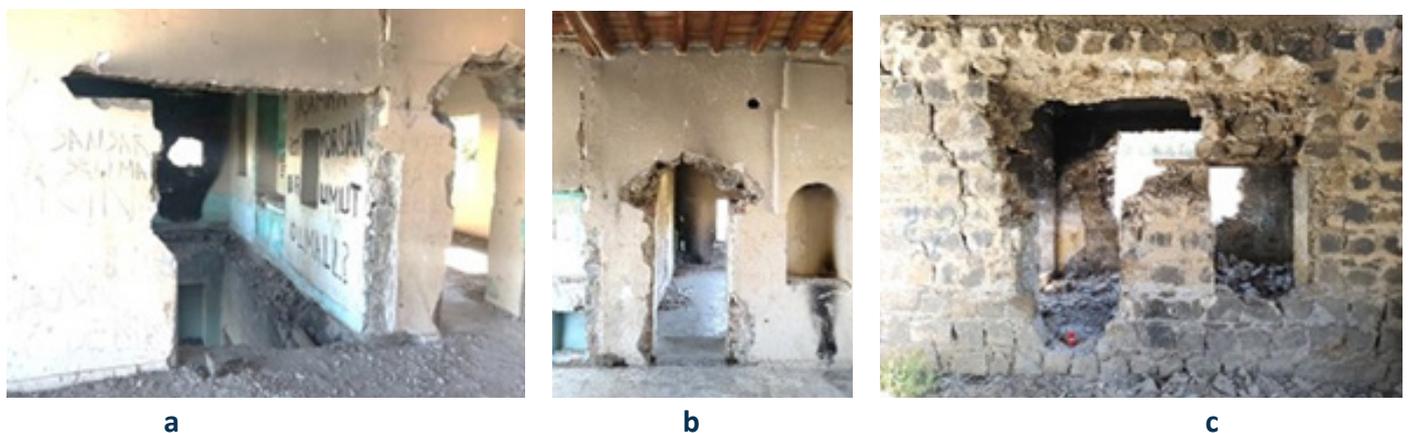
Figure 10. Deterioration and damage to the walls (Işık, 2021)

Partial collapses occurred in the interior walls of the ground and first floors of the mansion, and accordingly the load-bearing system was damaged. The damage in the whole structure increased due to the collapse of the walls that acted as carriers in the building constructed with the masonry construction technique (Figure 10 a, b, c).

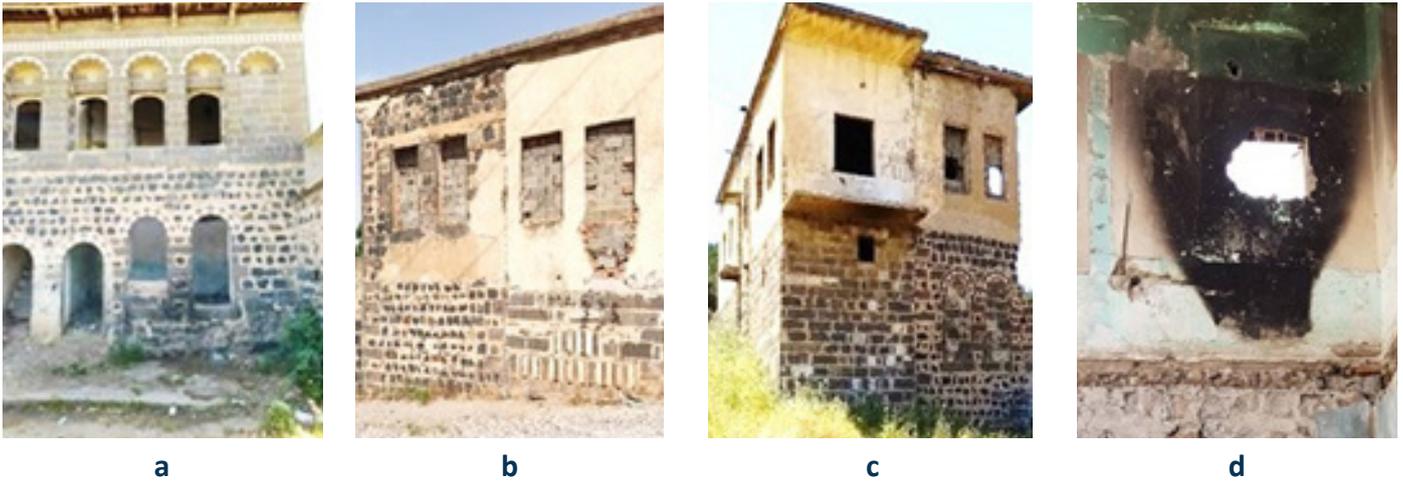
Figure 11. Deterioration and damage to the walls (Işık, 2021)

The unconscious destruction of the mansion by the users caused the deterioration of the building structure and original architecture. Closing the existing windows in the building, removing the existing window and door frames, starting a fire, etc. are some of these reasons (Figure 11 a, b, c, d).

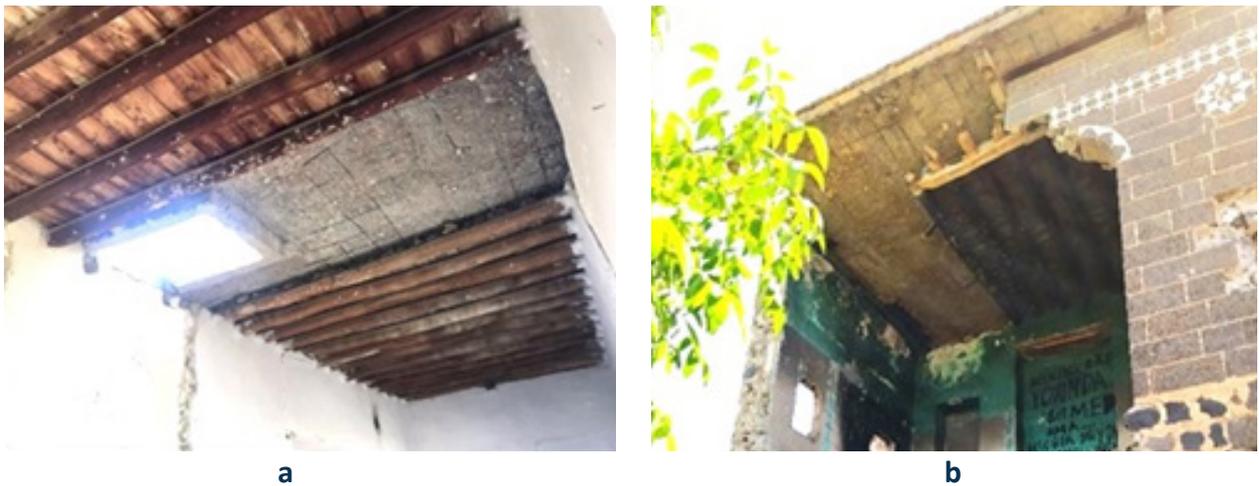
Figure 12. Deflection and material loss damages in wooden beams (Işık, 2021)

The wooden-beamed earthen roof in the original architecture of the mansion has been replaced with a reinforced concrete floor. The load irregularity brought by the flooring on the structure caused deflection damage, breakage and material loss in wooden beams (Figure 12 a, b)

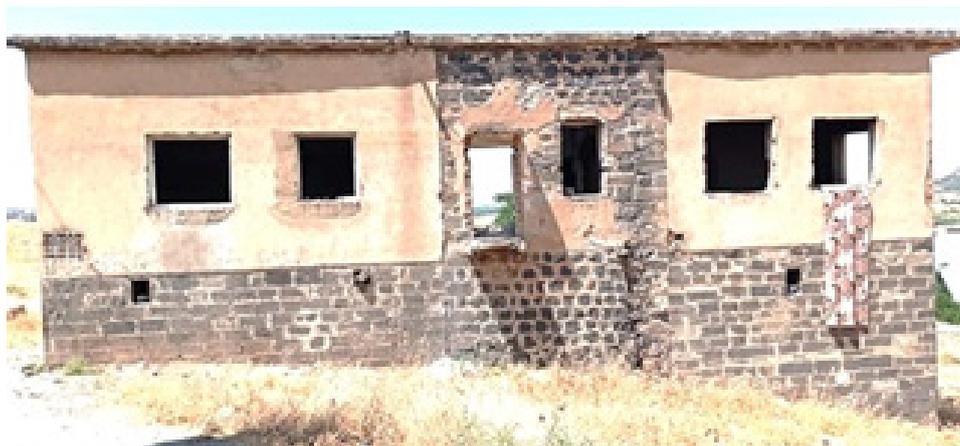
Figure 13. Damages on the southern wall of the Ferit Köşk (Mansion)(Işık, 2021)

The balcony walls protruding from the upper floor iwan on the south wall of the building have completely collapsed. The balcony floor, which is thought to have been added later, is made of concrete material and segregation damage has occurred between the plate and the wall (Picture 13).
