# Theoretical and practical issues regarding relocation of monuments – The case of Arslanagić Bridge in Trebinje

Maja TOSHIKJ<sup>\*</sup>

*Department of History of Architecture and Monument Preservation, Budapest University of Technology and Economics,  
Faculty of Architecture, Budapest, Hungary*

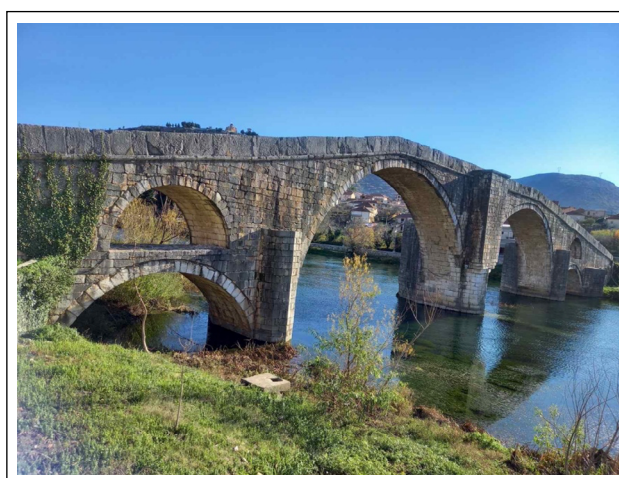
**Figure 1.** Arslanagić bridge in Trebinje, western facade (the photo was taken by the authors in 2022).

two larger ones with a width of about four meters, which are in the middle, then four smaller ones, placed one on top of the other on each side. The bridge’s total length is 92.55 meters,<sup>16</sup> with an approximate width of 3.50 meters. Its esthetic values, stylistic, and specific characteristics are “a consequence of the architect’s effort to find the most functional solution in the existing conditions of the terrain and the course of the river” (Tihic, 1966, p. 112). Consequently, it is included in the group of large bridge structures in Bosnia and Herzegovina from the Ottoman period; as Lovrenović (1998) notes:

Functionally and esthetically, these structures are perfectly adapted to the water on which they stretch and to the banks with which they merge. Again, although they all belong to a recognizable common style, these bridges were not built according to a standard model but varied in a multitude of forms: From the dignified, monumental horizontal of the Višegrad Bridge with its 11 arches to the vertiginously daring, but perfectly calculated, fantastical arch of Mostar’s Old Bridge and the unusual asymmetry of the design of the Arslanagić bridge over Trebišnjica. (p. 86) (Figure 1)

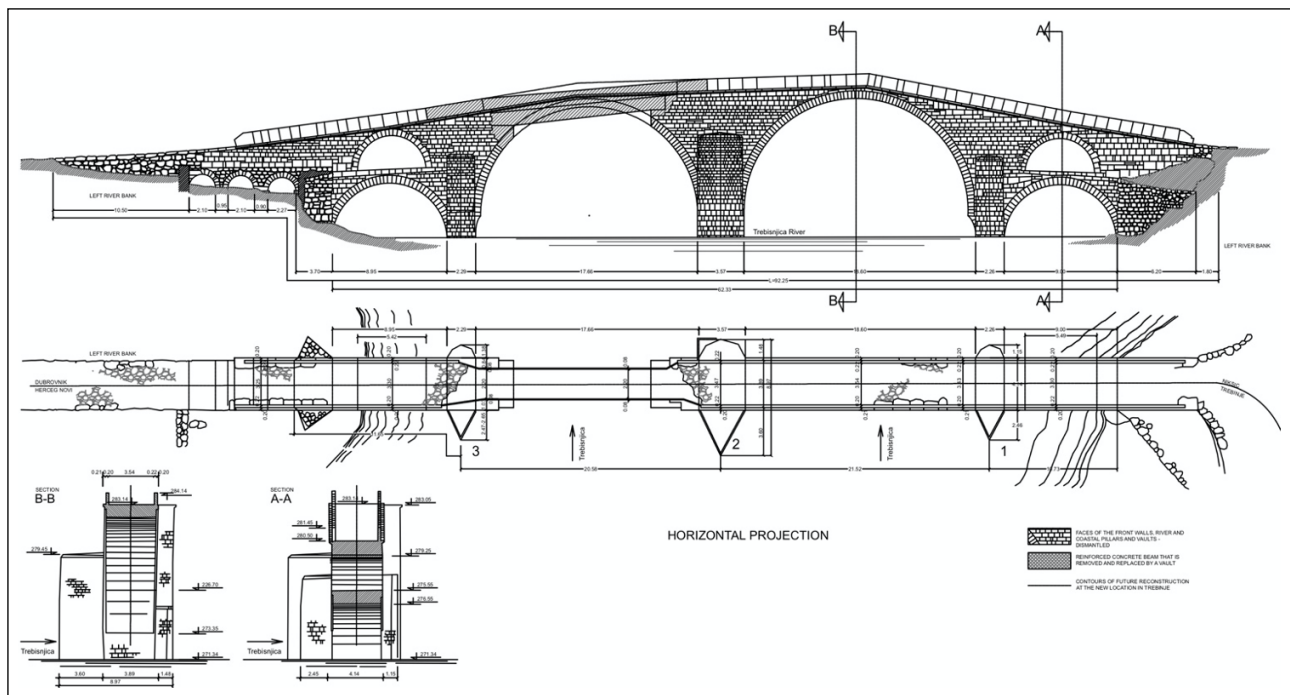
**Figure 2.** Horizontal projection of the upstream side façade of Arslanagić bridge before the relocation. A drawing made according to the technical data of the Institute for the Protection of Cultural Monuments in Mostar (redrawn by the authors after Милан Гојковић (1963)).

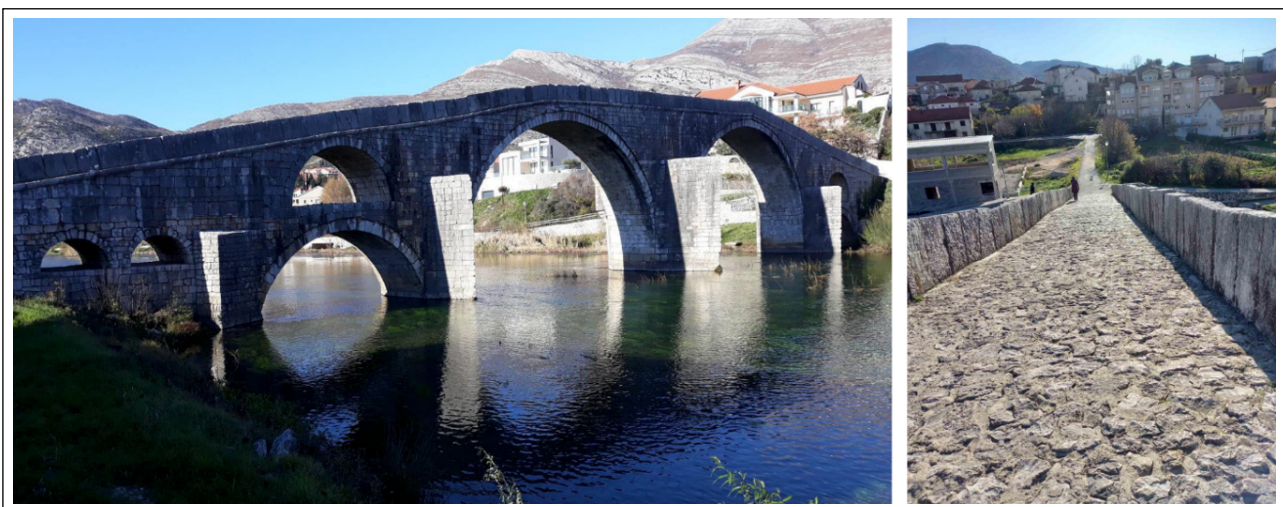
**Figure 3.** Arslanagić bridge in Trebinje after relocation, eastern upstream façade and paving (the photos were taken by the authors in 2022).

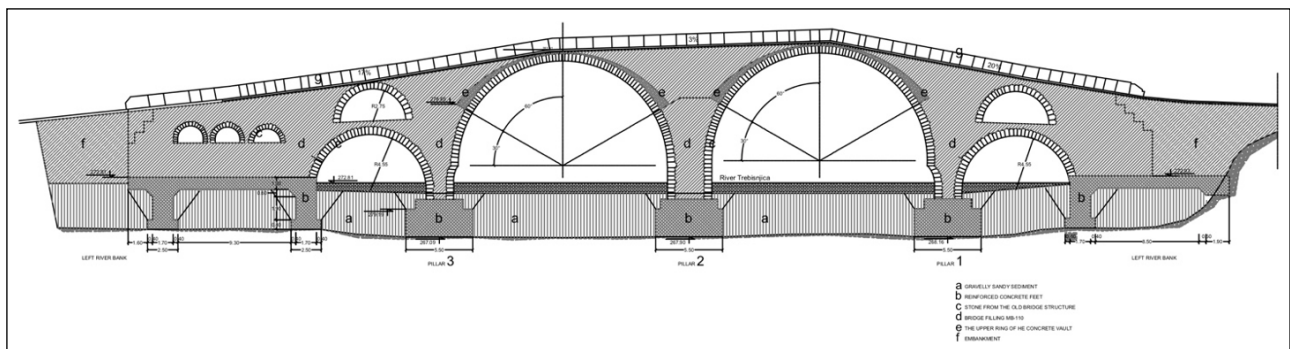
**Figure 4.** Structural integrity section of the reconstructed Arslanagić bridge (redrawn by the authors after Milan Gojković (1973)).

In the relocation project, the concrete beam was discarded as the goal was to reconstruct the entire bridge to its original appearance. During the reconstruction of the bridge facades, special attention was paid to the structural and architectural aspects. Two concentric rings formed the main structure of the vault; the lower one consisted of dismantled stone pieces and joints in cement mortar, while the upper one consisted of crushed aggregate and cement. The rough and uneven stone surfaces of the lower ring allowed an intimate connection with the concrete, resulting in a massive, vaulted structure.<sup>21</sup> Concrete was also used as a substrate for the reconstructed surfaces and the new foundations<sup>22</sup> (Figure 4).

The new concrete infill, which replaced the existing aggregate stone infill, led to a change in the cohesiveness of the internal structure, changing the integrity of the infill at the structural and material level. The original structural approach of the bridge lies in its nature as a stone aggregate; consequently, interventions in monuments made of small stones, is as Nenadović (1974) suggests, an act of demolition "their dismantling is only a kind of systematic and controlled destruction." Referring to the method of retaining the historical facade and making the internal structure from concrete, he points out that "the

<sup>22</sup>Both the main piers and the shore pier foundations, due to their considerable length, were constructed as reinforced concrete beams (see Gojković, 1973).

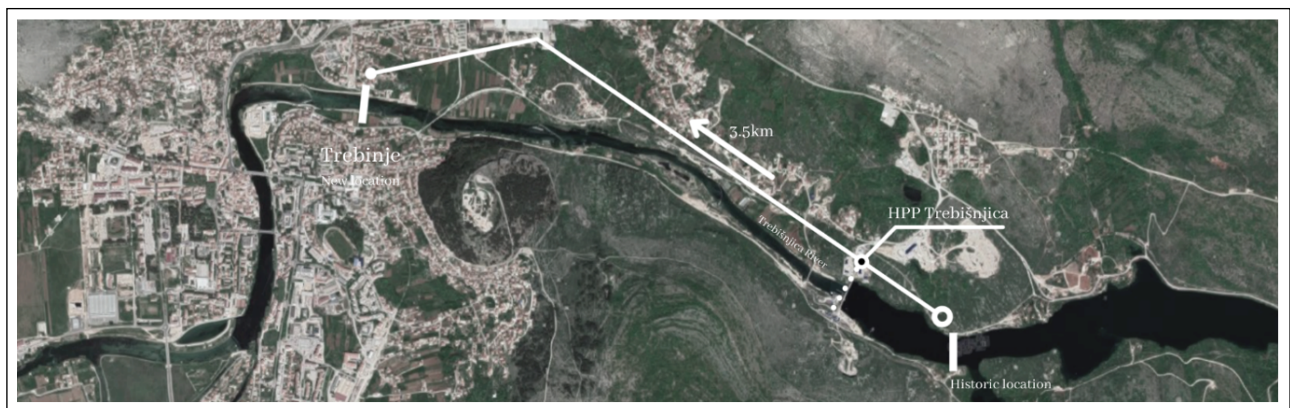
**Figure 5.** Map of Trebinje and surroundings showing the relocation distance and position of the historic and new Arslanagić bridge locations (the drawing was prepared by the authors in 2022).

The bridge was relocated 3.5 km from its original site, along the Trebišnjica River, north-west of Trebinje (Figure 5). A favorable cross-river profile was identified, determined by the municipal authority’s requirements, Trebinje’s housing issues, urban and touristic needs, and the opinions of the professionals who worked on the relocation to find the optimal spatial integration of the structural elements of the bridge and their integrity. Gojković (1973) observed, “the newly chosen site has special qualities and benefits to accommodate the orthogonal projection of the bridge; it emphasizes the bridge’s construction and its aesthetic value
