Conservation of Historic Sarıyer District in Istanbul: Improving the Sustainability and Energy Efficiency of a Bosphorus Village

İpek Zeynep KAPTANOĞLU,¹ Elif MIHÇIOĞLU BİLGİ²

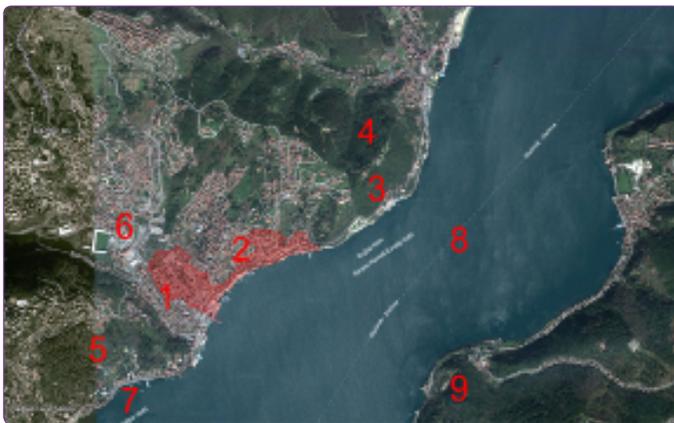
Figure 2. Boundaries of the study area: [1] Historic Sariyer and [2] Yenimahalle. Other important environmental locations outside the study area include: [3] the tomb of Telli Baba, a popular shrine of a Muslim saint for young women to pray, [4] a woodland on the road to Rumeli Kavağı, [5] a woodland belonging to the Russian consulate's summer cottage, [6] the Sariyer Sports Club's facilities, [7] Mesar Burnu-Piyasa Avenue, [8] Sariyer waterways used during the fishing season, and [9] Woodland at Anadolu Kavağı (Kaptanoğlu, 2014: 69).

ters, are the two oldest centres in this province and they cannot be considered separately, as historically they have always been commercially and socially connected (Fig. 2).

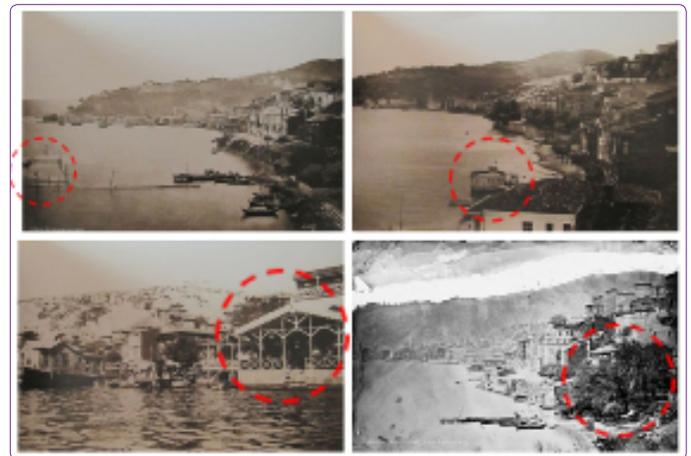
Figure 3. (Top left) Pazarbaşı fish pond in Yenimahalle in 1870 (Genim, 2006: 817; Paskal Sebah, No:16); (top right) Public sea bath (known as 'deniz hamamı' in Turkish) or beach at Yenimahalle in 1920 (Genim, 2006: 829; Anonymous, 1920); (bottom left) a restaurant and Hotel Osmanie in 1890 (Genim, 2006: 827; Anonymous, 1890); (bottom right) A tea garden by the sea in the 1880s (German Institute of Archaeology Archive, Guillaume Berggren).

Although as old as Sariyer, Yenimahalle is less frequently mentioned in the literature on the history of the Bosphorus. Since the Byzantine period, it was best known as a quiet fishermen's village and agricultural centre (Hürel, 2010: 669). İnciciyan (1758-1833) described Yenimahalle as the last settlement of summer houses in the 18th century (İnciciyan, 2000: 139). After the initiation of ferry service, Yenimahalle began to see more activity, especially in well-known recreational areas such as Pazarbaşı Fish Pond (known as 'dalyan' in Turkish), Fırıldaklıbahçe Tea Garden, the Music Hall ('Gazino'), public sea baths (originally known as 'deniz hamamı' in Turkish, meaning beach), and Hekimyan's Vineyard (Balci, 2006: 44, 47) (Fig. 3).

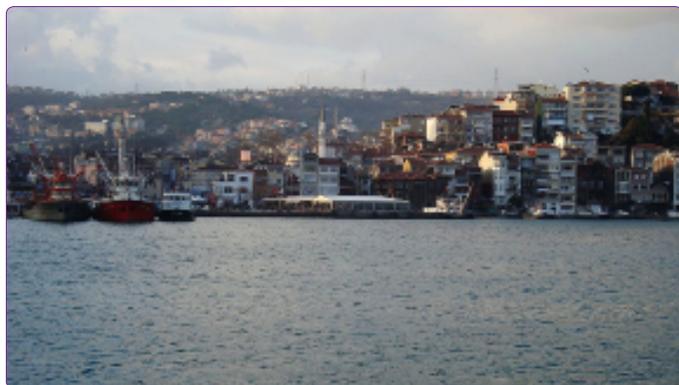
Figure 4. Silhouette of Sariyer Historic Center in 2014 (Kaptanoğlu Archive, 2014).

In time, the waterside houses came to be claimed by the wealthy residents, and the slopes of the Bosphorus were covered with newly-arriving poor squatters. The negative effects of urbanization, together with the low-income neighbourhoods, began to visibly change the natural and the historical fabric of Sariyer and Yenimahalle, especially after the 1970s (Fig. 4 and Fig. 5).

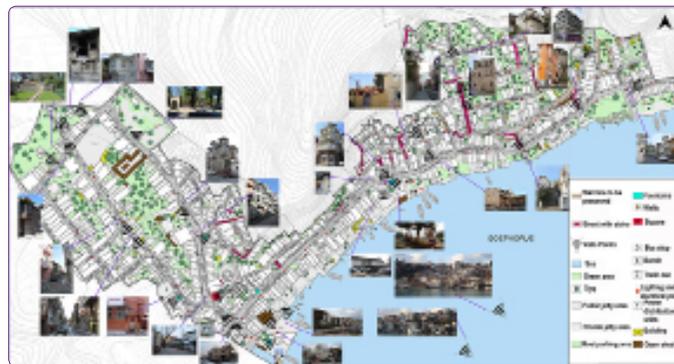
Figure 6. Environmental data analysis (Kaptanoğlu, 2014: 74).

Sariyer also faces the woodlands of Anadolu Kavağı on the Asian side, which is an important natural ecological landscape that enriches the visual quality of the city and the district. The greenery of the cemeteries at the end of Dursun Fakih Street, as well as the parks, other public lawns, and the large gardens of the houses, all substantially increase the rate of greenery in the area. Despite its location along the Bosphorus, public access is limited to only a few points: Taş İskele (Stone Pier) Park, Yenimahalle Park, and Pazırbaşı Park. The rest of the shore is for private use by the waterfront houses, which is the original condition of the Bosphorus coastline due to the ownership pattern (Fig. 6).

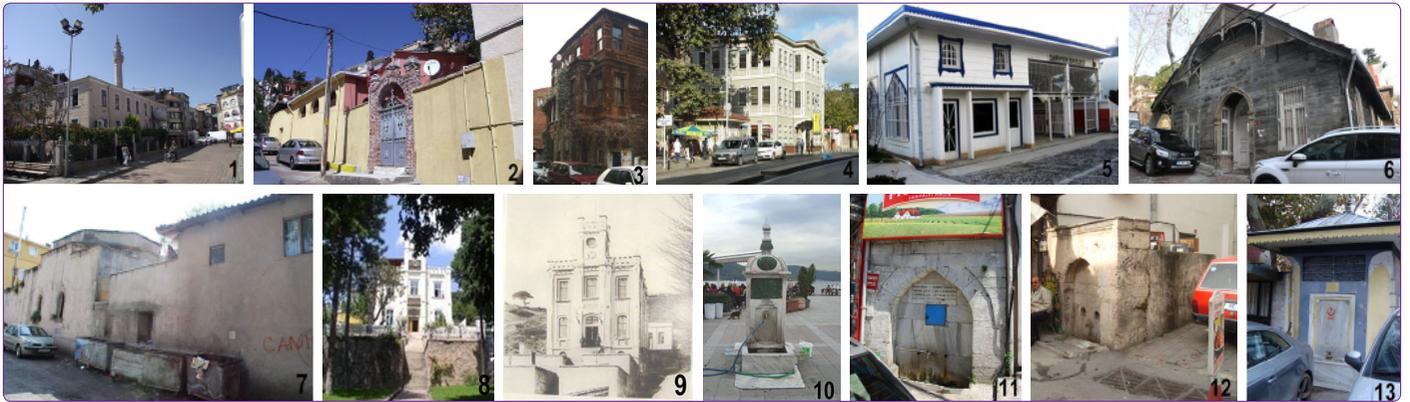
Figure 7. Monument buildings in the study area; [1] Ali Kethüda Mosque at Sariyer (URL3); [2] St. Prodromus Church (also known as Ionnes Greek Orthodox Church) at Yenimahalle (URL4); [3] Hakki Pasha Mansion (Kaptanoğlu archive, 2013); [4] Pertevniyal Valide Sultan Mansion (Kaptanoğlu archive, 2014); [5] Sariyer Jetty (Kaptanoğlu archive, 2014); [6] Armenian Elementary School at Haydar Doğ Street (Kaptanoğlu archive, 2013); [7] Sariyer Bath (or Avcı Mehmet Bath) (URL5); [8] Pazarbaşı Police Station in the early 19th century (Çiftçi, 599; German Archeological Institute-Yıldız Album) and [9] today (URL6); [10] Ahmet Kamili Fountain in Sariyer (Kaptanoğlu archive, 2014); [11] Mesut Ağa Fountain (Kaptanoğlu archive, 2014); [12] Hasan Paşa Fountain (Kaptanoğlu archive, 2014); [13] Tekke Fountain in Yenimahalle (Kaptanoğlu, 2014).

Sariyer Turkish Bath, the earliest monument in the area, dates back to late 16th or early 17th centuries. Other monumental buildings include; Ali Kethuda Mosque dated to late 17th or early 18th century; St. Prodromus Church built in the 19th century; the Armenian Elementary School and Pazarbaşı Police Station constructed from 1891 to 1892; Sariyer Pier erected in 1851; and seven fountains. These in-

clude the Mesut Ağa Fountain (1645), Ahmet Kamili Efendi Fountain (1812), Sadrazam Hacı Salih Paşa Fountain (1822), Çukur Fountain (date unknown), Kaptangazi Fountain (1884), Tekke Fountain (date unknown), and in Yenimahalle the Kaptan-i Derya Hasan Paşa Fountain (1784) (Fig. 7).

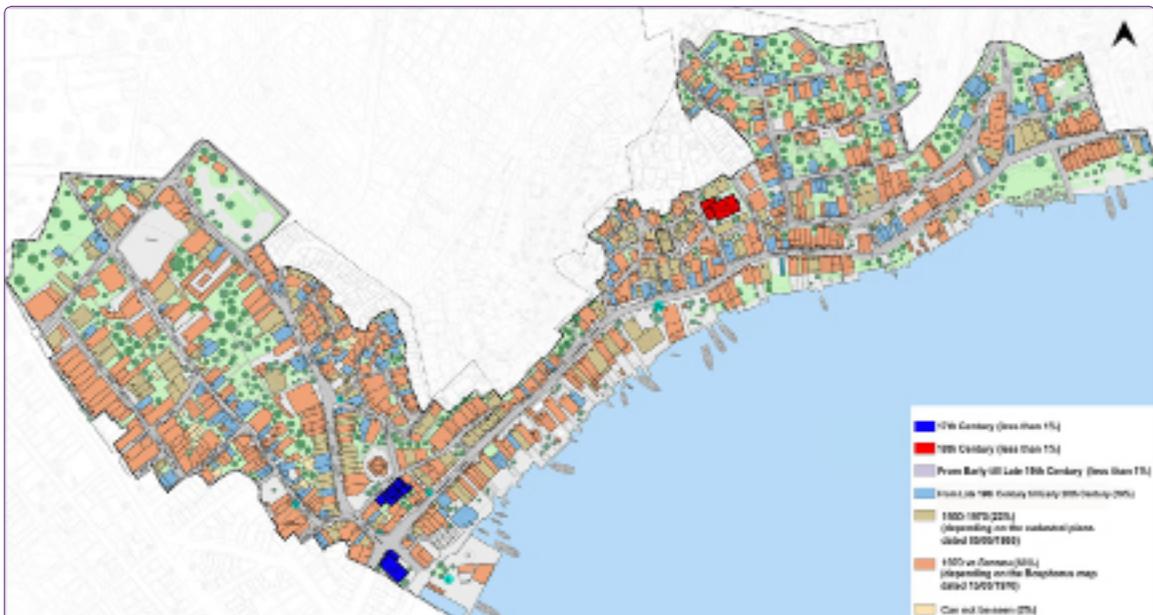
Figure 8. Periodical Analysis of the Buildings (Kaptanoğlu, 2014: 83).

The historic residential buildings, dating from the late 19th to the early 20th centuries, constitute approximately 20% of all the structures currently standing (Fig. 8). In contrast, the buildings with new structural systems built after the 1970s (55% reinforced concrete, 12% reinforced concrete with timber cladding, which are mostly the reconstructions, 7% concrete block masonry, and 2% steel frame) comprise the majority in the area, with 79% ruining the integrity and authenticity of the historic urban fabric. Early

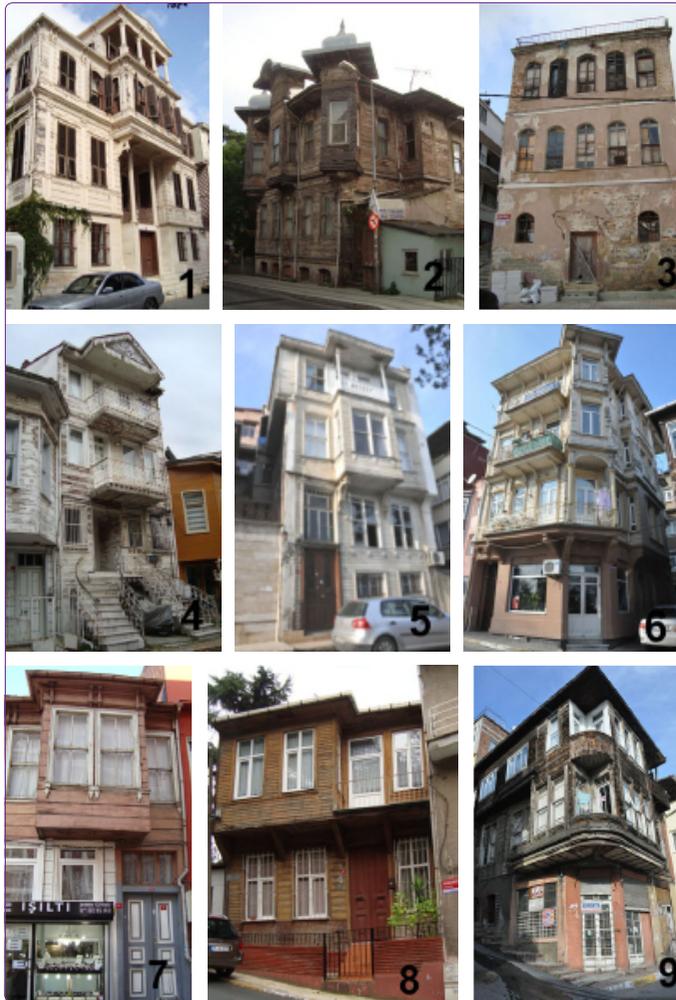
Figure 11. Some examples of historic residential buildings in the study area; [1] Karakütük Street No. 47; [2] Ortaçeşme No. 47; [3] Ocak Ağası Street No. 4; [4] Karakütük Street No. 64; [5] Karakütük Street No. 49; [6] Karakütük Street No. 105; [7] Dursun Fakih Street No.14; [8] Karakütük Street No. 76; [9] Karakütük Street No. 1 (Kaptanoğlu archive, 2014).

toric buildings are in good condition. Conversely, historic buildings reconstructed pursuant to previous conservation decisions, with reinforced structures and timber façade claddings, comprise approximately 11% of the buildings; they are mostly differentiated in terms of proportion and have lost their authentic properties completely. With regards to alteration, reconstructed buildings constitute one extreme group; there are no unaltered or completely original historic buildings in the area, which reflects the critical nature of this conservation problem (Fig. 11).

⁵ The proposals are developed, based on the analysis and evaluation of the single historic residential building at Ortaceşme Street No: 47 (at Fig. 11. [2]) chosen as a sample from the study area, which has a composite structural system, composed of brick masonry and timber skeleton, which is the most common structural system for historic buildings in the study area.
