The impact of the February 6th, 2023, Kahramanmaraş epi-centered earthquakes on traditional underground water systems: Gaziantep case

Gamze ÖZMERTYURT^{*} , Zeynep GÜL ÜNAL[†]

Department of Architecture, Yıldız Technical University, İstanbul, Türkiye

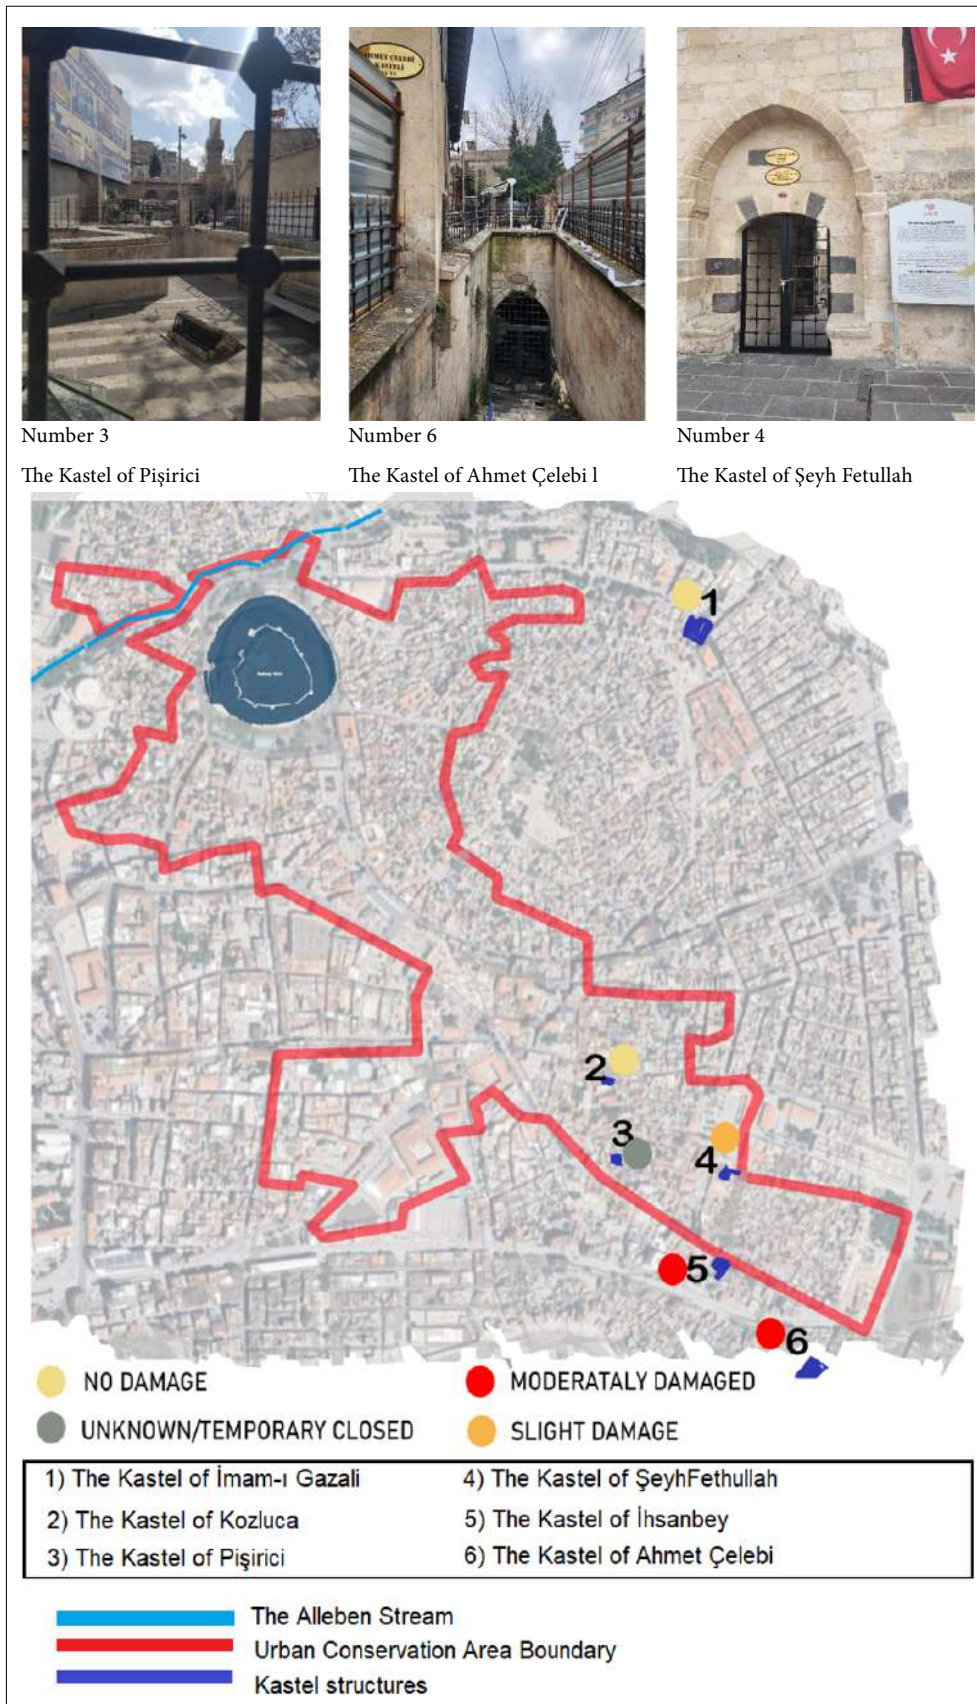
Figure 5. According to reports, the post-earthquake situation of the Kastels in Gaziantep City Center.

The latest findings regarding the livas and kastels in the city have not yet been disseminated to NGOs such as the OBRUK Cave Team and the ÇEKÜL Foundation/Gaziantep, as well as governmental agencies like the Ministry of Culture, the Cultural Heritage Protection Board, and the Gaziantep Cultural Heritage Protection Board. According to the assessment forms received from Gaziantep Conservation Board and Monuments Directorate after the 6 February earthquake, the Ahmet Çelebi Mosque and its kastel and the İhsanbey Mosque and its kastel were moderately damaged. The Mosque of Şeyh Fethullah and its kastel sustained minor damage, while the İmam Gazali and Kozluca kastels were reported undamaged. Since the last visits on 23.11.2023, the Kozluca and İhsanbey kastels in the region

are open to the public again. However, the Pişirici, Şeyh Fethullah, and Ahmet Çelebi kastels are not accessible. The İmam Gazali kastel remains partially open for visits, similar to its previous condition (Figure 5)¹.

Except for the kastels indicated as "no damage" in the Ministry reports, the condition of other kastels has been summarized during the fieldwork conducted. Furthermore, information regarding the post-earthquake condition of a kastel located outside the city has also been provided as a result of the fieldwork conducted in the area. This example is one of the instances that suffered physical damage following the earthquake. In spite of the identification studies conducted in the area being sufficient for a quick assessment, detailed studies by different disciplines are required to fully determine the damage.

covering the pool. The building also has toilets and laundry facilities (Çam, 1984). During the fieldwork, no entrance was provided into the Kastel of Pişirici because access to the site was closed post-earthquake. Only the surrounding area of the structure could be examined. However, discussions with the ÇEKÜL Foundation and the OBRUK Cave Team revealed that the Kastel of Pişirici was accessed and inspected through a special authorized study, and no damage was observed.

The Kastel of Şeyh Fethullah was built in the 16th century and was made of hewn stone. It is used as part of the ablution center in the courtyard of the Şeyh Fethullah Mosque. On the southwest wall, there is a livas connection (Çam, 2006). It has been temporarily closed due to a fragment detachment from the minaret of the mosque in the courtyard where the kastel is located. While the structural cracks and the falling stones of the minaret did not cause any damage to the kastel structure, effects such as collapse and fragment loss in the tall buildings surrounding the kastels can increase their vulnerability in the event of an earthquake. Similarly, the Kastel of Ahmet Çelebi is also temporarily closed, with ongoing restoration work focusing on strengthening the minaret. During the site visit, no visible physical damage was observed at the entrance of the kastel.

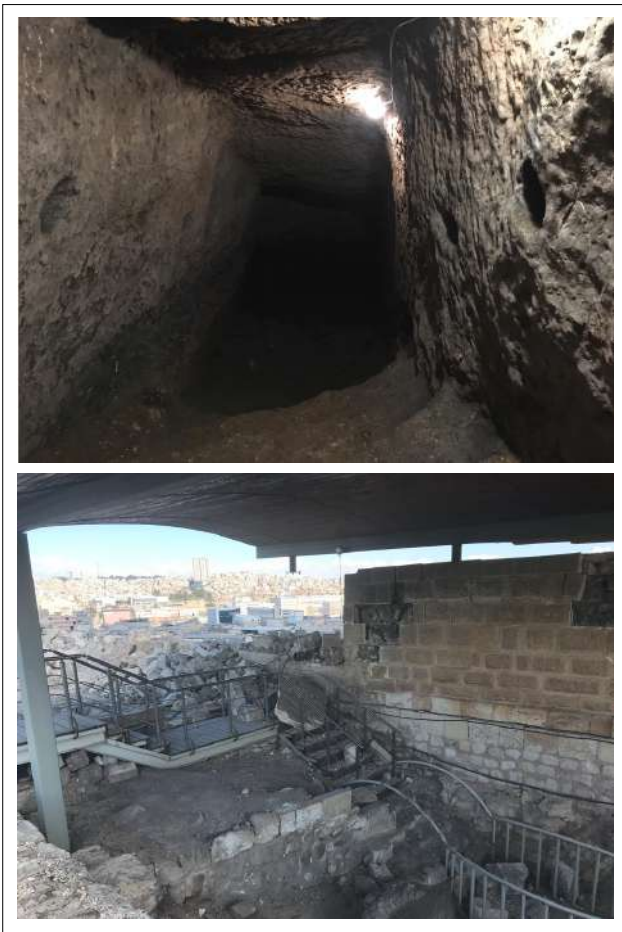
Figure 7. Gaziantep Castle tunnels lead to the bitter water-freshwater junction, and on the right, the view of the hill leading to the castle corridors after the earthquake (Umut Almaç³).

to be connected to livas lines (Beyazlar, 2003). Experts conducting damage assessments for the castle have stated that, in addition to the clearly visible damage observed on the surface, no definitive assessment has yet been made regarding the condition of the sweet water-bitter water source and the well inside the castle³ (Figure 7).

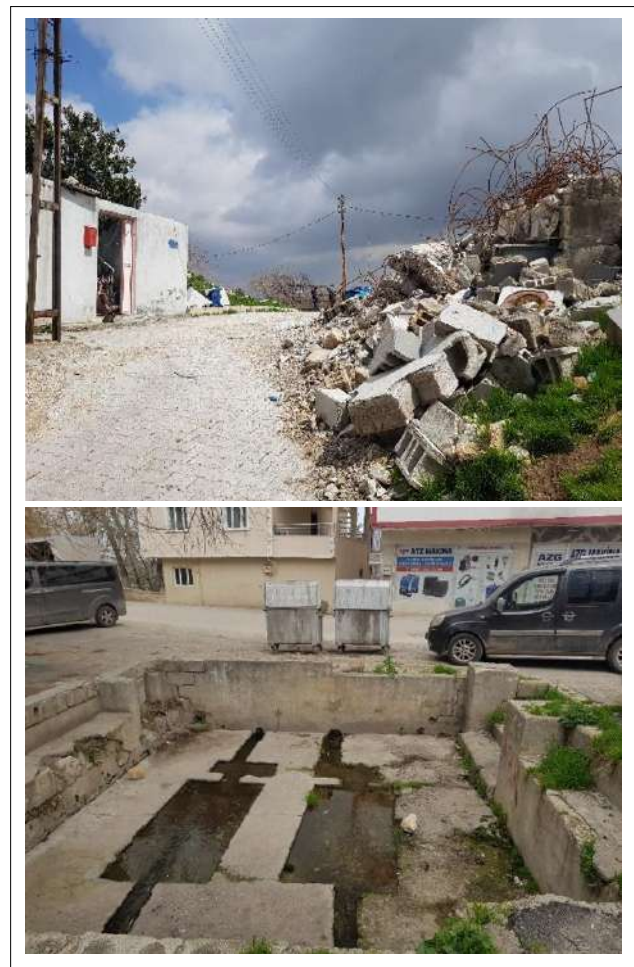
Figure 9. The post-earthquake situation in Sam Village, Gaziantep and the reference to "Küçük Pınar".

The earthquakes experienced on February 6th, 2023, in Kahramanmaraş underline the challenges faced in accessing basic needs such as clean drinking water and water for personal hygiene during and after the event, further emphasizing the importance of this topic. After the earthquakes, it was observed that local people, especially those living in rural areas, experienced water shortages and used water for drinking and cleaning purposes from the Kastel of 'Küçük Pınar' in the village center (Figure 9).

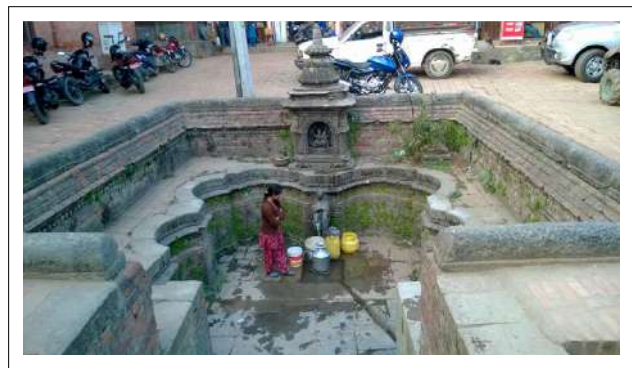
Figure 11. The traditional water supply system in the Kathmandu Valley is utilized for both daily needs and emergencies (Jigyasu, 2015).

Jigyasu (2015), in his example on the role of traditional water systems in natural disaster situations using the case of Nepal, emphasized their contribution to forming resilient communities (Figure 11). Water tank systems or wells in the historical urban fabric of the Kathmandu Valley met the city's water needs in emergencies. Jigyasu (2015) mentioned that these systems are currently facing pressure from intense urbanization. This not only accelerates the disappearance of cultural resources but also increases the fragility of communities against natural disasters by disrupting the local ecological balance (Jigyasu, 2015).
