## Water supply of the Topkapı Palace kitchen complex: Review and interpretation based on new findings

Ece UYSAL ENGÜDAR\*<sup>ORCID</sup>, Uzay YERGÜN<sup>ORCID</sup>

Disposing of wastewater; fountains;  
Topkapı Palace kitchen complex;  
water supply; water wheel of well.

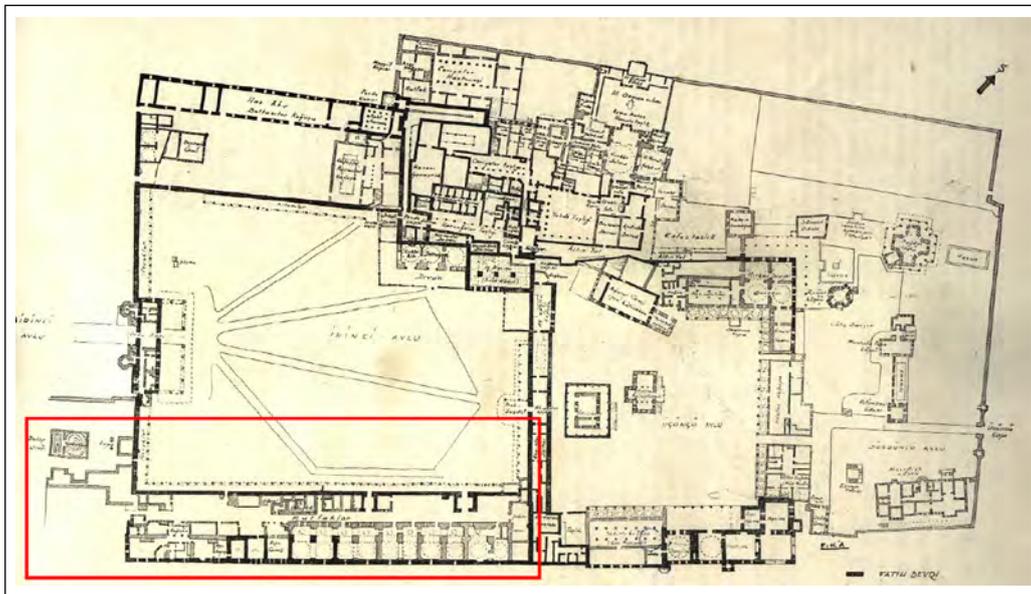
**Figure 1.** Kitchen complex (mutfaklar) is located at the south west direction of the Topkapı Palace (marked in red rectangular). Remains from the Mehmed II period (r.1451–1481)<sup>2</sup> (Ayverdi, 1953) are indicated in bold.

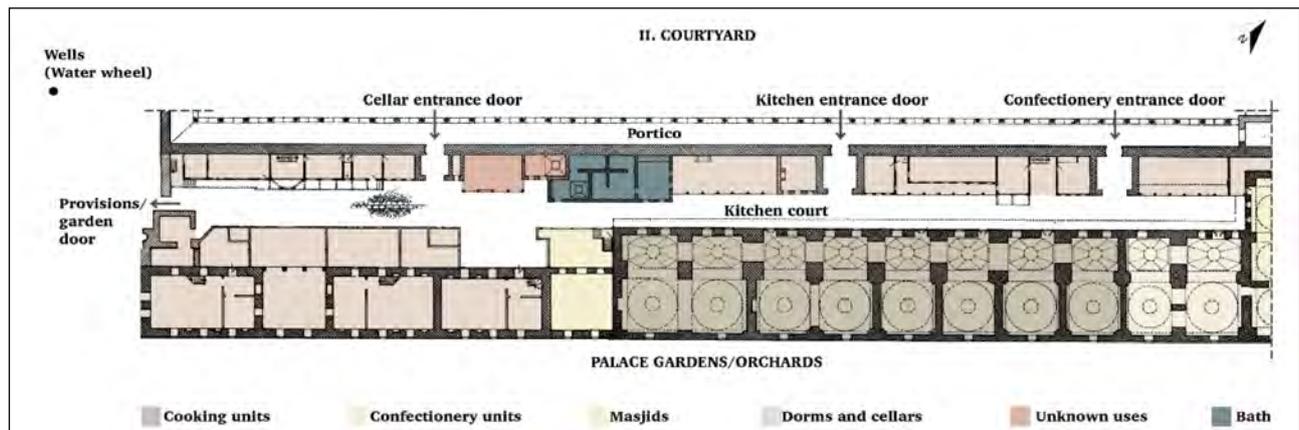
**Figure 2.** A revised design of Eldem's restitution project circa the beginning of the 20<sup>th</sup> century (Eldem & Akozan, 1982) by Ece Uysal Engüdar. This drawing shows the units of the kitchen complex.

when the harem moved out of the New Palace as well. As such, Topkapı Palace became where the sultan lived his private life alongside conducting all of the state's official affairs (Sakaoğlu, 2002). That move also evoked the palace's population to grow in the 16<sup>th</sup> century. Although we do not know what the kitchens' original architectural plan would have been like, we do know that one would have entered the kitchen courtyard through a cellar door; the kitchen and confectionery doors were located in the porticoes on the right side of the second courtyard. Along these doorways, there are a confectionery dorm, a bath, a place presumed to be a tin house, cooks' dorms and cellars. On the other side, there are oil, sugar and rice warehouses/pantries, a cooks' masjid next to it, cooking areas, a confectionery, and a confectionery masjid (Eldem & Akozan, 1982; Figure 2).

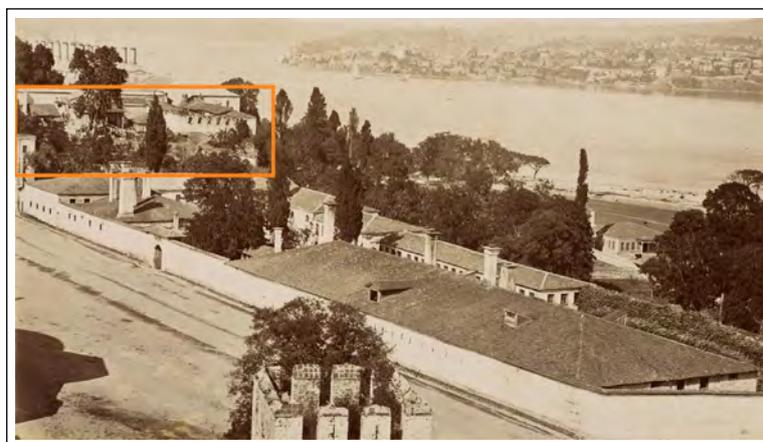
**Figure 3.** Units of the kitchen complex in the first courtyard from an anonymous photo dated 1875 (Anonymous, 1875).

The increase in the palace population rendered the dorms and storage areas insufficient; thus, the kitchen sub-units overflowed from the second into the first courtyard. The first courtyard contains dorms (Kömürçiyân, 1988), cellars, warehouses, a masjid (BOA, 1285) and a water wheel (Tezcan, 1984), or *dolap ocağı*, in Turkish (Figure 3).

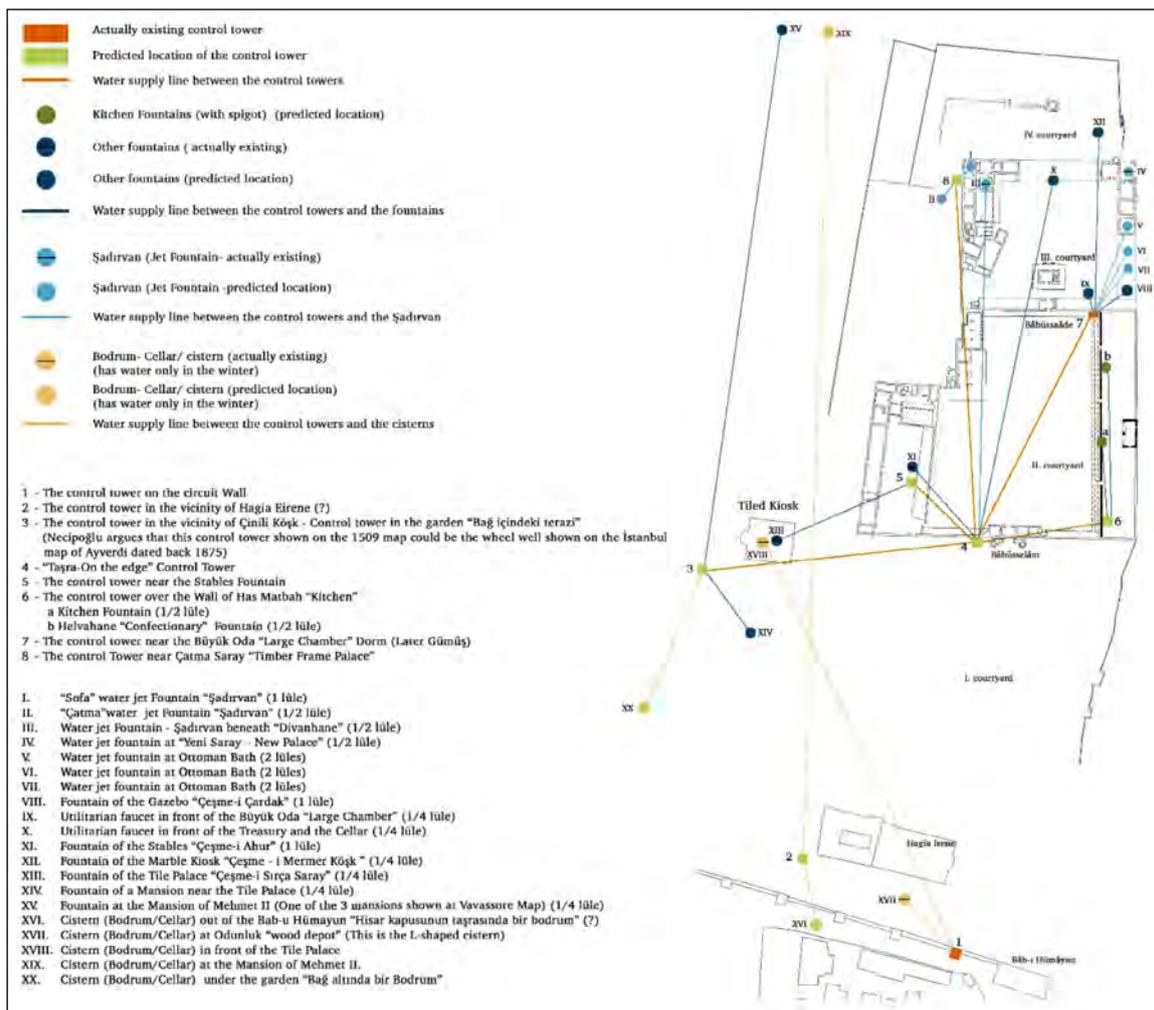
**Figure 4.** A schema demonstrating the repair of the water supply of Topkapı Palace after the 1509 earthquake. Designed by Ece Uysal Engüdar on the basis of Necipoğlu’s article (Necipoğlu, 2013). Special thanks to Çiğdem Özkan Aygün (İTÜ) for advice.

So, water was supplied from the Halkalı-based Beylik and Kırkçeşme water supply lines. Beylik water was closer to the surface and was sent to the upper levels by water towers. Conversely, the Kırkçeşme water supply line was connected to the lower levels of the palace and sent through the wells (Özkan Aygün, 2014; Özkan Aygün, 2015). Document TSMA D. 10137 found by Necipoğlu shows the past repairs made in the palace’s water supply lines. She predicts the document’s date as just after the earthquake in 1509 (Çelebi, 2003) which caused heavy damage to the whole system. She illustrates the connections between water towers, partial fountains, şadırvans, and cisterns; hence, we can infer that the source of the water ought to be the Halkalı water supply line, indicating that “the existing system could be used”. This suggests that the water towers were not new. Neither of the two towers nearby the Bâbüselâm fed the kitchen (1/2 lüle) and the confectionary fountains (1/2 lüle); exist today (Figure 4). Necipoğlu claims that the place of this water tower should be the water tank (Figure 5) – which is next

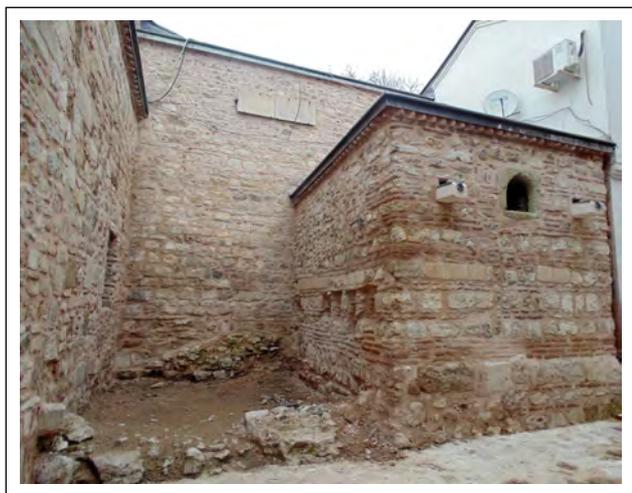
**Figure 5.** The water tank in kitchen complex, next to the main wall of portico (Uysal Engüdar, 2021).

Another water tank that is difficult for us to analyse is located in the kitchen courtyard next to the main wall of the portico. As has been mentioned above, one of Beylik water supply line maps (1584) is ripped (Bilge, 1969) and there is no information about kitchen sections on the maps from 1607 or 1748 ( e en & Kolay, 1997). We can thus infer the water should have been supplied from the Kırk e me water supply lines via wells leading to the water tank. This water tank is located on the ground floor of the wooden dorms for kitchen staff (Eldem & Akozan, 1982) which no longer exists. All units of the palace had a function; therefore,

exit point for *lûles*, there are some small niches presumably for glasses (Figure 5). However, we have no information about this water tank in any studies.

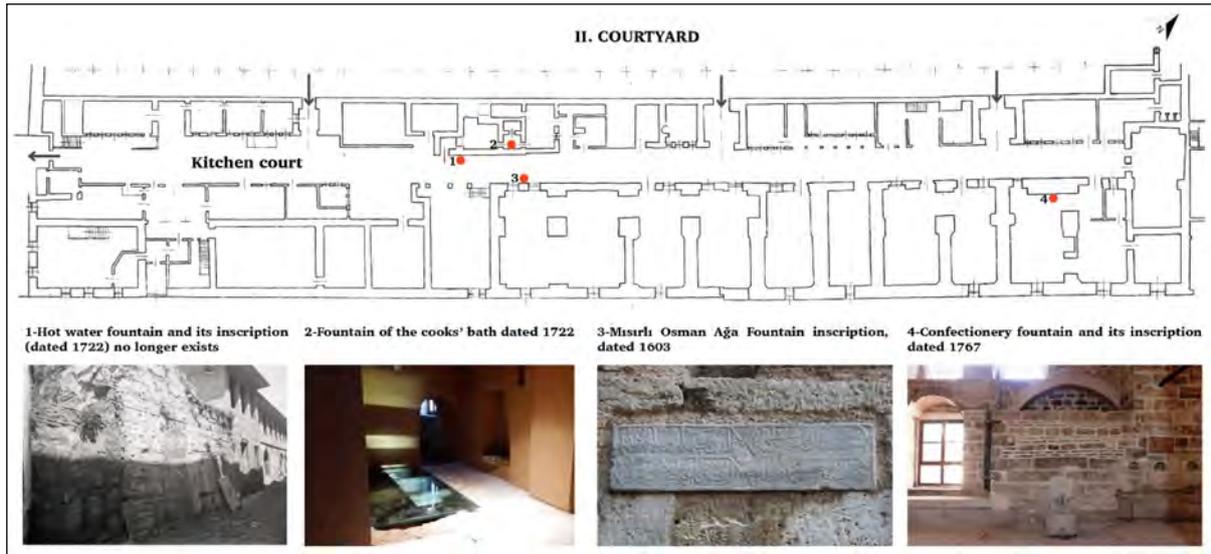
**Figure 6.** Complete fountains of the kitchen complex on an anonymous plan (Anonymous, 1894-1912) shown by Ece Uysal Engüdar. No 1: hot water fountain and its inscription (dated 1722); it no longer exists (EHAEA, 1940-1944). No 2: the fountain of the cooks' bath dated 1722 (Uysal Engüdar, 2017). No 3: Mısırlı Osman Ağa Fountain inscription, dated 1603 (Uysal Engüdar, 2021). No 4: confectionery fountain and its inscription, dated 1767 (Altınbıçak, 2012).

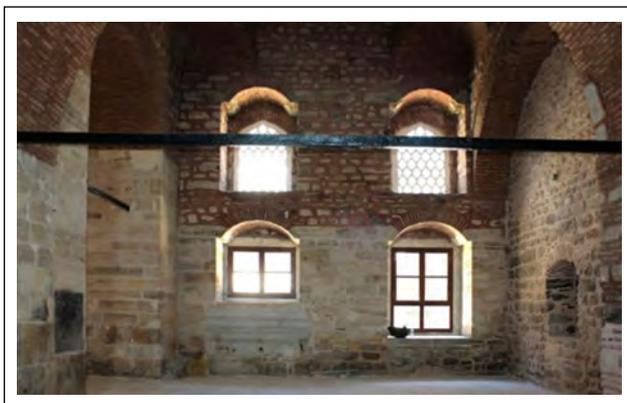
**Figure 7.** Fountain face located at the kitchen unit, next to the confectionery (Altınbıçak, 2012).

remains (Figure 7). Three things show us that the number of fountains had increased: (1) removing the old fountains from their places in 1825, (2) transferring the water to a new place, and (3) adding a fountain in 1868. The location of the sewer cover on the other side cannot be determined because there is no clear description; however, it must be connected to the canal passing through the kitchen court (Figure 8).

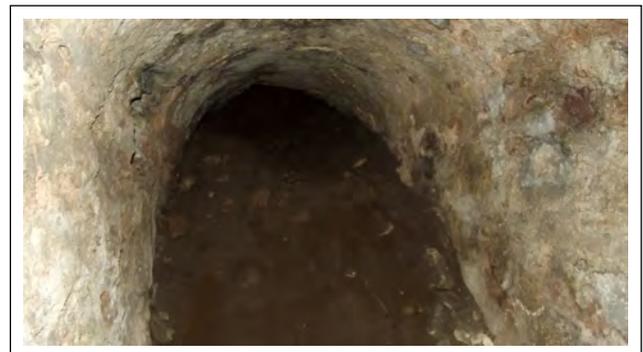
**Figure 8.** Vaulted drainage underground channel at the kitchen court (Özbersan İnşaat ve Ticaret Ltd. Şti., 2013).

vaulted channel in the kitchen courtyard. Yet, where the channel connected and continued to before it ended up at the Marmara Sea still remains unknown; surveys and excavations are needed to clarify this. Moreover, another point to consider is the addition of Kennedy Street outside the sea walls which complicates the research.

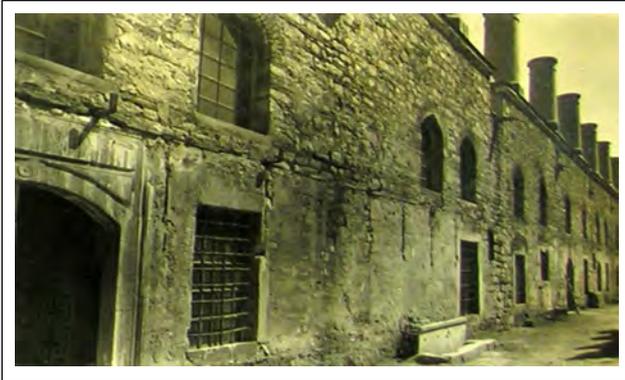
**Figure 9.** The fountain assumed to be used for ablution on the kitchen main wall (TSMA, 1940). Traces of the porch are obvious.

Another fountain on the kitchen facade would have been used for ablution. Since there is no shadirvan in the kitchen complex, the kitchen staff would have performed their ablution using the fountains scattered throughout the courtyard. According to a document from 1874, a lead-covered new porch eave was built with the wooden painted ceiling above the ablution fountains of the confectionery (BOA, 1291). During restoration work in the 1940s, there was (still) a fountain on the court side of the confectionery – just as the 1874 document mentions (Figure 9). The

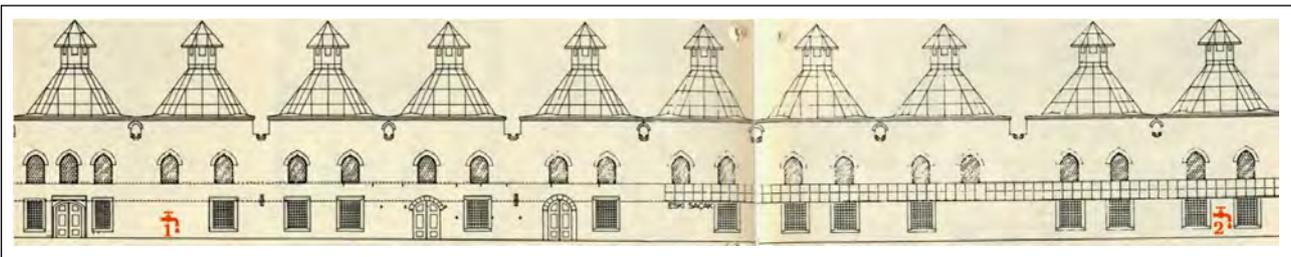
**Figure 10.** Demonstration of the fountains on the kitchen main wall assumed to be used for ablution on the elevation of Eldem's restitution (Eldem & Akozan, 1982); 1 for the fountain which is currently not existing, 2 for the Mısırlı Osman Ağa fountain dated 1603 revised and edited by Ece Uysal Engüdar.

ablution fountains (Penzer, 1967). Traces of the porch are still visible today (Figure 10). The other probable fountains must have existed in the restrooms of the dorms, which one can detect from their plan that they date to the beginning of the 20<sup>th</sup> century (Figure 12).

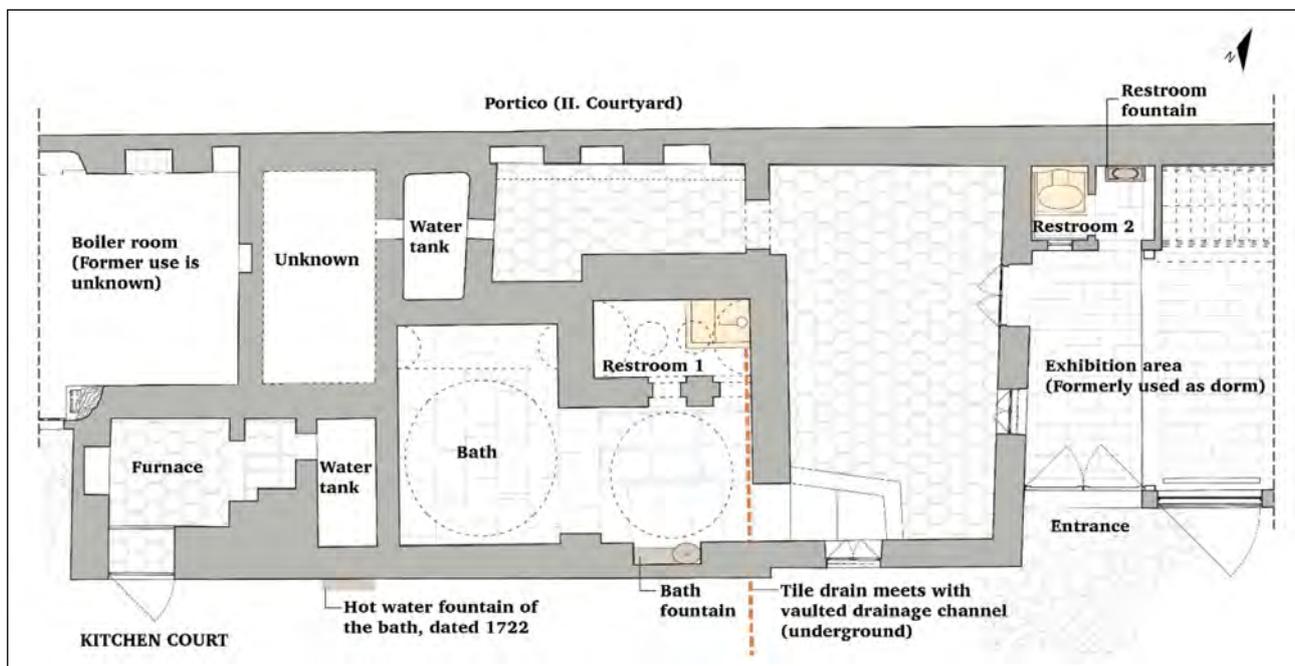
**Figure 11.** The cooks' bath on the partial plan of TÜRES Turizm Planlama ve Restorasyon San. ve Tic. Ltd. Şti. revised and edited by Ece Uysal Engüdar.

There are two restrooms in the palace kitchens that can still be identified today. The first one is located in the bath; the wastewater from it would have been disposed of via a tile drain to a vaulted underground channel beneath the kitchen courtyard.<sup>6</sup> The second one facing the qibla<sup>7</sup> is located at the dorm next to the bath and would have been built for decoration during 1940's restorations (Figure 11 – Restroom 2). On the other hand, the other restrooms were located in the dorms where kitchen servants lived – at least, according to the design. The space referred to as the control

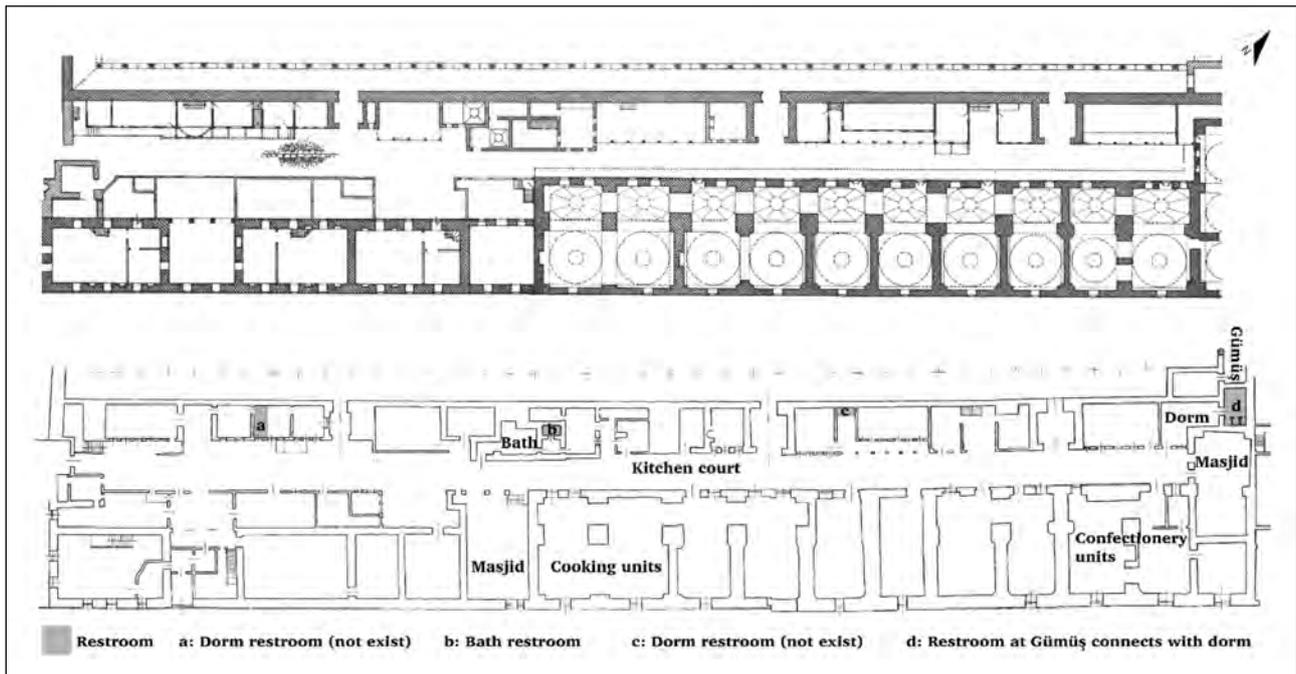
**Figure 12.** The restrooms of the kitchen complex are demonstrated both on the elevation of Eldem's restitution above (Eldem & Akozan, 1982) and an anonymous design below (Anonymous, 1894–1912) revised and edited by Ece Uysal Engüdar.

tower – in a document from 1509 (Necipoğlu, 2013) – was converted into a water distribution centre. Half of it was used as storage, while the other half was used as a restroom for visitors at an unknown date. Referred to as Gümüş (Çeçen & Kolay, 1997), the second half was connected to the dorm. This restroom sits next to the Confectionery Masjid, and would also have been used for ablution purposes. Beyond that, such a dual cellar-restroom feature placed next to the Cooks' Masjid is very unique – given that there were also restrooms for each ward unit (Figure 12).

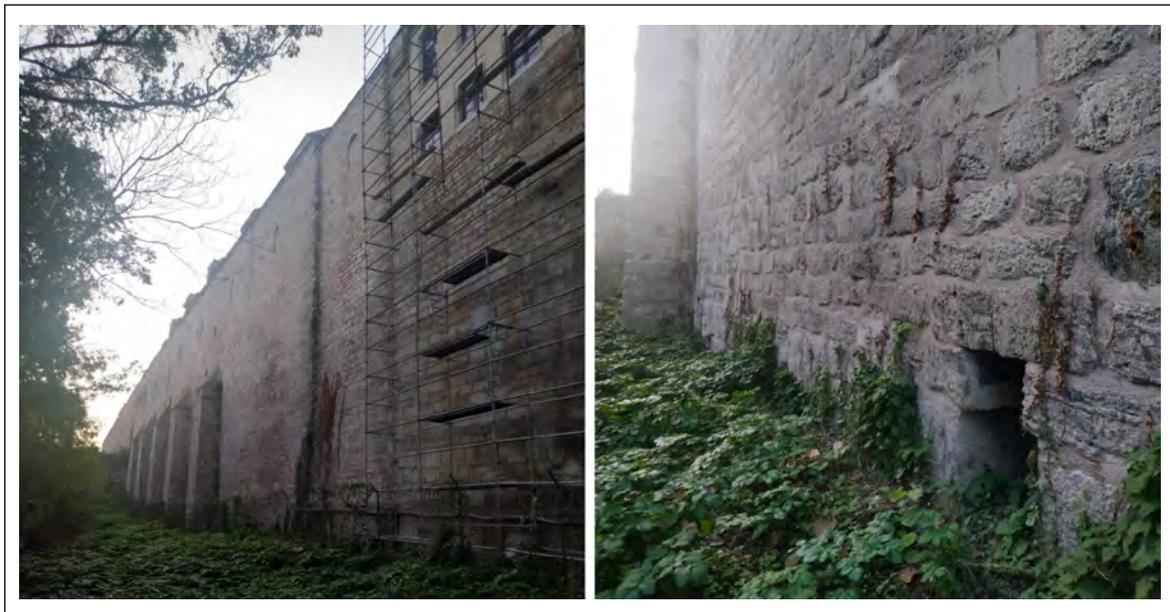
**Figure 13.** Left: general view of the kitchen complex's retaining wall with buttresses facing the Marmara Sea. Right: a barbican located on the retaining wall (Uysal Engüdar, 2021).

All of the kitchen units are supported by a retaining wall featuring buttresses, as there is an elevation difference between the upper courtyard and the lower seaside gardens where they are located. Similarly, there also are still traces of barbicans that would have prevented the retaining wall from taking on

an additional load of rain water that may accumulate, and that would have helped filter the water from the soil, without being collected under the kitchen (Figure 13).

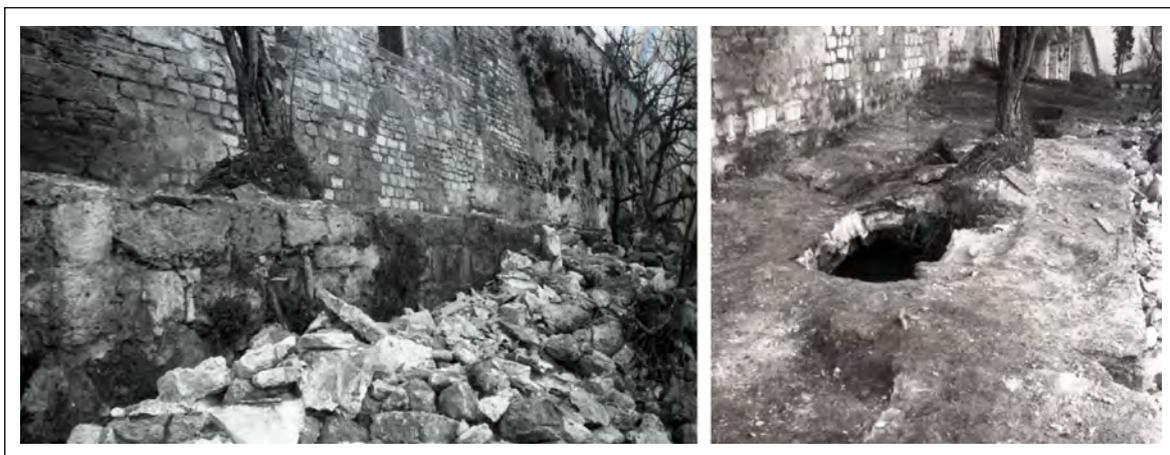
**Figure 14.** Left: the kitchen complex's retaining wall facing the Marmara Sea where the unidentified vaulted element is located. Right: a close-up view unidentified vault element (EHAEA, 1940-1944).

There is a photograph from the Archive of the Institute of Ekrem Hakkı Ayverdi, which houses the personal works of Ayverdi, the person in charge of the restorations of the palace kitchens in the 1940's. In the photograph, we can see an architectural element of which only the top part is visible. It could possibly be vaulted adjacent to the retaining wall, and it extends towards the Cooks Masjid. Alternatively, it might be a water tank or used as a warehouse due to its proximity to the cellar. Whether it belongs to the Ottoman or the Byzantine era is debatable, given that Topkapı was built over Byzantine structures (Figure 14).

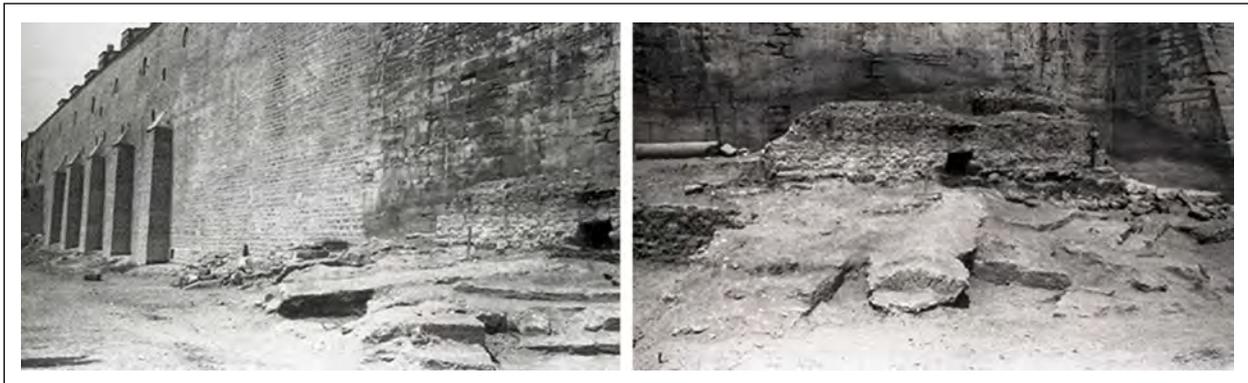
**Figure 15.** Left: A presumed vaulted drainage channel under the bath’s retaining wall, facing the Marmara Sea, next to the kitchens. Right: a close-up view of the channel (EHAEA, 1940-1944).

In another photograph from the Archive of Ayverdi, we see a vault at the bottom of the retaining wall continuing towards the palace bath next to the kitchen might and this may have been used to dispose of wastewater from the palace bath.<sup>9</sup> Despite that, similar channels do not exist on the same level of the kitchen alignment (Figure 15). In that case, the wastewater of the kitchens should have been collected in a single channel extending towards the hospital, and then extending out towards the sea, as Pouqueville suggested (Pouqueville, 1805). As it stands, the slope direction of the vaulted channel at the kitchen courtyard already extends towards the palace hospital. The drainage channels of the kitchens and palace bath should have been separate, as K m rciyan (K m rciyan, 1988) and  nciciyan ( nciciyan, 1956) mentioned.

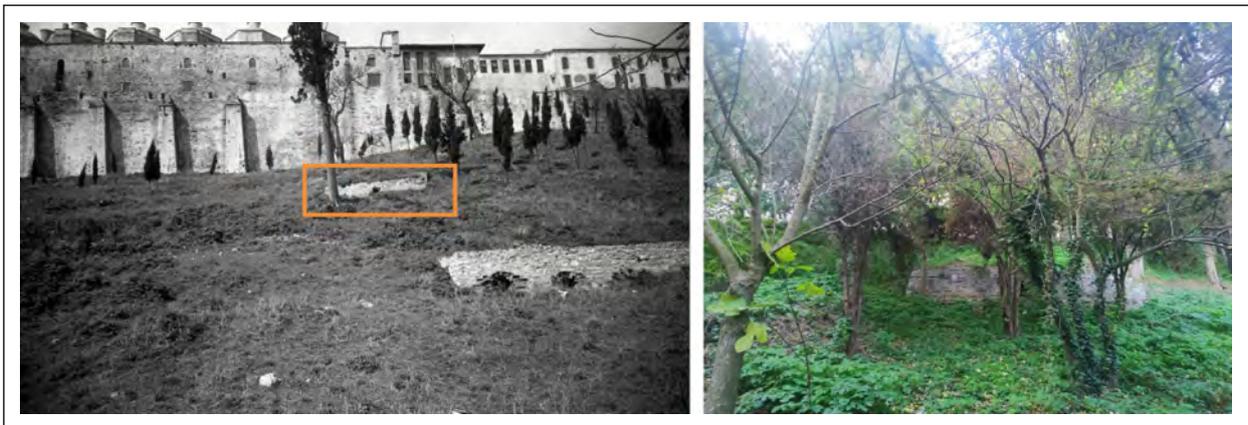
**Figure 16.** The remain assumed as a water tank is located at the palace garden behind the kitchens. The photo on the left was taken by Ayverdi in 1940’s (EHAEA, 1940-1944). The photo on the right shows its current condition (Uysal Eng dar, 2021).

There is a masonry mass – presumably a water tank – in the palace garden between the retaining wall and the sea wall (Figure 16). However, it is overgrown with wild flora, and thus not suitable for architectural examination at the

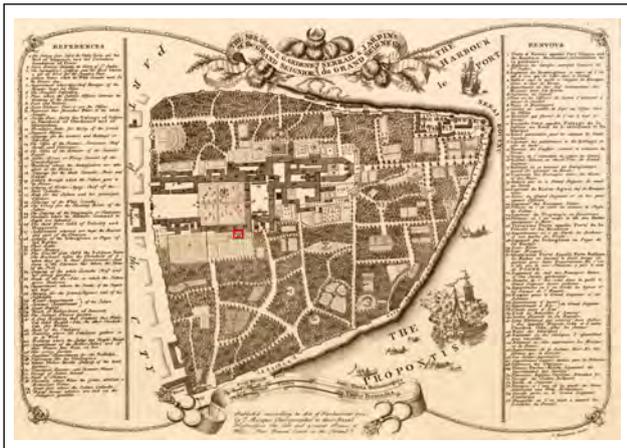
**Figure 17.** Rocque, the Seraglio & Gardens of the Grand Seignior, 1752 (Rocque, 1752). Number 10 is marked in red square.

moment. The same point is also demonstrated in Rocque’s map (dated 1752) (Figure 17); he, too, claimed that it is a water tank supplying water to the entire palace (Rocque, 1752). However, this mass is located at least 15 m below the kitchen’s level. Pumping water from a lower-level water tank to upper-level buildings is not convenient; hence, this water tank – if it, indeed, is one – may very well have been used for irrigation.

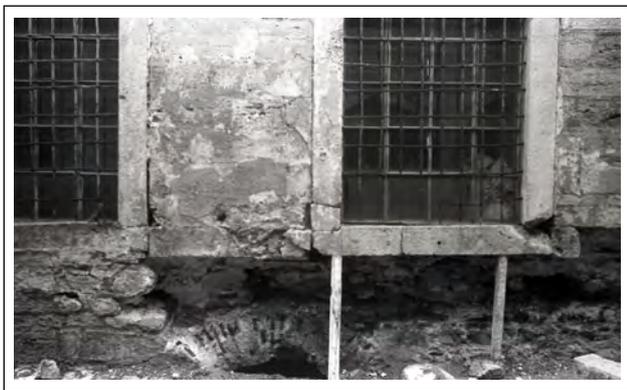
**Figure 18.** The brick arch on the kitchen's wall during restoration between 1940 and 1944 (EHAEA, 1940-1944).

Another photo from Ayverdi Institute depicts a brick arch located by the wall of the kitchen units that was partially buried in the ground under the ashlar – it hailed from the Mehmed II period (r.1451–1481) (Figure 18). This arch, too, might be related to the water supply line. The wastewater may have been disposed of from the arch to the vaulted drainage channel in the kitchen courtyard.

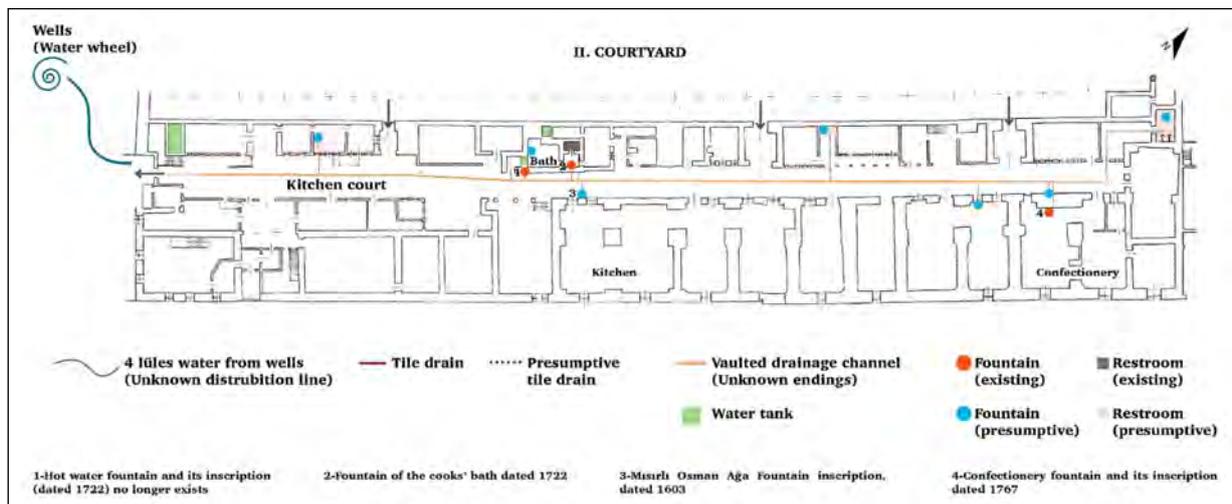
**Figure 19.** Complete water way elements of the kitchen complex on an anonymous plan (Anonymous, 1894-1912) shown by Ece Uysal Engüdar.

Wastewater from the kitchen units was disposed of via a vaulted underground channel beneath the kitchen court (Figure 19). It may have poured out into the sea from a different channel via the palace hospital. The varied channel ways are mentioned in multiple sources (Pouqueville, 1805).
