ARCHIVES OF THE TURKISH SOCIETY OF CARDIOLOGY

Conservative Management of Left Ventricular Pseudoaneurysm After Transfemoral Transcatheter Aortic Valve Implantation

CASE REPORT OLGU SUNUMU

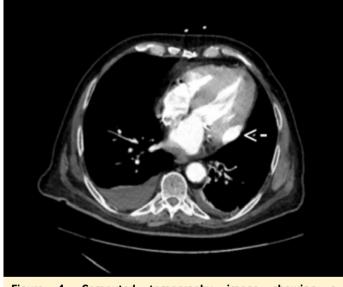
Figure 4. Computed tomography image showing a left ventricular pseudoaneurysm (arrow indicates the pseudoaneurysm).

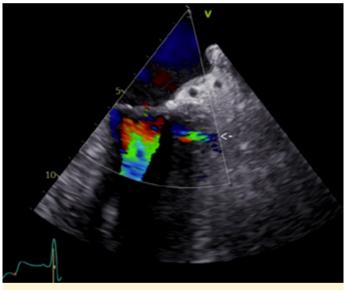
Figure 5. Transesophageal echocardiography showing the left ventricular pseudoaneurysm in the inferolateral segment and color Doppler flow.

ventricle and the pseudoaneurysm (Figure 5, Video 2). Surgical treatment was recommended by the Heart Team due to the high risk of spontaneous rupture. However, the patient declined the operation. A repeat CT scan performed one week later showed no changes in the size or length of the pseudoaneurysm. While on amiodarone therapy, the patient did not experience any further episodes of ventricular arrhythmia. Subsequently, an implantable cardioverter-defibrillator was implanted, and the patient was discharged. At the one-month follow-up, both transthoracic echocardiography and computed tomography were repeated and showed no change in the size or length of the LVPA (Video 3). The patient remained asymptomatic. At the six-month follow-up, TTE revealed that the LVPA size
