Case images

Evaluation of early dysfunction of a prosthetic mitral valve by real-time 3D transesophageal echocardiography

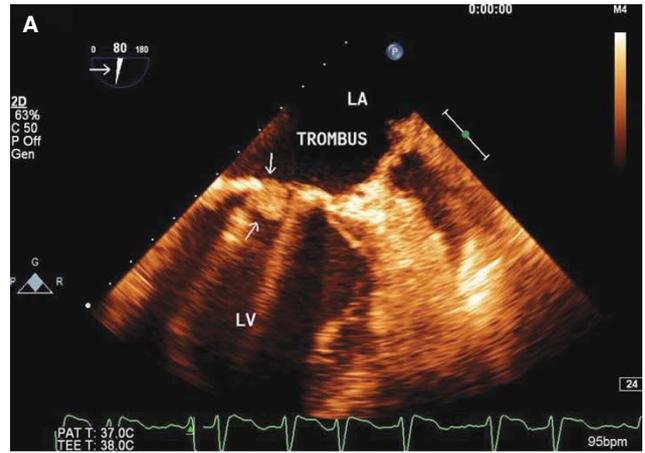
Figures– (A) Two-dimensional transesophageal echocardiography demonstrated restriction in anterior leaflet movement and a mobile thrombus image (1.3x1.0 cm) attached to the ventricular face of the posterior mitral leaflet. (B) Real-time three-dimensional TEE images of a prosthetic anterior mitral leaflet stuck in the closed position and a mobile thrombus attached to the posterior mitral leaflet. (C) Operation views of the prosthetic mitral valve, with a stuck anterior leaflet and thrombus.

8.5 mmHg and an effective orifice area of 1.3 cm²/m². Two-dimensional transesophageal echocardiography (2D TEE) demonstrated restriction in anterior leaflet movement and a mobile thrombus image (1.3x1.0 cm) attached to the ventricular face of the posterior mitral leaflet (Fig. A). In support of the 2D TEE findings, real-time three-dimensional (3D) TEE (iE 33 ultrasound, Philips Medical Systems) demonstrated a prosthetic anterior mitral leaflet stuck in a closed position and a mobile thrombus attached to the posterior mitral leaflet, which replaced from the left ventricular face to the atrial face in every diastole (Fig. B). The patient underwent another operation, and we observed that the stuck anterior leaflet was caused by a discrete subvalvular tissue that was interfering with the prosthetic mechanism. In addition, we observed a mobile thrombus attached to the posterior leaflet, which also caused obstruction (Fig. C). In this case, 3D TEE was used as novel cardiac imaging which was a useful tool that provided unique views that are comparable with surgical views.
