# Intraoperative Repair of Pilot Balloon Inflation Line Damage: A Practical Solution to Tube Replacement

## Abstract

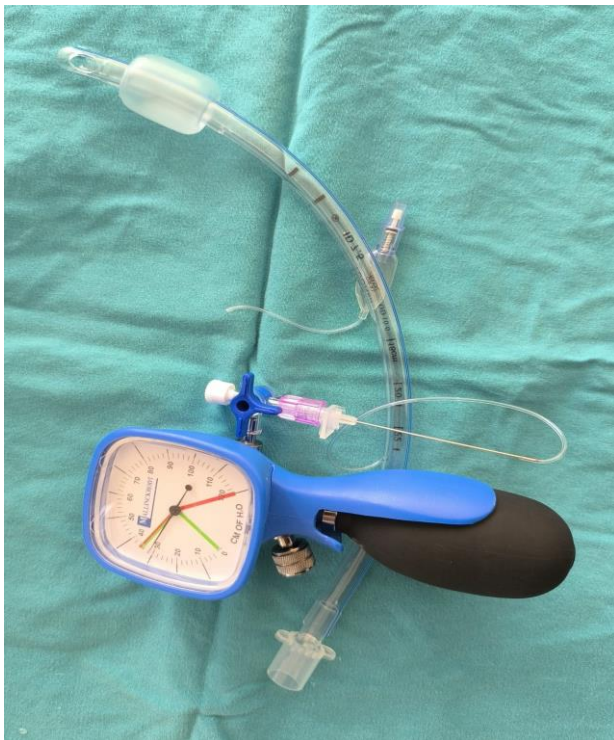
**Figure 2:** Reinflation of the cuff using a 20G IV angiocatheter needle inserted into the severed pilot balloon inflation tube.

the bellows” (Figure 1). The anesthesia system was checked, but no equipment-related malfunction was identified. On auscultation, diminished breath sounds were noted bilaterally. Inspection of the ETT revealed a severed inflation line of the pilot balloon. During the intraoperative period, the patient's vital signs remained stable. Instead of replacing the endotracheal tube (ETT), an alternative approach was adopted to manage the ruptured pilot balloon. A 20G intravenous angiocatheter was inserted into the remaining

inflation line of the balloon. During the first attempt, the plastic cannula over the steel needle became bent during insertion. On the second attempt, the plastic cannula was removed, and the steel needle tip was inserted directly into the inflation line, carefully positioned to avoid further damage. Because the steel needle has a lumen, the pilot balloon was successfully reinflated using a syringe (Figure 2), which resolved the ventilator alarms. A three-way stopcock and a cuff pressure manometer were subsequently connected to the system, allowing for continuous monitoring and adjustment of cuff pressure. The stopcock was closed to prevent air leakage. Central venous catheterization was completed without complication. The surgical procedure lasted approximately three hours. The patient was transferred to the cardiovascular intensive care unit (ICU) while still intubated. The ICU team was informed about the pilot balloon repair and instructed on the management of the modified system. The patient was extubated eight hours postoperatively and transferred to the surgical ward on postoperative day two.

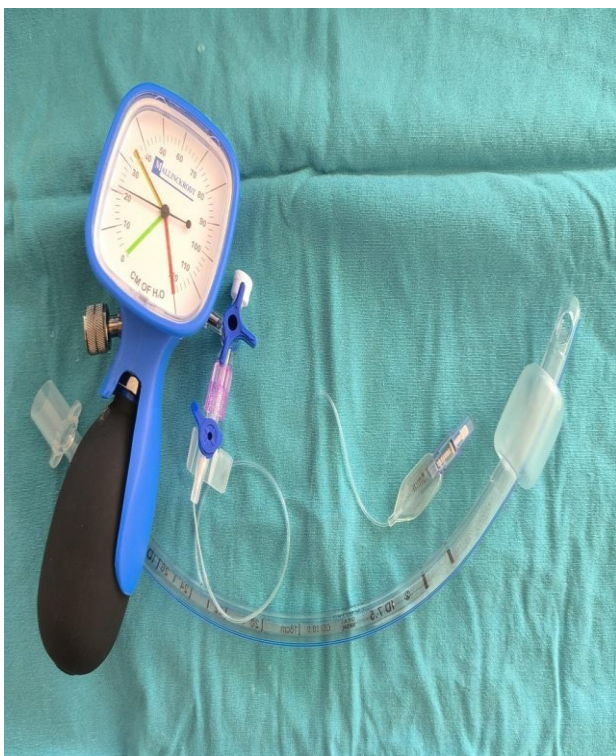
**Figure 4:** Controlled reinflation of the cuff using a cuff pressure manometer, three-way stopcock, and 20G/22G IV angi catheter (needle or plastic cannula) in various configurations.

practical and effective airway-saving alternative to ETT replacement in a hemodynamically stable patient. Moreover, both the needle and plastic cannula components of 20G and 22G intravenous angi catheters proved effective in the repair of inflation line damage (Figures 3–5).
