Intrapelvic Protrusion of the Fractured Ceramic Liner Through the Acetabular Shell Case Report

SUMMARY

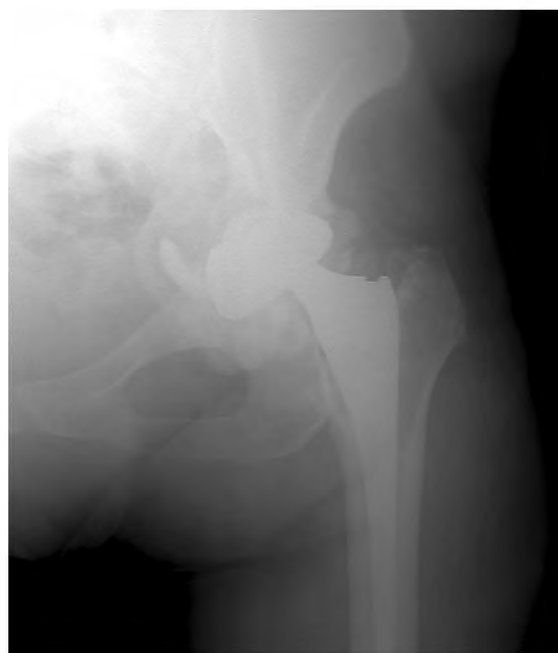
On clinical examination, a functional limb shortening of 3 cm. and a Trendelenburg gait on the operated side were revealed. On radiographic examination of the hip, an uncemented THA with a well-fixed femoral stem and failure of the acetabular component with protrusion into the pelvis were seen (Fig. 1). The acetabular shell was completely disturbed by the femoral head and neck being displaced into the

shell, with a fracture of the acetabular wall. The pelvic ring had lost its continuity, and broken ceramic components of the acetabular ceramic liner were in the pelvic ring. Revision surgery was performed using the previous anterolateral incision.

Figure 1: Radiography shows a failure of the acetabular component with protrusion into the pelvis.

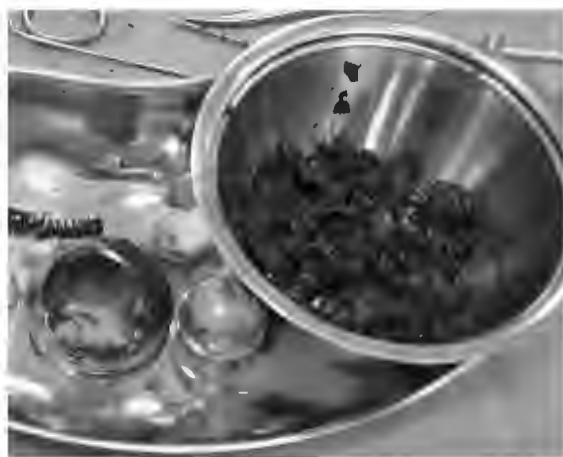
Intraoperatively, migration of the proximal femoral head into the acetabulum was observed. After gentle dislocation of the hip, the ceramic femoral head was removed to facilitate exposure of the acetabular component. The ceramic femoral head surface was intact but was severely abraded and revealed a band of metallic deposition. The acetabular liner was completely broken with one large and multiple small pieces dispersed into the soft tissues. The entire wound was covered with black-colored tissue, extensive metallosis. The titanium acetabular shell was completely abraded at the central part with a big hole (Fig. 2). The acetabular titanium shell was loose but all three screws were firmly fixed to the bone; their heads had completely lost their shape. The shell was carefully detached from each screw by gentle

rotary movements and removed from the bony acetabulum. Broken parts of the acetabular liner were found in the pelvis and fragments of the broken ceramics, covered with black metallic deposition, were removed. During the debridement, great attention was given to preserve healthy tissues away from the sharp edges of the liner. The large cavitory defect in the acetabulum was reconstructed with demineralized bone matrix/bone morphogenic protein putty, allograft and a reinforcement ring. An all-polyethylene cup was inserted into the reinforcement ring and secured with cement. The femoral stem was not changed as it seemed well-fixed. A new, reinforced stainless-steel femoral head was used to replace the damaged femoral head. The patient had an uneventful recovery and had no pain at the hip at the most recent follow-up examination at 15 months. The patient was able to return to full activity without any discomfort in the hip. The acetabular grafts healed well and the acetabular and femoral components were well-fixed (Fig. 3).

Figure 2: The photograph shows titanium acetabular shell completely abraded at the central part with a big hole and the fractured pieces of the ceramic liner. Extensive metallosis was debrided.

The vulnerability property of ceramic prostheses seems to be impinging between components, e.g., the stem neck and the inferior portion of the acetabular rim in external rotation and the superior rim of the ceramic liner by the femoral head. Cracks may propagate, suggesting the cause of the fracture might be the stress concentration (3). To minimize the risk of impingement and to achieve better forces distribution, acetabular component should be placed at 45° (8). Thick liners were designed to control the risk of fracture. The ceramic liner without a polyethylene layer is thicker than that of a sandwich cup. However, very careful technique is required when inserting the ceramic liner into the metal shell to avoid chip fractures. The presence of a polyethylene layer in a sandwich cup can ease the insertion of the ceramic liner into the metal shell (6). However, we think much more attention should be given to the convex liner surface (i.e., the metal backing–acetabular liner interface) as another possible cause of impingement. Recent studies evaluate the relationship between wear of the convex surface and the importance of screw

holes and other potential conduits in the process of acetabular osteolysis, with little association being reported (1). Prominent heads of improperly placed screws may be another cause of impingement; stress concentration at the screw heads and the full-thickness ceramic liner could cause early catastrophic liner fractures. The internal stresses within the ceramic liner and the metal backing increase with nonconformity of the surfaces. Ceramics have excellent compression and limited bending strength. Small irregularities can grow until a sudden fracture without adequate trauma occurs (9). The stress concentration at the rim of the ceramic liner has been reported as the possible cause of the ceramic liner fracture. Vertical placement of the cup and avoiding impingement are recommended. Hasegawa et al. (4) suggest that the rim of the alumina ceramic liner must be made thicker, but others direct attention to the reduction of the rigidity of the ceramic-on-ceramic coupling and prevention of impingement by the layer of polyethylene between the ceramic liner and metal neck of the femoral stem. In our case, breakage of the liner was possibly due to mistakes during the implantation of the ceramic liner into the metal shell at the initial operation, rather than late trauma or patient obesity. Thick ceramic liners need more attention during insertion and we need more industrial investigations to produce better and easier-to-use hardware.

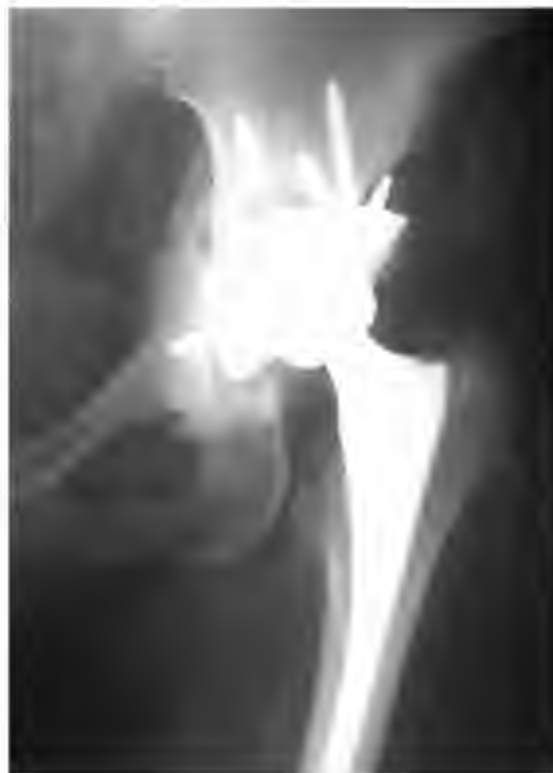
Figure 3: Radiography taken fifteen months postoperatively shows the healed acetabular grafts and well-fixed components.
