# Material analyses and field applications for the conservation of archeological remains found in the aerial cable car station construction site in Hatay (Türkiye)

Dilek EKŞİ AKBULUT<sup>1\*</sup>, Mehmet UĞURYOL<sup>2</sup>, Burak HAZNEDAR<sup>3</sup>

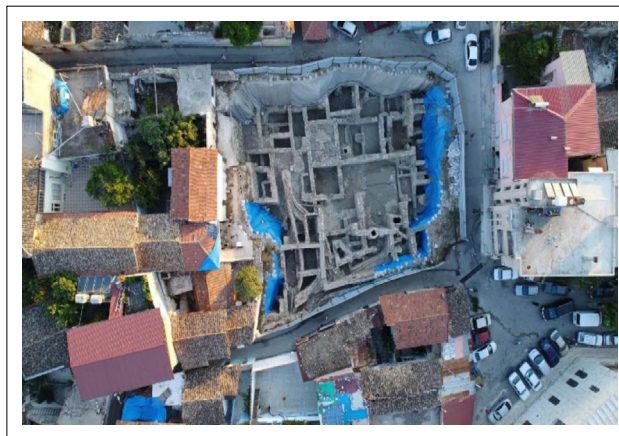
During the archaeological work, rooms of a settlement belonging to the Roman Period were discovered (Figure 1), whereas remains from the Byzantine and Ottoman periods were also unearthed, which are all well below the elevation level currently in use due to the stratification built up over the centuries. Through the archaeological work, it was determined that modifications, including the use of spolia, and repairs were made during each main period of the building (Pamir & Sezgin, 2016). Although the remains carry features from different periods, the structure is assumed to be a Villa Urbana type Roman building in general terms. The entrance of the building, which has commercial units facing the street on both sides, appears to be located in the north direction, adjacent to the atrium (main hall). The entrance section, where the triclinium (dining room) and atrium are placed and covered with mosaics, can also be read as an example of a quintessential garden arrangement, which is frequently seen in Roman villas. The dining area, which is adjacent to this garden at the entrance, is believed to be located at the center of the building, with other spatial usages surrounding these two main areas.

**Figure 1.** General view of the excavation area.

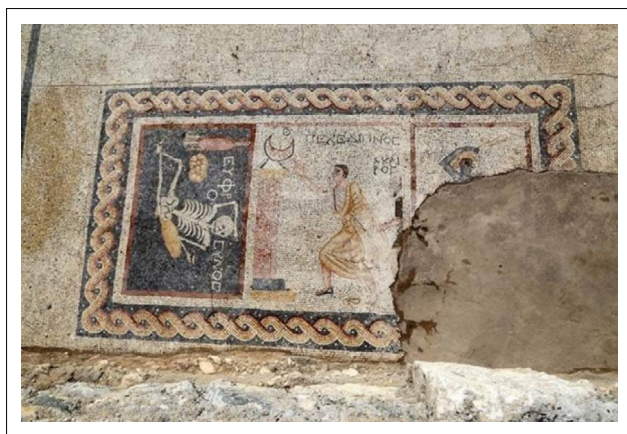
A monochrome (white) figureless floor mosaic is laid in the entrance of the villa, and the Three-Panel Mosaic with Figures (Figure 2) located in the dining hall is dated to the 3<sup>rd</sup> or 4<sup>th</sup> century AD. The Greek inscription on the mosaic conveys enjoying, having fun, and cheering up (Pamir & Sezgin, 2016).

**Figure 2.** Three-Panel Mosaic with figures.

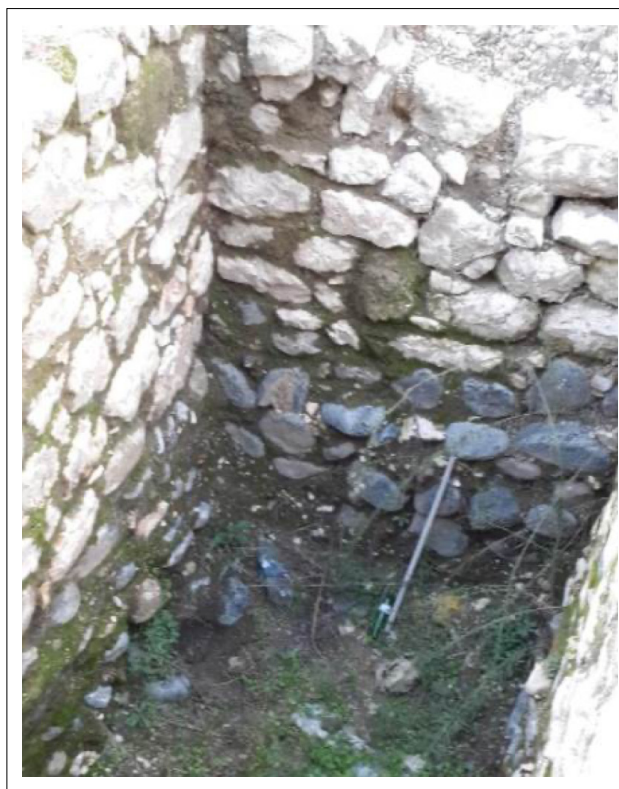
During the on-site inspections conducted in November 2014, the ground floor floors of the building were determined to be made of limestone slabs, whereas the walls were built with stone and brick (Figure 3; Figure 4). Two types of stones and three types of bricks of different heights (thickness) were determined throughout the building. The heights of the bricks are 40 mm, 35 mm, and 50 mm; the width and length of a 35 mm-high brick, of which all dimensions can be measured, were observed to be approximately 300x300 mm in size, whereas the mortar in the joints was seen to vary between 20 and 40 mm in height. In addition, on some bricks, 8 mm wide and 1 mm deep diagonal grooves were identified that were opened to increase the adherence between brick and mortar (Figure 4).

**Figure 3.** The different types of stones that were used throughout the structure.

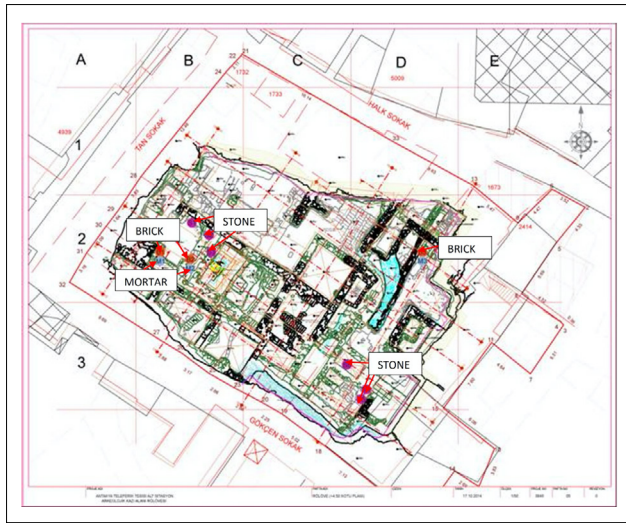
recommendations that would be appropriate to be used for the consolidation works, six stone, three brick, and three mortar samples were taken from the locations identified in the Roman building remains. Locations of the samples were marked on the scaled survey drawings (Figure 5). Building materials that were loosened or disintegrated in their original location were determined through a visual inspection and were chosen for sampling to minimize the probable damage to the adjacent sound materials in better condition.

**Figure 5.** Location of the samples (purple marks represent natural stones, orange marks represent bricks and blue marks represent mortars).

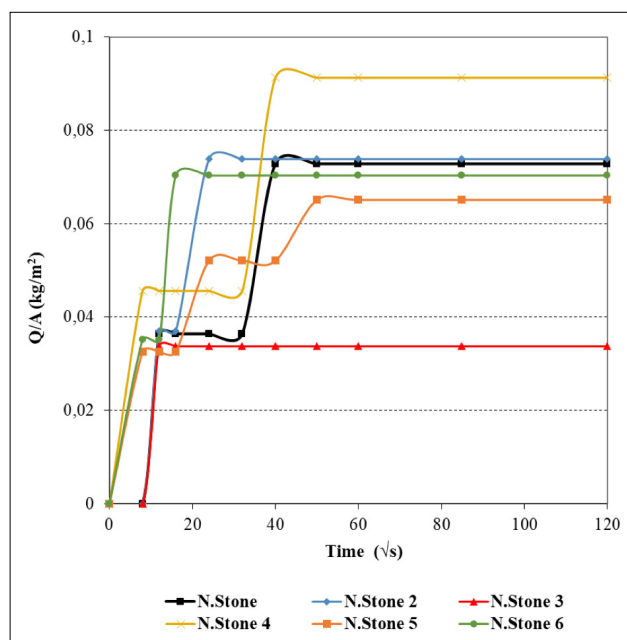
Within the scope of physical properties of the stone samples, real density, apparent density, and total and open porosity of the specimens were determined (Table 2) according to TS EN 1936 (TSE, 2007). Moreover, their water absorption (Table 2) was identified, and capillary water absorption curves were drawn (Figure 6) to calculate the capillary water absorption coefficient in line with TS EN 15801 (TSE, 2010) using cube specimens prepared with dimensions of 50±5 mm. However, since there was very little to no capillary water absorption on the surfaces of the specimens within the first hour, the regression line could not be drawn on the graph, and the capillary water absorption coefficient could not be determined.

**Figure 6.** Average capillary water absorption curves of the stone specimens.

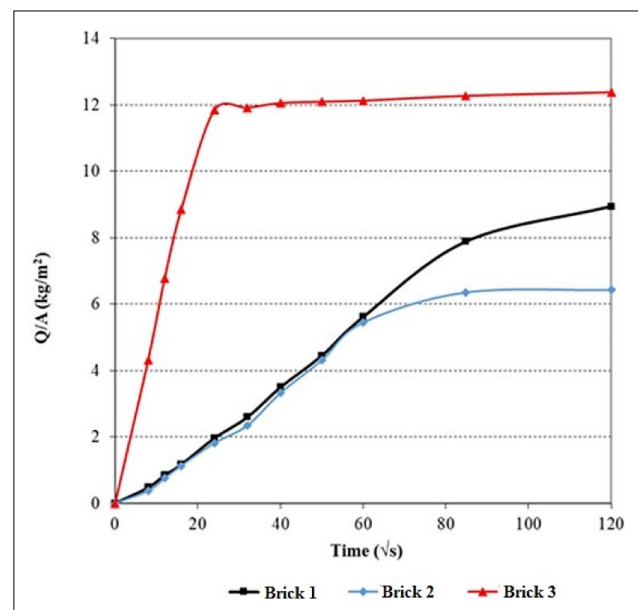
Brick specimens were detected to have an average apparent density of 1.8 g/cm<sup>3</sup>, a real density of 2.8 g/cm<sup>3</sup>, a total porosity of 35%, an open porosity of 29% according to TS EN 1936 (TSE, 2007) a water absorption ratio by weight of 17%, an average capillary water absorption coefficient of 0.1684 kg/(m<sup>2</sup>·√sec) according to TS EN 15801 (TSE, 2010) and it ranged from 0.0643 to 0.3680 kg/(m<sup>2</sup>·√sec). The capillary water absorption curves given in Figure 7 were utilized to determine the capillary water absorption coefficient.

Figure 7. Average capillary water absorption curves of the brick specimens.

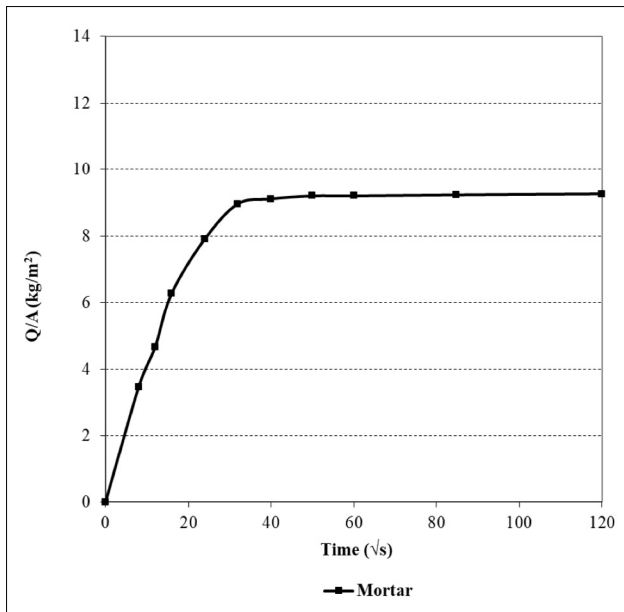
The capillary water absorption coefficients of the mortar samples were determined according to TS EN 15801 (TSE, 2010). Three specimens could be prepared only from mortar sample no. 3 based on the dimensions and geometrical qualities specified in the standard. The capillary water absorption coefficients of those three prismatic samples are presented in Table 9. The capillary water absorption curve given in Figure 8 is used to determine the capillary water absorption coefficient.

**Figure 8.** Average capillary water absorption curve of the mortar specimens.

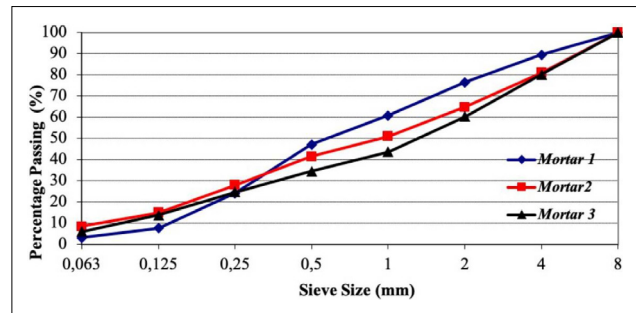
Acid loss analysis was performed to roughly estimate the binder:siliceous aggregate ratio of the mortar samples taken from different locations (Figure 5). Specimens weighing at least 50 g were taken from the mortar samples, pulverized, treated with 10% hydrochloric acid, and mixed for 60 minutes, and the weight loss ratio of each after acid treatment was determined by filtering them through filter paper. According to the results given in Table 10, the binder:aggregate ratio varies between 1:2 and 1:4. The aggregates retained after acid treatment were subjected to sieve analysis to determine their grain size distributions, as presented with the granulometry curves in Figure

9. Accordingly, the maximum aggregate grain size was determined to be 8 mm for all mortar samples.

**Figure 9.** Grain size distribution of the aggregates.

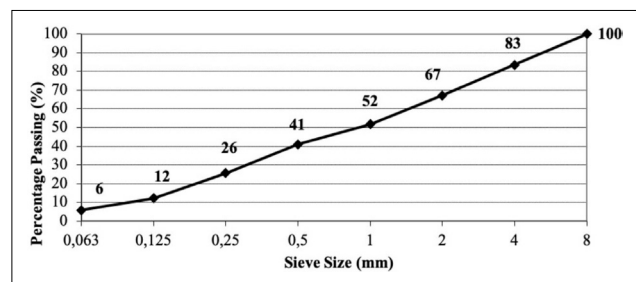
**Figure 10.** Suggested granulometry values for aggregate to be used in consolidation mortar.

considered suitable for use in the consolidation of the structure is given in Table 12. In the mixture, silica-based aggregate with a maximum grain size of 8 mm and natural hydraulic lime in NHL 3.5 class in accordance with TS EN 459-1 (TSE, 2012b) or alternatively lime putty (air lime) with pozzolan as the binder, are recommended to be used, and the grain distribution of the aggregates is suggested to be in accordance with the granulometry curve in Figure 10.

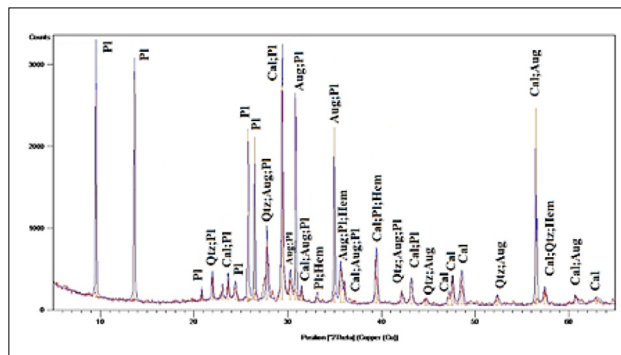
XRD analysis was performed using a GNR brand APD 2000-PRO model device, and the minerals contained in the powdered tuff specimen ( $d < 63 \mu\text{m}$ ) were determined qualitatively. According to the XRD analysis, quartz, plagioclase (anorthite), calcite, augite, and hematite minerals were observed in the diffraction patterns of the examined material (Figure 13). No distinct amorphous phase could be detected due to the XRD analysis of the examined sample. In order to determine the chemical composition of the material under investigation, XRF (X-Ray Fluorescence Spectrometry) analysis was performed on powder samples ( $d < 63 \mu\text{m}$ ) prepared in the laboratory using a Bruker brand S8 Tiger model device. The results

**Figure 13.** XRD diffraction patterns of the examined sample (Aug: Augite; Cal: Calcite; Hem: Hematite; Pl: Plagioclase; Qtz: Quartz).

not meet the minimum limit value of 70%, which is one of the conditions specified in TS 25 (TSE, 2008) and required for the material to be qualified as natural pozzolan.

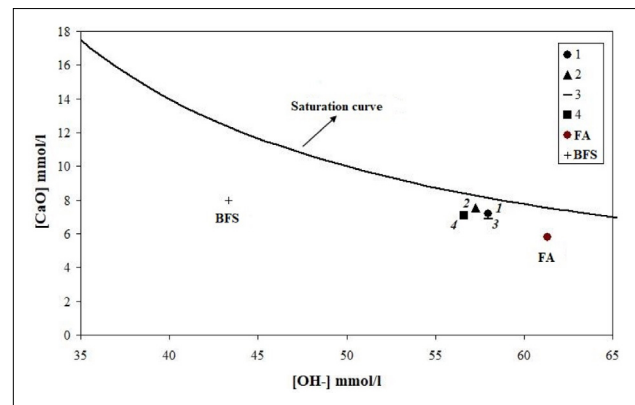
When the results of the mineralogical analysis (XRD), chemical analysis (XRF), and strength tests are taken into account, the examined material cannot be qualified as a natural pozzolan for cement and concrete as specified in TS 25. However, according to the results of the Frattini test, which is based on the chemical titration method and performed in accordance with TS EN 196-5 (TSE, 2012c), it was determined that the material in question showed low pozzolanic activity. In addition, blast furnace slag and fly ash, which are widely used artificial pozzolans, were also analyzed in order to compare the pozzolanic activity of the material under investigation. The results showed that the pozzolanic activity of the examined tuff fragments was lower than that of blast furnace slag and fly ash (Figure 14). In order to increase the pozzolanic effect, and thus the lime mortar strength, the contractor was advised to reduce the grain size below 63 or 75 microns by grinding the tuff fragments.

**Figure 14.** Frattini test results of four specimens from the same tuff sample (1, 2, 3, and 4), along with a blast furnace slag (BFS) specimen and a fly ash (FA) specimen. The plots of the four tuff specimens are situated near the saturation curve, indicating that they exhibit low pozzolanic activity.

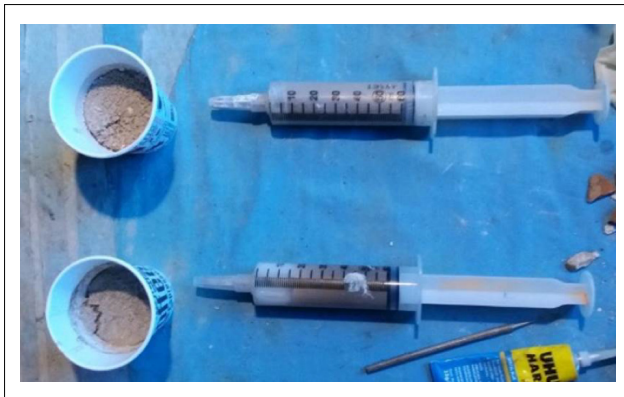
and tuff powder (under 75 microns). The grout mixtures were poured into 60-mL injectors standing vertically and also into small cups. It was observed at the end of one week that samples containing equal amounts of tuff powder and

limestone powder took a longer time to set, shrank, and bled more compared to those containing only limestone powder as the aggregate (Figure 17). These results suggested that tuff powder did not sufficiently react with air lime, which is a non-hydraulic component of NHL, and did not contribute enough to the setting process. Hence, the results were considered compatible with the results of the pozzolanic activity tests applied. With respect to this, the tuff powder was decided not to be used in the next trial blends prepared at the worksite. In this context, trial blends containing NHL, limestone powder, water, and acrylic dispersion (Primal AC33 equivalent) were prepared. To be able to ensure sufficient fluidity by using the minimum amount of water, the amount of water in each blend prepared was reduced compared to the amount used

**Figure 17.** Injectors and cups used to monitor the bleeding water, shrinkage amount, and setting status of the trial grouts prepared at the worksite for injection.
