## Recommendations for investigation and improvement of the effect of solid waste irregular storage area on water sources in Düzce, Turkey

#### Abstract

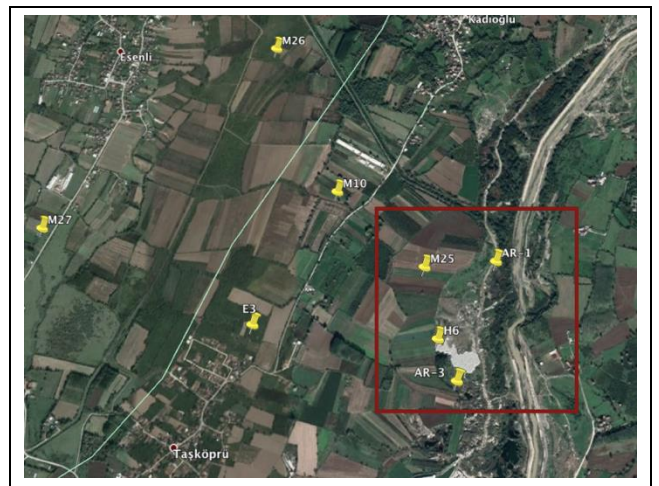
Figure 5. Satellite image of boreholes and research pits in the study area.

In order to determine the quality of surface and groundwater and the degree of being effected from solid waste irregular storage area in the study area, water samples were taken from representative points on the upstream and downstream sides of the site (Figure 5). Hydrogeochemical analysis of the water samples taken from the study area was made, and water classification was made using Schoeller and Piper diagrams (Table 1&Table 2). In addition, the drinkability and the irrigation suitability of the waters have been determined.

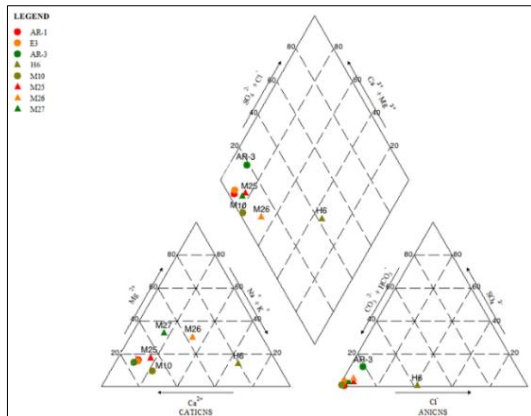
Figure 6. Demonstration of water samples on piper diagram (%meq).

In order to determine the facies of the water samples taken from the study area, the % meq values of the major anions and cations were calculated and shown in the Piper diagram (Figure 6). According to the Piper diagram, the sample H6 is in the Na-HCO<sub>3</sub> waters class and others are in the with Ca-HCO<sub>3</sub> water class. Sample H6 was taken from the leak-water at the boundary of downstream of the solid waste site.

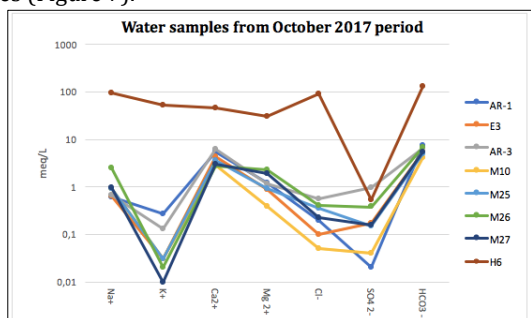
Figure 7. Demonstration of water samples on schoeller diagram.

Groundwater in the study area generally shows similar characteristics (Ca<sup>2+</sup> + Mg<sup>2+</sup> > Na<sup>+</sup> + K<sup>+</sup>) and HCO<sub>3</sub><sup>-</sup> > SO<sub>4</sub><sup>2-</sup> > Cl<sup>-</sup>) in terms of major elements. H6 has shown different properties (Na<sup>+</sup> > K<sup>+</sup> > Ca<sup>2+</sup> > Mg<sup>2+</sup> and HCO<sub>3</sub><sup>-</sup> > Cl<sup>-</sup> > SO<sub>4</sub><sup>2-</sup>), and the being has different facies was associated with solid wastes (Figure 7).

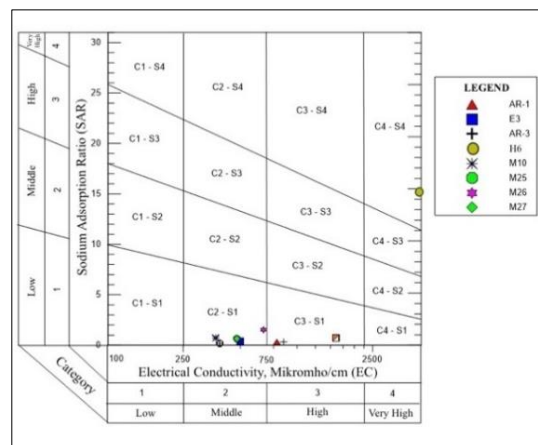
Figure 8. Demonstration of water samples on US salinity diagram.

According to the US Salinity Diagram, water samples taken from boreholes are in good condition in terms of usability as irrigation water (Figure 8).

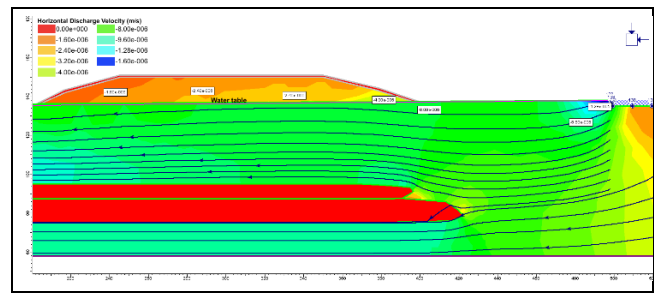
Figure 9. Horizontal flow velocities and vectors of groundwater in natural state in solid waste storage area.

Scenario-I indicates the groundwater level model findings (horizontal flow velocities and vectors) in the natural condition of the solid waste storage site (Figure 9). It is seen that from this scenario-I model findings there is no horizontal groundwater flow in the solid wastes. In Scenario II, the groundwater flow model of the Küçük Melen Stream in the flooding condition was made. In Scenario III, groundwater flow model analysis was made for different depths of an impermeability curtain that did not reach the impermeable base.

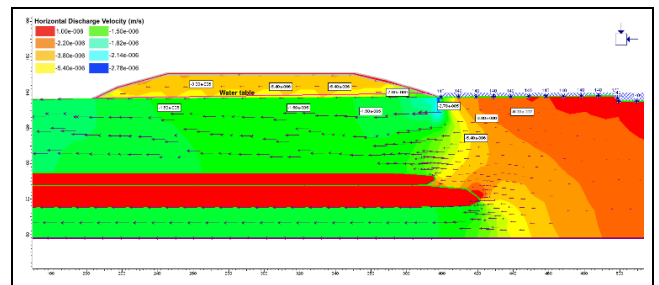
Figure 10. Horizontal flow velocities and vectors of groundwater in case of flooding in the solid waste storage area.

In case of Küçük Melen Stream overflowing 2 m (Scenario II), it has been observed that the water table rises by 2.6 m in the solid wastes and groundwater flow was occurred in the solid wastes (Figure 10).

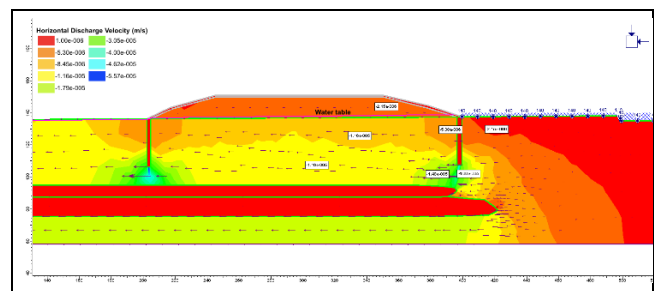
Figure 11. Horizontal flow velocities and vectors of groundwater when a 30m impermeable curtain is applied in the flood in the solid waste storage area.

In Scenario-III, analyzes were repeated for impermeable curtain systems at different depths in order to reduce the water table rising in overflowing situation. In a condition of the impermeability curtain depth is 10 m, 20 m and 30 m, decreasing of groundwater level by 35 cm, 62 cm and 88 cm have been observed in the analysis (Figure 11).

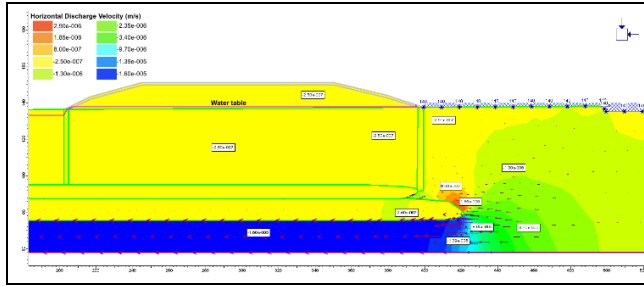
Figure 12. Horizontal flow velocities and vectors of groundwater when 45m impermeable curtain is applied in flood in the solid waste storage.

However, these values are lower than the rise at the moment of flood. For all that, it was observed that the horizontal flow decreased significantly at the base of the waste field. In case of the vertical impermeable system is lowered to the natural impermeable clay layer on the base (45 m), solid wastes covered with impermeable clay were completely isolated from the surface water and groundwater (Figure 12).
