Safe right bundle branch block pattern during permanent right ventricular pacing: a case report

Abdelkarim Errahmouni, M.D., Jean Christophe Charniot, M.D., Jean Yves Artigou, M.D.

Department of Cardiology, Avicenne Hospital, (Assistance Publique Des Hôpitaux De Paris), Bobigny, France

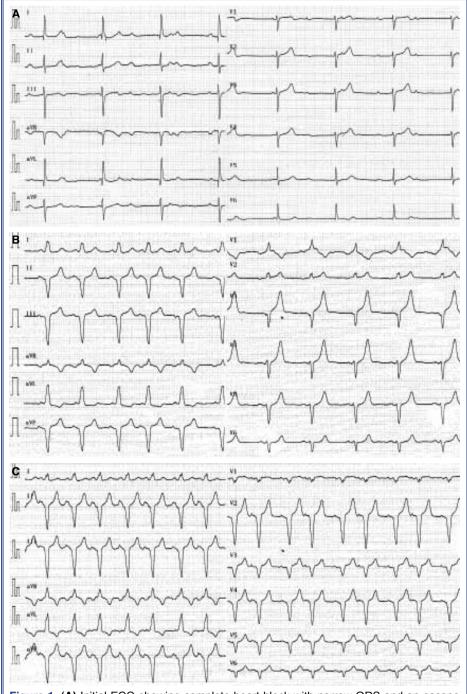
Figure 1. (A) Initial ECG showing complete heart block with narrow QRS and an escape rhythm at a rate of 44/min. **(B)** Postoperative surface ECG showing atrial tracking and ventricular pacing with RBBB pattern in V1 and V2 (Rs and R complexes) associated with a frontal axis of -70°. **(C)** Moving the leads V1-V2 one interspace lower than standard results in LBBB configuration with the inscription of QS complexes in leads V1 and V2.

A 72-year-old male was admitted to our hospital for new-onset history of syncope. His physical examination was unremarkable except for a slow heart rate (44 beats/min). His initial electrocardiogram (ECG) showed complete heart block with an escape rhythm at the rate of 44 beats/min and QRS complex duration <100 ms (Fig. 1a).

A transvenous dual chamber pacemaker was implanted. The postoperative course was uneventful with normal physical examination, but the initial ECG showed an unusual RBBB pattern with LBBB in lead D1. QRS on the frontal axis was around -70° with exclusive R wave in V1 and V2 leads. Precordial transition occurred by lead V3 (Fig. 1b). Malposition of a ventricular lead was suspected and an echocardiography was

review, an ECG maneuver by placing leads V1 and V2 one intercostal space lower than standard eliminated the RBBB pattern (Fig. 1c), and the pacemaker was deemed by the cardiologist to be operating properly.
