Bilateral isolated traumatic patella fracture: A case report

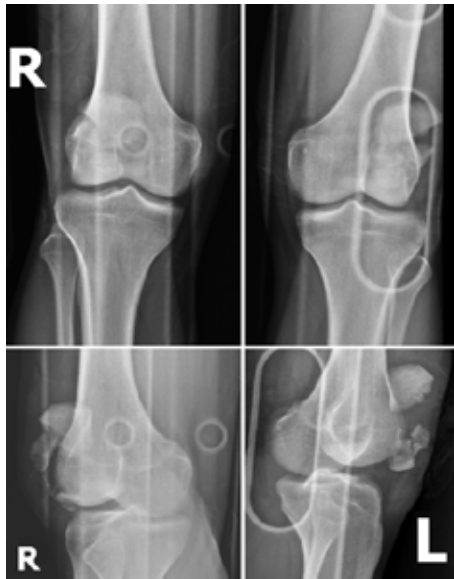
Figure 1 Direct radiographs of bilateral traumatic patella fracture.

Physical examination revealed significant swelling in both knees and crepitation due to fractured fragments. The patient had no other injuries. Radiographs revealed comminuted displaced patella fractures in both knees.

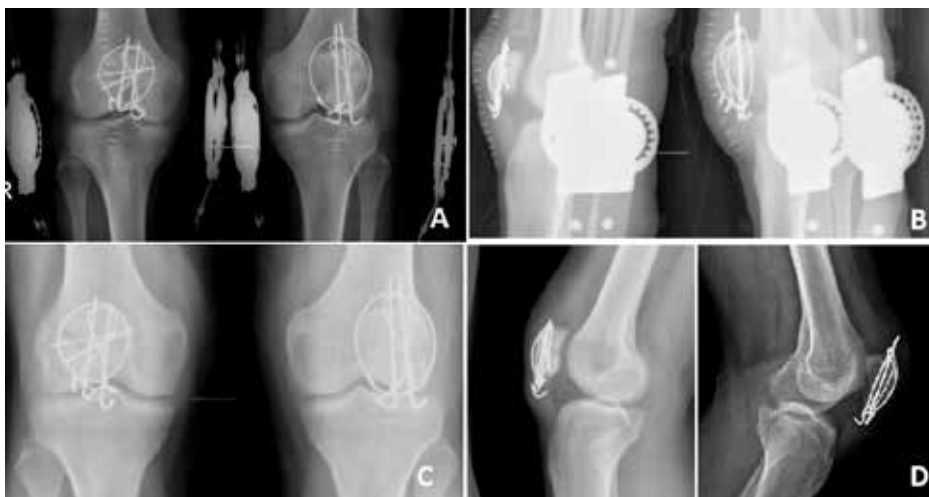
Figure 2 (a and b) Postoperative anterior–posterior and lateral radiographs of the patient who underwent anterior cross-tension band and circumferential cerclage application to both knees. (c and d) Anterior–posterior and lateral radiographs showing complete union in the postoperative sixth week.

The patient was hospitalized, and both his knees were operated on the same day as the accident, under spinal anesthesia and in the same session with tourniquet control. Open reduction and internal fixation were performed. The patient was placed supine, and an anterior longitudinal incision was made on both knees. The fracture fragments were reduced and stabilized using 1.6-mm Kirschner wires. An acceptable degree of superficial stepping/surface mismatch was detected by controlling the patella joint surface in both knees, and an anterior cross-tension band technique was applied with the help of a 1-mm cerclage wire. In addition, a circumferential cerclage technique was applied using a 1-mm cerclage wire due to multipart fractures. The reduction quality and articular surface were examined using fluoroscopy. The retinaculum was repaired in both knees. Then, the stability was

to both sides. On the postoperative fourth week, the knee brace angle was increased to 60° and the exercises were continued. The complete union was observed in the postoperative sixth week, and the knee braces were completely removed. The patient could walk without support in the postoperative 18th month. All knee joint ranges of motion were open and painless, and the patient was satisfied with his life.
