The role of bedside ultrasonography for occult scaphoid fractures in the emergency department

Ahmet YILDIRIM, Erden Erol ÜNLÜER, Nergiz VANDENBERK, Arif KARAGÖZ

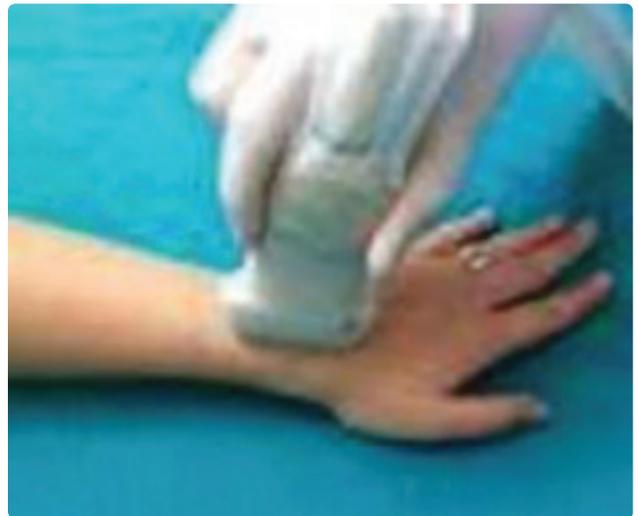
Fig. 1. Orientation of ultrasonography probe while longitudinal scanning of the scaphoid bone.

Immediately following the clinical examination, US was performed by the emergency physician. Images were obtained using the standard equipment available in the emergency department (DC 3, Mindray Bio-medical Electronics Co., Shenzhen, China), with a small, compact linear (5-13 MHz) transducer for superficial structures. The examination was made through transmission sonographic gel. Using the anatomical landmarks of the wrist, and commencing the examination at the radius, the scaphoid was identified by its bi-lobed or peanut shape with a smooth and hyperechoic bone surface contour.^[3] In order to correctly elongate the scaphoid, the hand was positioned in ulnar deviation, both in frontal and sagittal planes. A neutral frontal plane image, with the palm lying on the table, was also obtained to assess the dorsal aspect of the bone (Fig. 1). Using these different wrist positions, BUS examination covered the volar, dorsal, and lateral aspects of the scaphoid, with images obtained in the longitudinal and axial planes of the bone. The radiocarpal and midcarpal recesses were inspected in the sagittal plane, for both the dorsal and volar planes of examination.^[3,4]

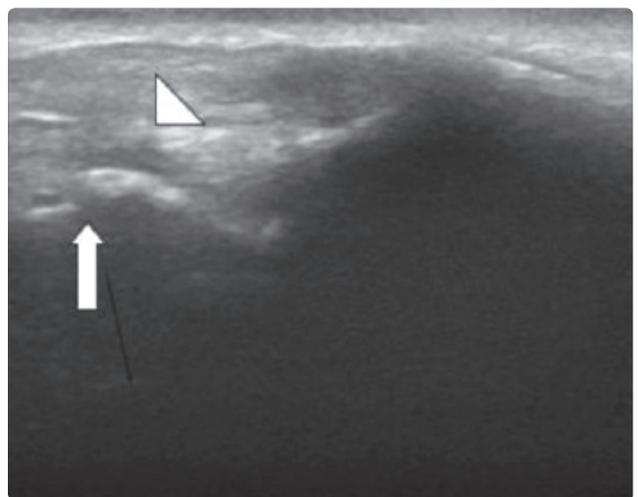
Fig. 2. Longitudinal view of the scaphoid bone with ultrasound shows cortical discontinuity (white arrows), along with radio-carpal effusion and surrounding hematoma, suggestive of scaphoid fracture (white arrow head).

The emergency medicine physician was asked to assess the continuity of the scaphoid cortex (seen as a smooth, thin, hyperechoic line) and the presence of fluid effusion in the radioscaphoid and scaphotrapezium trapezoid spaces (Fig. 2).^[3,5] Signs associated with scaphoid fracture were either the cortical disruption of the scaphoid contour, producing a focal deformity, or hemarthrosis, seen as hypoechoic fluid in the radioscaphoid or scaphotrapezium trapezoid spaces.^[6,7] These findings have been reported in the literature as the most suggestive signs associated with scaphoid fracture.^[3,5,8] MRI of the wrist was performed within 24 hours of the sonographic examination.
