A new approach based on reliability-based analyses for allocation of fault between responsible parties in geotechnical failures

Gokhan IMANÇLI^{1*}, Gürkan ÖZDEN²

Research Article/Araştırma Makalesi

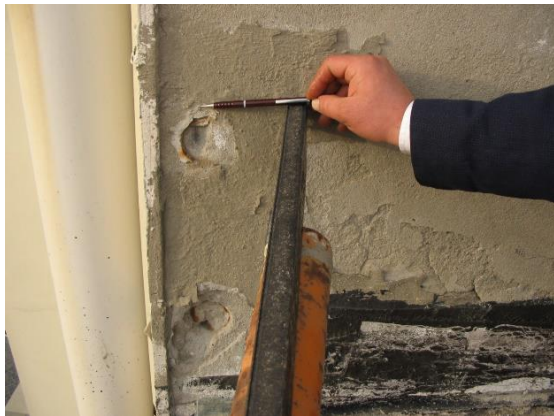
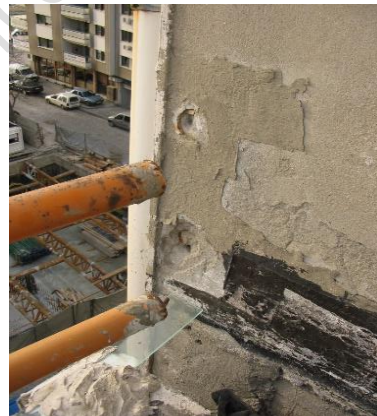
Figure 4. Upper-Level Deformations of the Damaged Building Subject to the Lawsuit.

Deformation Perpendicular to the Excavation (14 cm)

Deformation Parallel to the Excavation (13cm)

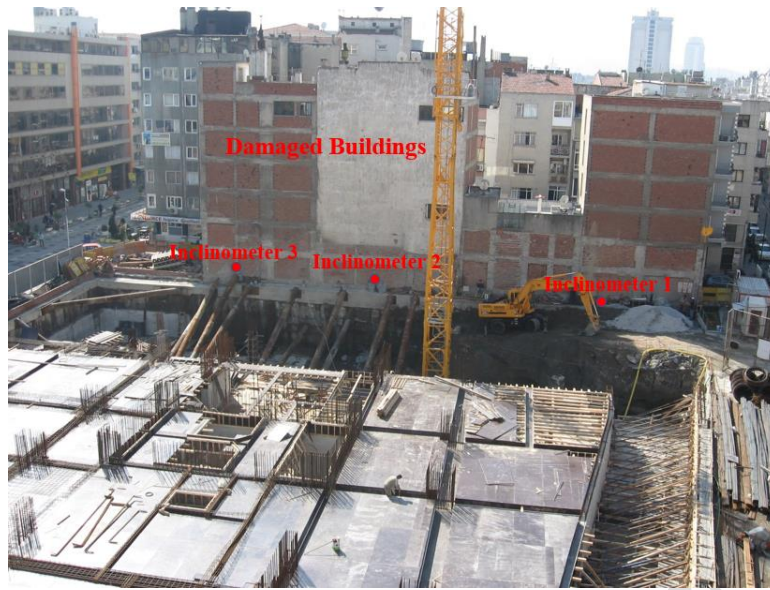
Figure 5. View of the subject building and the location of the inclinometers.

are shown in Figure 5, the steel pipe struts with 3 m plan spacing shown in both Figure 5 and Figure 6 were placed between the raft foundation and the shoring cap, which were completed in stages. As a result of the examination of the project drawings, it has been determined that the buildings to be protected with a staggered strut system on the west side have generally been constructed by their projects. The technical committee decided to carry out instrumental observations in the field in order to complete the excavation safely. These instrumental observation works are organized as summarized below:

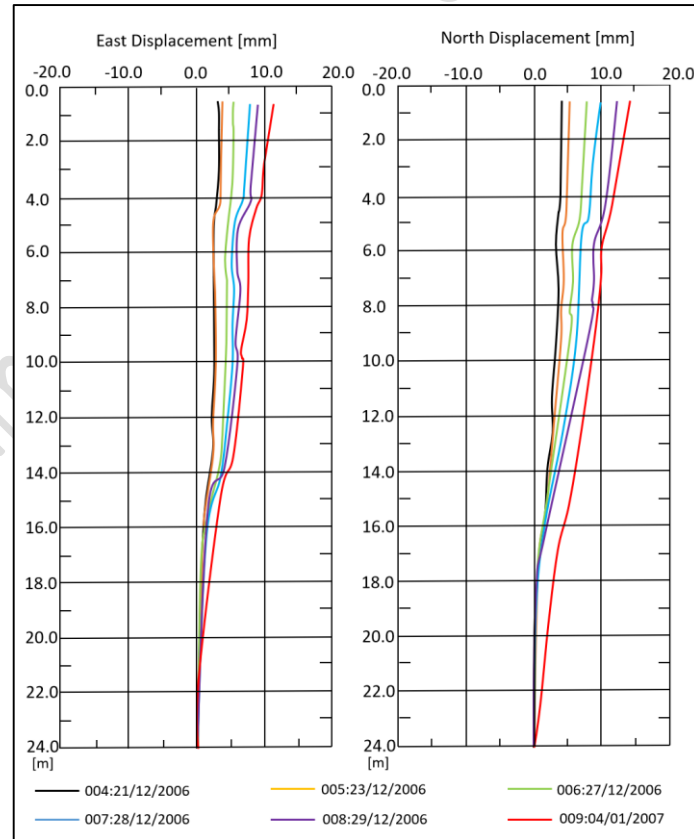
Figure 7. No. 2 Inclinometer measurement graphs.

When the inclinometer measurements were analyzed, it was determined that the excavation continued after the necessary precautions were taken, when the final excavation level was reached, approximately 15 mm deformation occurred at the pile cap level in the direction perpendicular to the excavation and approximately 12 mm deformation occurred in the direction parallel to the excavation (Figure 7). As a result of the measures taken, the deformations could be kept under control and the basement construction was completed.

1. Periodic readings were taken from the three inclinometer wells adjacent to the buildings subject to the lawsuit, of the excavation pit. During the excavation process of the part that has not yet been excavated on this side of the excavation area, it is foreseen that inclinometer measurements will be of great benefit in taking additional measures before the deformations in this side shoring structure reach the limits that will damage the structures, and in this way, the works will be completed safely.
