Measurement of important tribocorrosion properties of titanium implant and assessment with digital image processing

Emrah Irmak^{1*}

doi: 10.5505/pajes.2025.55562
Research Article/Araştırma Makalesi

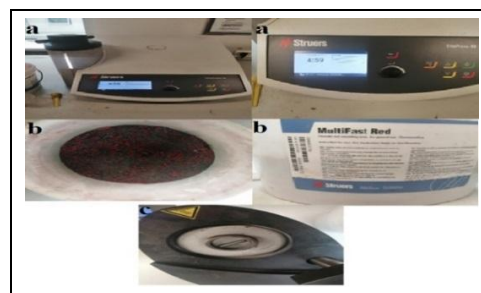
Figure 2(a): Hot molding device. (b): Phenolic resin. (c): Placing the cut sample into the hot molding chamber.

Samples cut to appropriate sizes are placed in the hot molding device using phenolic resin. The sample to be examined is placed in the chamber of the bakelite device in an appropriate manner. First, hot bakelite powder is poured onto the sample. The point to be noted here is that the powders should be compacted because when compaction occurs, the bakelite powder should pass the sample surface and it is also important that the bakelite powder completely covers the other surfaces of the sample. After the sample is placed, the sample and bakelite powders are kept at 150 °C temperature and 30Mpa pressure for a certain period of time, then cooled and the sample is removed from the chamber. Resins such as bakelite, acrylic and epoxy are preferred when hot molding is applied. Phenolic resins are a thermoset plastic. After the cut samples are placed in the hot molding device and a certain amount of phenolic resin is added, the device is turned on and the sample is made ready. Figure 2 shows the placement of the phenolic resin and samples in the hot molding device. The surfaces of the samples cut with precision cutting are scratched and rough. The sample should be sanded to remove this rough and scratched surface. The sanding process is done in order. In each order, the finer sanding is used than the previous one. In this way, the deformation and scratches formed on the samples are reduced to a minimum level. Sandpapers are obtained by sticking SiC, Al₂O₃ similar abrasives that are resistant to water, hard or fabric. Sandpapers are numbered according to the size of the abrasives. The numbering of sandpapers is done according to the number of abrasive grains. As the sandpaper number increases, the abrasive particle sizes on the sample surface

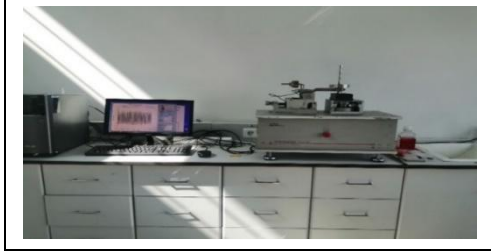
Figure 4. UTS Tribometer T10 tester.

UTS Tribometer T10 test device was used in the abrasion tests. Tests in accordance with ASTM G-99 standard can be performed with this test device. Abrasion and friction behaviors can be examined by performing tests in accordance with ASTM G13 standard. Thanks to the corrosion cell, it allows the examination of abrasion and friction on materials in different corrosive environments (body fluids, basic solutions,

etc.). Electro-Tribocorrosion test can be performed by adding a potentiostat. It provides high resistance of the material against corrosion and enables long-term use. It allows abrasion and friction tests to be performed on biomedical materials. The test device used for abrasion test is shown in Figure 4.

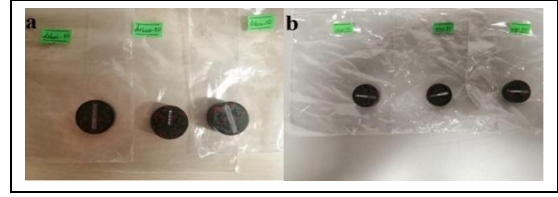
Figure 7(a): Images of samples coming out of the abrasion tester after applying 10 N, 20 N and 30 N loads to Ankara samples, respectively. (b): Images of samples coming out of the abrasion tester after applying 10 N, 20 N and 30 N loads to Gaziantep samples, respectively.

All samples were cleaned with alcohol before and after the abrasion test. Figure 7 shows the samples coming out of the

abrasion tester after applying 10 N, 20 N and 30 N loads to the samples from two companies, respectively.

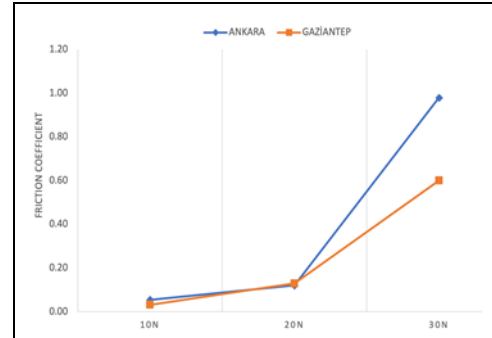
Figure 9. Average values of friction coefficient.

The average values of abrasion depth, friction coefficient and friction force of the samples after the abrasion test are shown in Figure 8, Figure 9 and Figure 10, respectively.

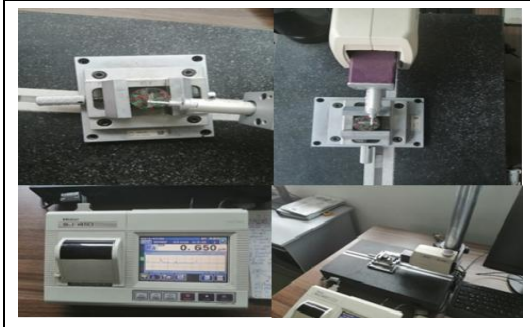
Figure 12. Placing the samples in the device for abrasion scar depth.

The placement of the samples supplied by both companies in the device used to determine the abrasion scar depth is shown in Figure 12.

The abrasion scar depths of the samples obtained from the wear test were measured in the order of Ankara 10 N, Ankara 20 N, Ankara 30 N, Gaziantep 10 N, Gaziantep 20 N, Gaziantep 30 N. The results of the measurements are shown in Table 2 and Table 3.

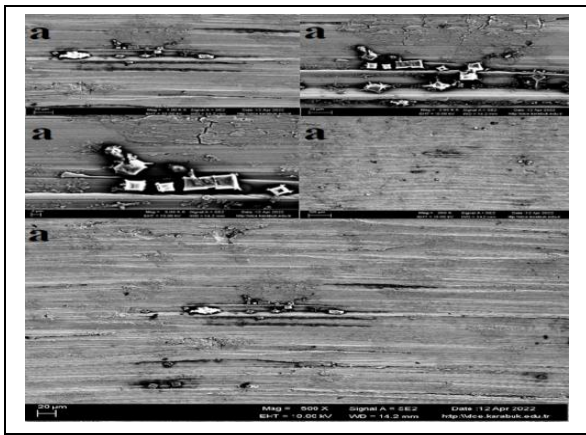
Figure 15. Ankara 10 N-1.00kx, 2.50kx, 5.00kx, 250x, 500x SEM images of the samples after the abrasion test, respectively.

Scanning Electron Microscope (SEM) images of the titanium alloy after abrasion and corrosion were taken to investigate the potential of using image processing techniques in tribocorrosion applications. SEM images of the samples supplied by two companies were taken. Figure 15 shows SEM images of the samples obtained from Ankara company after the abrasion test.

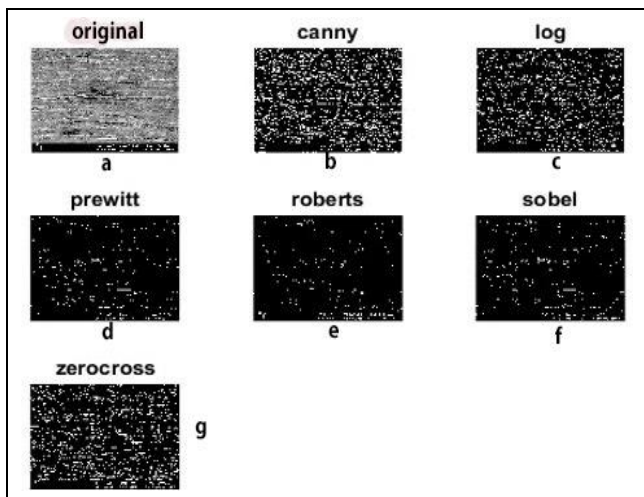
Figure 21. Applying edge detection process to Ankara 10 N abrasion sample image.

Edge detection on an image can be used to detect, count and determine the properties of objects in that image. Edge detection algorithms are most basically determined by the differences in the color values of pixels on the image. These differences are called transitions and represent the edge lines for us. In this section, each algorithm can detect by making its own inferences. In Figure 21 and 22, you can see an image with the edge extraction algorithm applied.

The Canny algorithm uses four filters to detect horizontal, vertical and diagonal edges in the blurred image. The image is filtered by the kernel to obtain the first derivative in both horizontal and vertical directions. Roberts, Sobel and Prewitt are Gradient-based edge detection and involve finding the gradient of the image intensity function. The gradient measures the rate of change of intensity, and edges are typically located where this rate of change is maximized. Laplacian of Gaussian (LoG) and Zero-cross are Gaussian-based edge detection and involve smoothing the image with a Gaussian filter to reduce noise and then detecting edges, often using second-order derivatives. In Figure 21 and Figure 22, the edge detection process from digital image processing techniques was applied to the samples with the help of the MATLAB program. Using the edge detection method, discontinuities in the depth of the images, orientations on the sample surface and changes in material properties were examined. Thanks to the edge detection algorithm, a path is created corresponding to the boundaries of the objects, the boundaries of the surface marks and discontinuities in the surface orientation.
